Article

The influence of welding heat input on the quality and properties of high strength low-alloy dissimilar steel butt joints

Abstract: The paper presents the results of non-destructive and destructive tests of dissimilar high-strength low-alloy S460ML and S460N steel butt joints. These steels are characterized by similar mechanical properties, but their carbon equivalent C_{eqW} values are much different. The joints were made using different values of heat input for each welding bead. They were tested by non-destructive methods: visual, penetrant, radiographic and ultrasonic tests. Then, the destructive tests were made: static tensile test, bending test, impact test and Vickers HV10 hardness measurements. The results of prepared examinations showed, that welding with higher heat input has significant impact on the mechanical properties of the dissimilar steel joints – the joint welded with bigger heat input was characterized by better mechanical properties.

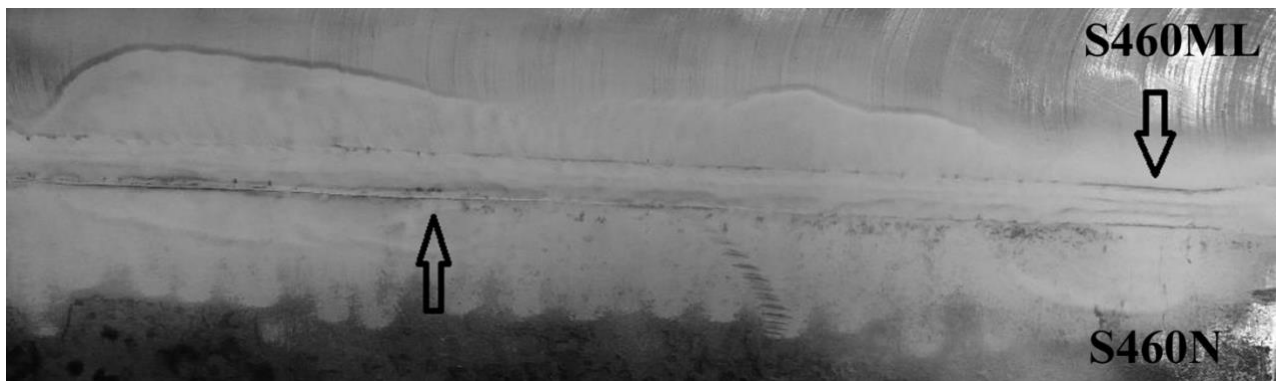
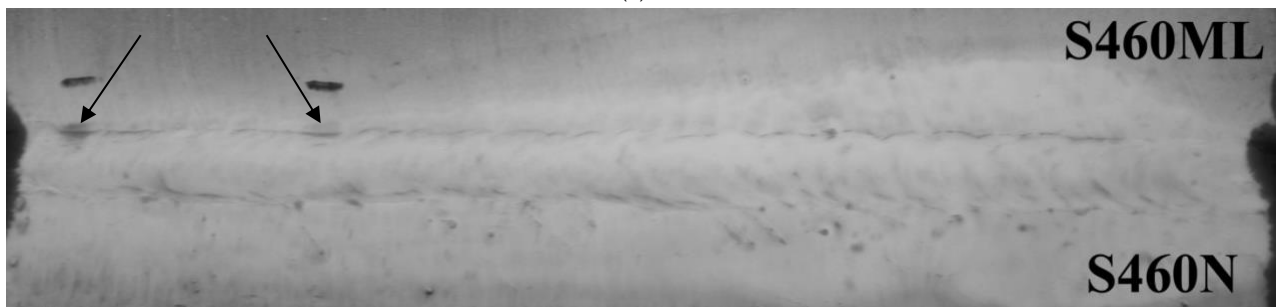
Fig. 4. Results of PT: a) Specimen 1, porosity in the middle, indication at right; b) Specimen 2, lack of fusion marked by lines

Before applying the penetrant, the surfaces were cleaned and the spatters were removed from them. A penetrant was then applied, the excess of which was removed with a cleaner after ten minutes, to then apply a developer layer. During the examination of the first sample, two indications appeared on both sides of the weld at the fusion line and a cluster of blisters at the place indicated during VT tests from the S460N steel side. Examination of a sample welded with lower heat input showed no other indications than in VT tests. The results of PT testing are presented in figure 4.

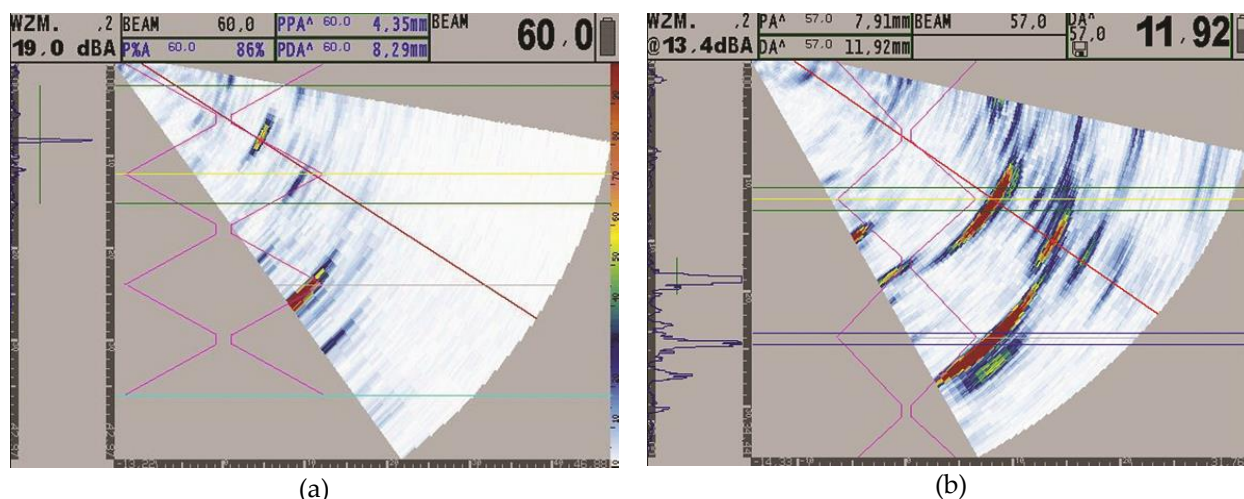
Fig. 6. Example results of UT, Phased Array: a) Specimen 1; b) Specimen 2

The Phasor XS defector was used to perform the ultrasonic tests, allowing the use of the Phased Array head. A 16-element head was used, the wedge of which has a 36° angle of inclination. The head sends 4 MHz waves. During the tests, type A and S imaging were obtained. For both joints, the tests were carried out in places where indications on radiographs appeared so as to determine their depth of occurrence. Similarly to other non-destructive tests, it was proved that a greater number of discrepancies occurred in joint 2, which was performed using a smaller amount of introduced heat. It was also confirmed that discrepancies occur at the fusion line and in the HAZ of S460N steel. In the case of the first joint, discrepancies occurred at a depth of 8 to 11.5 mm from the upper surface of the sample, while in joint 2 their depth was more diverse, from 5 to 12 mm. Examples of type A and S flaw detectors imaging are presented in figure 6.
