Article

Mechanical and Microstructural Characterization of TIG Welded Dissimilar Joints between 304L Austenitic Stainless Steel and Incoloy 800HT Nickel Alloy

Abstract: In this article, the mechanical properties and microstructure of 304L austenitic stainless steel/Incoloy 800HT nickel alloy dissimilar welded joints are investigated. The joints were made of 21.3 mm × 7.47 mm tubes using the TIG process with the use of S Ni 6082 nickel filler metal. No welding imperfections were found and high strength properties of joints were obtained, meeting the assumed acceptance criteria of the product's standards. The tensile strength of the welded joints was higher than for the joined materials (Incoloy 800HT). Macro- and microscopic metallographic tests revealed the correct morphology of the joints and the appropriate structures in their critical zones. However, differences were found in the morphologies of the zones between the weld and the base materials. In fusion boundary from the side of the Incoloy 800HT alloy, no clear outline of the fusion line was observed (type A fusion boundary), while increased grain size and an epitaxial structure were observed. In turn, in the zone: weld–304

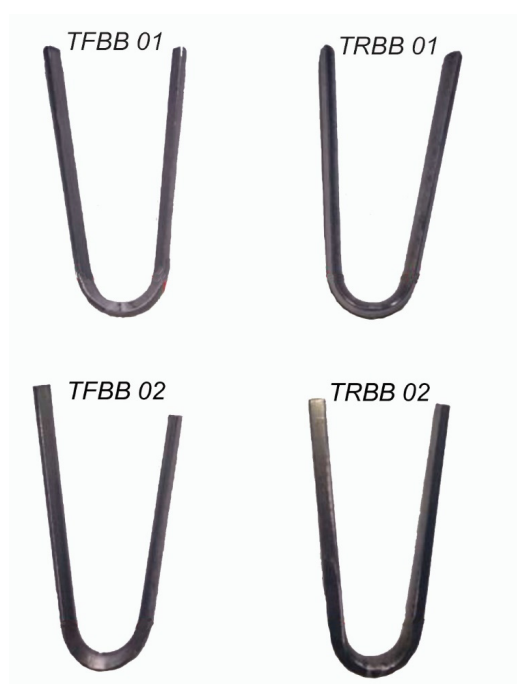
Figure 5. Specimens after bending tests.

The obtained test results were considered positive. All specimens reached a bending angle of 180° . There were no cracks or other material defects on the tensiled surfaces. Even areas not subjected to assessment did not show welding imperfections. This proves the very good plastic properties and lack of welding imperfections in the tested specimens. Like the strength properties, the plastic properties are a derivative of the proper selection of the filler metal and welding parameters. The proposed bevel angle did not cause a reduction in the wettability of the filler or fusion of the tube walls, as evidenced by the lack of cracks and delaminations of the tensiled surfaces.

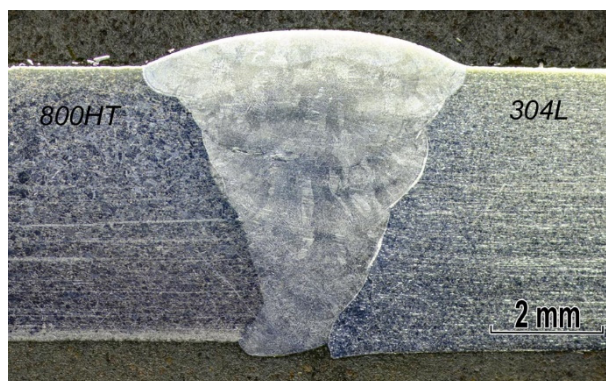
Figure 6. Cross-section of the Incoloy 800HT nickel alloy–304L austenitic stainless steel welded joint.

Figure 6 presents a macroscopic view of a cross-section of the obtained dissimilar welded joint. There were no welding imperfections in the specimen, i.e., no cracks or porosity. The joint was symmetrical and was characterized by complete penetration and a smooth transition of the face into the base material. On the fusion line in 304L steel, white bands can be seen, which were formed as a result of structural changes. Metallographic microscopic tests were performed for base materials, weld and in the transition areas: weld–Incoloy 800HT and weld–304L stainless steel. Figure 7 shows the structure of base materials: Incoloy 800HT and 304L austenitic stainless steel. Incoloy 800HT is a solid solution with a full austenitic structure, many twins (Figure 7a) and Ti(N,C) precipitates (Figure 7b, indicated by an arrow). No changes were found relative to the typical structure of the material; 304L stainless steel has an austenitic structure (Figure 7c) with characteristic twins, slip bands and δ ferrite precipitates (Figure 7d). The structure of the tested 304L steel is correct. No structural anomalies caused by the manufacturing process, e.g., inadequate solution annealing, were identified for either material. Figure 8 shows the structure of the middle part of the weld. The weld has an equiaxed, fully austenitic structure with coarse and fine dendrites. Eutectics and microcracks were not detected in the weld.
