# Dissimilar underwater wet welding of HSLA steels

Jacek Tomków<sup>1</sup> · Dariusz Fydrych<sup>1</sup> · Grzegorz Rogalski<sup>1</sup>

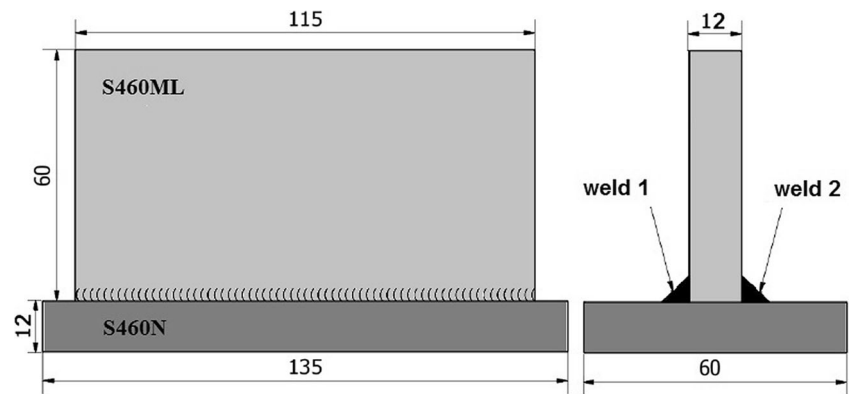
**Fig. 1** Schematic view of T-joints with fillet welds

water surface to the upper surface of S460N steel) at a temperature of 20 °C. Plates from S460ML steel had a dimension of 115 × 60 mm; dimension and plates from the S460N steel had a dimension of 135 × 60 mm. The schema of T-joint is presented in Fig. 1.

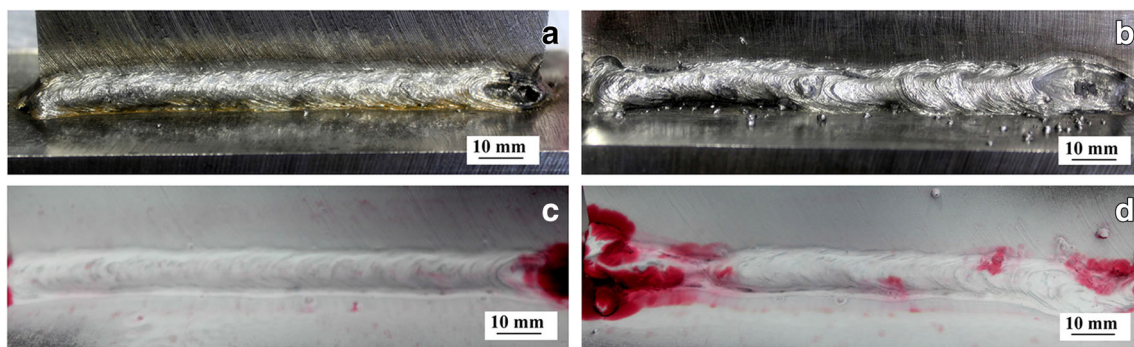
**Fig. 2** Exemplanary results of the non-destructive tests. **a** VT, weld 1 from specimen 1; **b** VT, weld 1 from specimen 3; **c** PT, weld 2 from specimen 1; and **d** PT, weld 2 from specimen 2

At first, all six welds were visually tested in accordance with the EN ISO 17637:2011 standard [44]. Then, all of them were subjected to PT in accordance with EN ISO 3452-1:2013-08 standard [45]. Non-destructive tests were performed which showed some imperfections in welds prepared using the TBW technique. The most common imperfections were lack of fusion and undercut (Fig. 2b and d). These imperfections resulted from temper beads which were laid only for tempering the previous beads. Because the undercuts are classified as imperfect shape and dimension of weld, and do not affect the changes in the structure and properties of joints, all specimens were subjected to further tests. During testing, spatters was found on the surface of the specimens. In all welds, there were areas without any surface imperfection, which allowed the specimens and preparing cross-sections for further examinations. The exemplary results of the non-destructive tests are presented in Fig. 2.

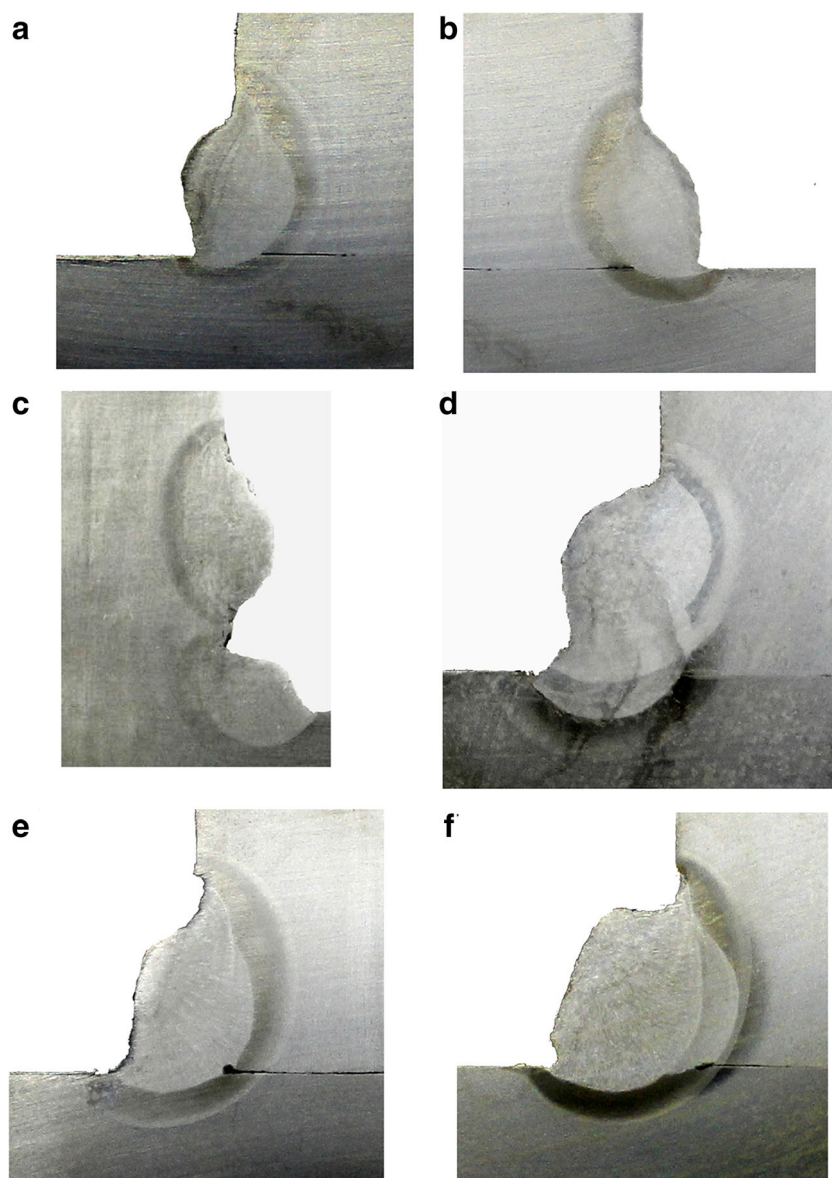
**Fig. 3** Results of the macroscopic testing. **a** Weld 1 specimen 1—without TBW, **b** weld 2 specimen 1—without TBW, **c** weld 1 specimen 2—pitch 0%, **d** weld 2 specimen 2—pitch 79%, **e** weld 2 specimen 3—pitch 91%, and **f** weld 1 specimen 3—pitch 100%

Macro- and microscopic investigations were performed in accordance with EN ISO 17639:2013 standard [46]. After cutting, all the cross-sections were ground, polished, and etched with Nital (4%). The main aim of the macroscopic testing was to calculate the pitch in specimens 2 and 3. During macroscopic observations, the imperfection was seen as gas pores in both welds from specimen 1, weld 1 from specimen 2, and weld 2 from specimen 3. All these imperfections were located near the point of contact between the BMs. The used TBW technique did not affect their formation—the second weld did not cover these places. The results of the macroscopic testing are presented in Fig. 3.

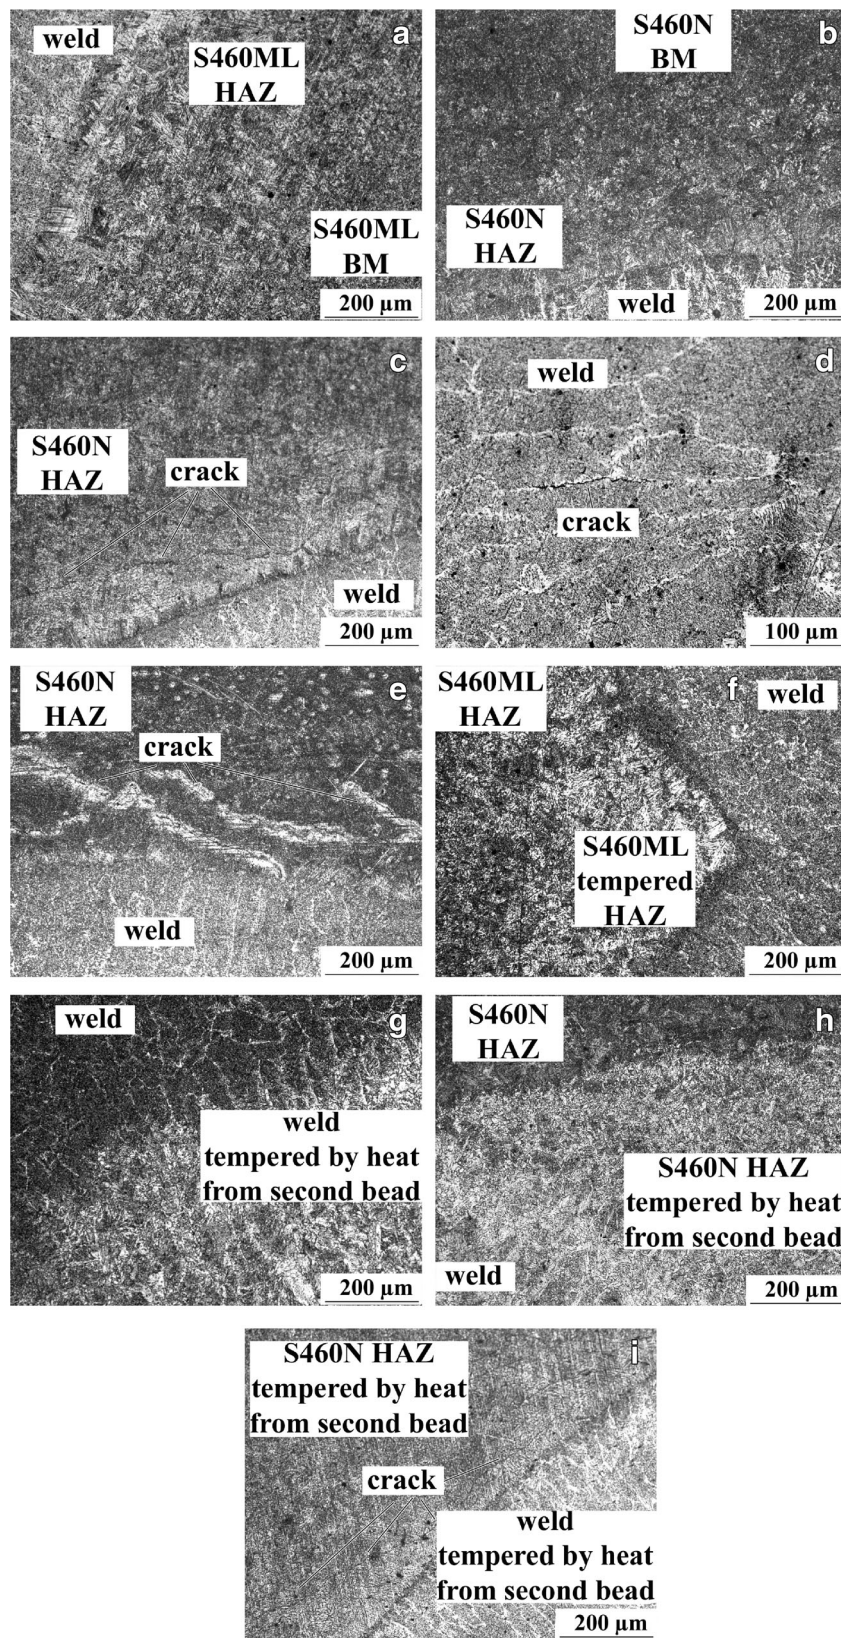
**Fig. 4** Results of the microscopic tests. **a** Structure of S460ML HAZ—without TBW, **b** structure of S460N HAZ—without TBW, **c** cracks in S460N HAZ—without TBW, **d** cracks in weld material—without TBW, **e** cracks in S460N HAZ—pitch 0%, **f** tempered S460N HAZ—pitch 0%, **g** S460ML weld material tempered by heat from second bead, **h** tempered S460N HAZ that was affected by heat from second bead, and **i** cracks in S460N HAZ—pitch 91%

After macroscopic tests, the microscopic investigations were performed. The weld metal structures in specimen 1 were built of dendrites. In the specimen 1—welded without TBW technique, brittle structure such as low-carbon martensite was found in the HAZ of both steels in each welded joint. Near the fusion line the Widmannstätten structure was observed (Fig. 4a and b). In addition, in the HAZ of the S460N steel, cracks were found in weld 2, which was welded with a lower heat input (Fig. 4c). These cracks started in HAZ and propagated along approximately 80% of the length of the fusion line in the S460N steel. Cracks were also found in the weld material of the specimens in

which the TBW technique was not applied (Fig. 4d). In the case of specimens made using TBW, there was no crack in the weld materials. In weld 1 specimen 2, where the pitch was 0%, the HAZ in S460N was not changed and still presented brittle structures with cracks (Fig. 4e). The pitch was 0%; however, the HAZ from tempering bead refined and tempered the coarse-grained zone of the first bead in the S460ML steel (Fig. 4f). In the specimens with the pitch in the range of 79–100%, the tempering effect was observed in the HAZ of both the investigated materials. With an increase in the pitch, there was a decrease of grain size, which was expected in accordance with previous works [30, 31]. In the places where the HAZ of the second bead tempering the weld from the first bead, there was a partial disappearance of the structure of the dendritic base bead and the formation of a ferritic fine-grained structure (Fig. 4g). The structures in the area where the HAZ from tempering bead overlapped the HAZ of the first bead in both steels were characterized by the refined and tempered coarse-grained zone (Fig. 4h). The cracks in the HAZ of the BMs were found only in weld 2 in specimen 3 in the S460N steel (Fig. 4i). In the previous investigations [27, 30], it was found that TBW could not repair the microcracks that formed during the welding of the first bead. However, TBW could help to avoid cold cracking that might occur after welding [47, 49].

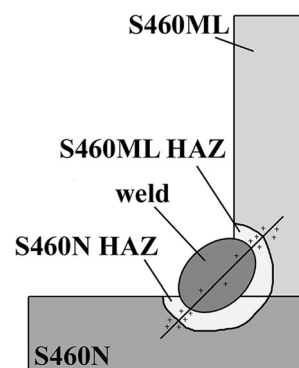
Fig. 5 Hardness point distribution for specimen welded without and with TBW technique

The hardness was measured in BM, in each HAZ, and in the weld material for each investigated weld of a specimen. The schema of distribution of hardness points is presented in Fig. 5.

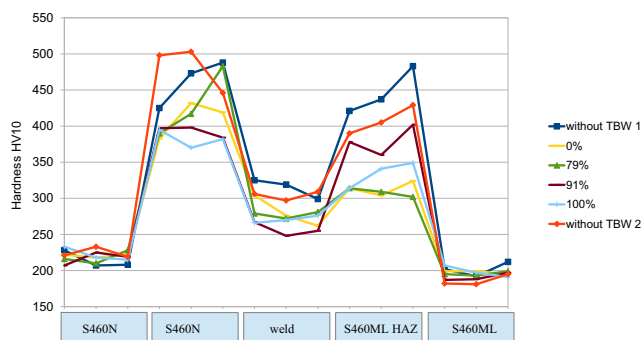
**Fig. 6** Hardness HV10 distribution for each specimen

The values of hardness in each point are presented in Table 4. The phrase “without TBW” means specimen welded without additional (tempering) bead. The specimen with “0%” pitch was welded with tempering bead. However, in the area of cutting specimen for metallographic testing, the second bead did not lay on the first one (Fig. 3c), but the heat from the second bead affects the previous laid stitch. The hardness distributions for each specimens are presented in Fig. 6.
