Dissimilar underwater wet welding of HSLA steels

Abstract

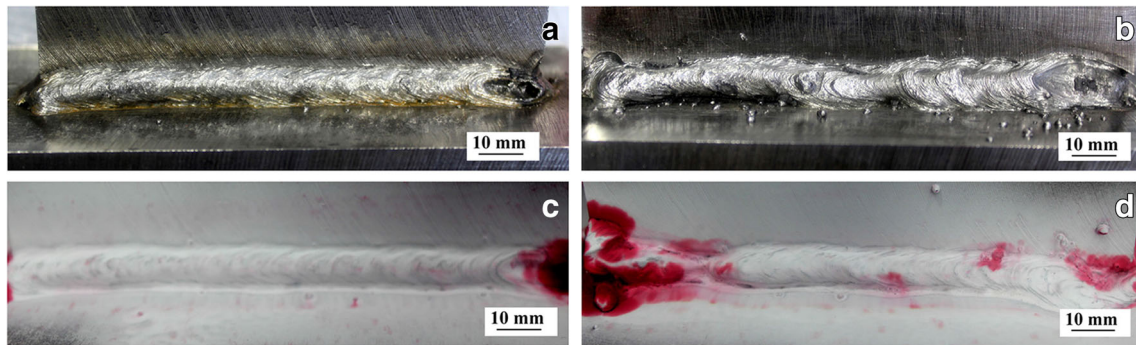
Fig. 2 Exemplanary results of the non-destructive tests. **a** VT, weld 1 from specimen 1; **b** VT, weld 1 from specimen 3; **c** PT, weld 2 from specimen 1; and **d** PT, weld 2 from specimen 2

At first, all six welds were visually tested in accordance with the EN ISO 17637:2011 standard [44]. Then, all of them were subjected to PT in accordance with EN ISO 3452-1:2013-08 standard [45]. Non-destructive tests were performed which showed some imperfections in welds prepared using the TBW technique. The most common imperfections were lack of fusion and undercut (Fig. 2b and d). These imperfections resulted from temper beads which were laid only for tempering the previous beads. Because the undercuts are classified as imperfect shape and dimension of weld, and do not affect the changes in the structure and properties of joints, all specimens were subjected to further tests. During testing, spatters was found on the surface of the specimens. In all welds, there were areas without any surface imperfection, which allowed the specimens and preparing cross-sections for further examinations. The exemplary results of the non-destructive tests are presented in Fig. 2.

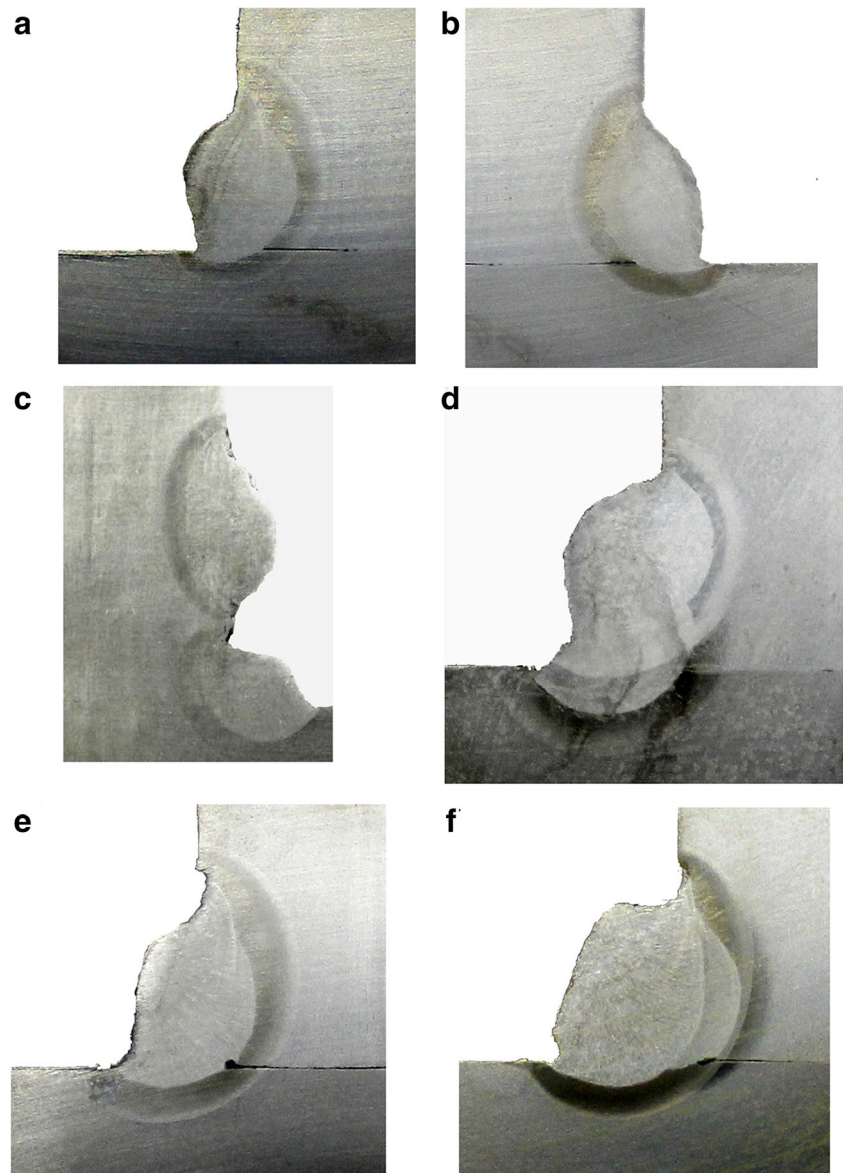
Fig. 3 Results of the macroscopic testing. **a** Weld 1 specimen 1—without TBW, **b** weld 2 specimen 1—without TBW, **c** weld 1 specimen 2—pitch 0%, **d** weld 2 specimen 2—pitch 79%, **e** weld 2 specimen 3—pitch 91%, and **f** weld 1 specimen 3—pitch 100%

Macro- and microscopic investigations were performed in accordance with EN ISO 17639:2013 standard [46]. After cutting, all the cross-sections were ground, polished, and etched with Nital (4%). The main aim of the macroscopic testing was to calculate the pitch in specimens 2 and 3. During macroscopic observations, the imperfection was seen as gas pores in both welds from specimen 1, weld 1 from specimen 2, and weld 2 from specimen 3. All these imperfections were located near the point of contact between the BMs. The used TBW technique did not affect their formation—the second weld did not cover these places. The results of the macroscopic testing are presented in Fig. 3.

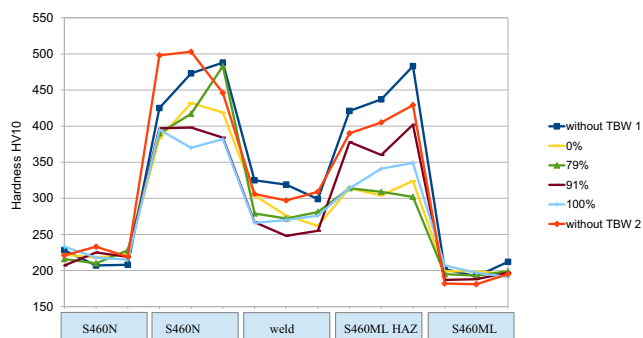
**Fig. 6** Hardness HV10 distribution for each specimen

EN ISO 15614-1:2017 standard for used steels. It was also observed that the hardness of S460N HAZ was higher than that of S460ML HAZ. In the specimen with the 0% pitch, the heat from the second bead, which was laid in S460N BM, affected the hardness of both steels. Second, HAZ was overlapping first in S460ML, and the hardness in this area decreased by 80–100 HV10 in comparison with the specimens welded without the TBW technique. In S460N HAZ, the hardness decreased by 40–80 HV10. In the next specimens, it was observed that if the pitch between two beads increased, the hardness in HAZ and weld material decreased. The best results for the investigated BMs were observed in the specimens with 100% pitch. The hardness measurements showed that the TBW technique allowed to reduce the hardness HV10 values of joints made in the water to the values lower than in specimens welded in the air [27]. Similar results were observed for welding of HSLA steel butt joints [49]. The reduction of hardness limits one of the factors adding to the initiation of cold cracks, which contributes to a reduction of cracking susceptibility.

The values of hardness in each point are presented in Table 4. The phrase “without TBW” means specimen welded without additional (tempering) bead. The specimen with “0%” pitch was welded with tempering bead. However, in the area of cutting specimen for metallographic testing, the second bead did not lay on the first one (Fig. 3c), but the heat from the second bead affects the previous laid stitch. The hardness distributions for each specimens are presented in Fig. 6.
