Dissimilar underwater wet welding of HSLA steels

Abstract

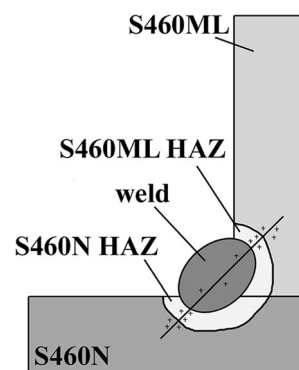
Fig. 5 Hardness point distribution for specimen welded without and with TBW technique

The hardness was measured in BM, in each HAZ, and in the weld material for each investigated weld of a specimen. The schema of distribution of hardness points is presented in Fig. 5.
