# Non-Destructive Testing of the Longest Span Soil-Steel Bridge in Europe—Field Measurements and FEM Calculations

**Abstract:** The article describes interdisciplinary and comprehensive non-destructive diagnostic tests of final bridge inspection and acceptance proposed for a soil-steel bridge made of corrugated sheets, being the European span length record holder (25.74 m). As an effect of an original concept a detailed and precise information about the structure short-term response was collected. Periodic diagnostics of bridge deformations was done one year after it was built. Load test design was based on numerical simulations performed by means of finite element method (FEM). In situ measurements were done with the aid of: inductive sensors, optical total station, and terrestrial laser scanner. The results produced by terrestrial laser scanning were used to build a precise image of structure deformation in 3D space during the tests. The accuracy of laser mapping was significantly increased using the information coming from total station and inductive sensors. These have higher accuracy and therefore can be used as reference. Thus, new quality in measurements is introduced. Good

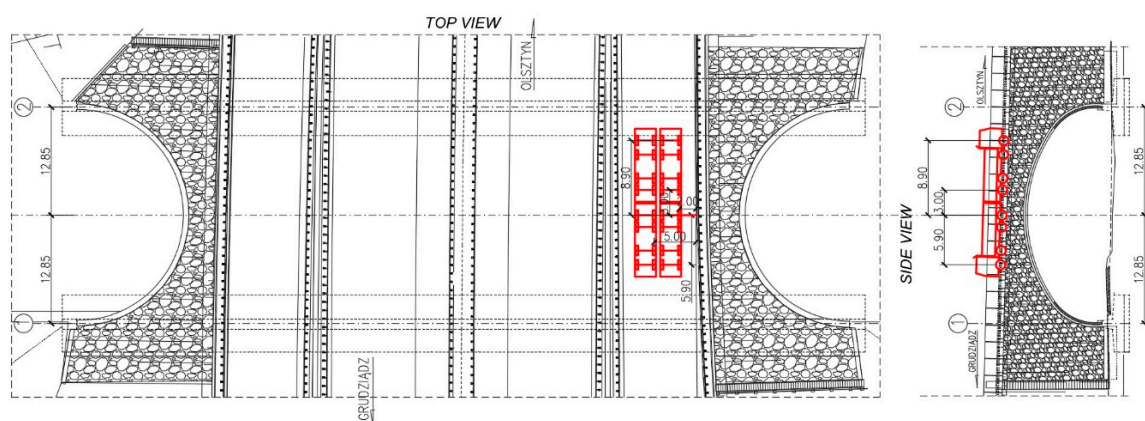
**Figure 9.** Schematic drawing of trucks locations during the S2 test configuration (dimensions in (m)).

Schematic drawing of trucks locations during the S2 test configuration is presented in Figure 9. Views from three different perspectives that present trucks positions during the S2 test are depicted in Figure 10.

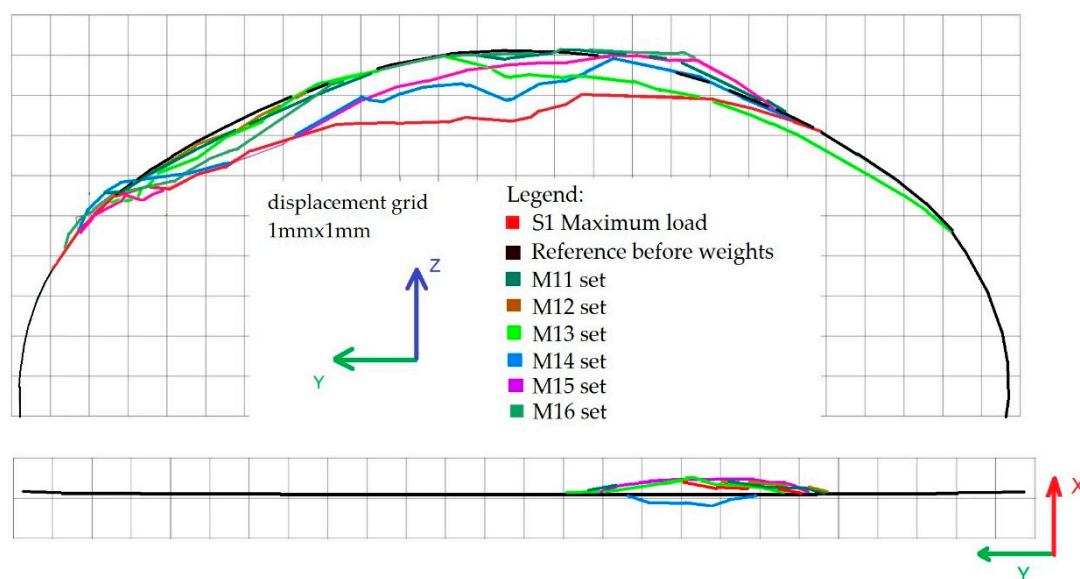
**Figure 13.** Deformations of the bridge cross Section 2-2 in the Y-Z (top) and X-Y (bottom) planes under loading schemes S1 and M11–M16.

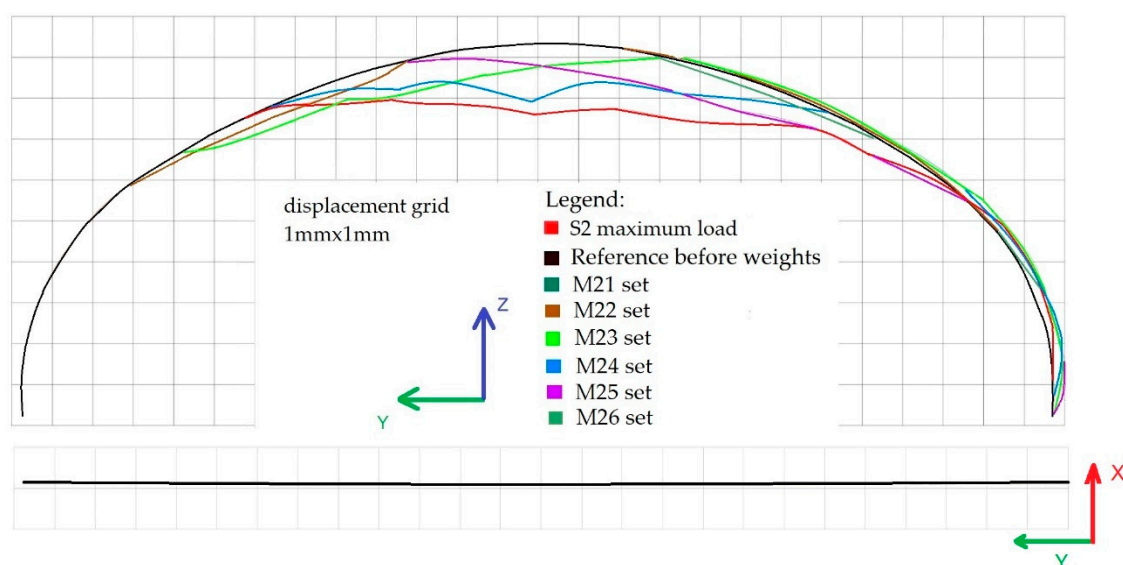
**Figure 14.** Deformations of the bridge cross Section 4-4 in the Y-Z (top) and X-Y (bottom) planes under loading schemes S2 and M21–M26.
