Article

# Plasticity of Bead-on-Plate Welds Made with the Use of Stored Flux-Cored Wires for Offshore Applications

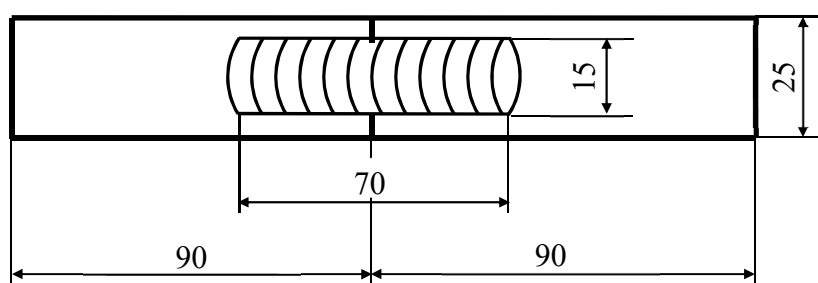
Figure 1. Scheme of test specimen and dimensions in millimeters.

Bead-on-plate welds were made on S355J2 steel specimens with thicknesses of 10 mm. Dimensions of specimens are given in Figure 1, chemical composition of base material and weld metal made with the use of wires is given in Table 1. Basic mechanical properties of weld metal made with the use of wires are given in Table 2.

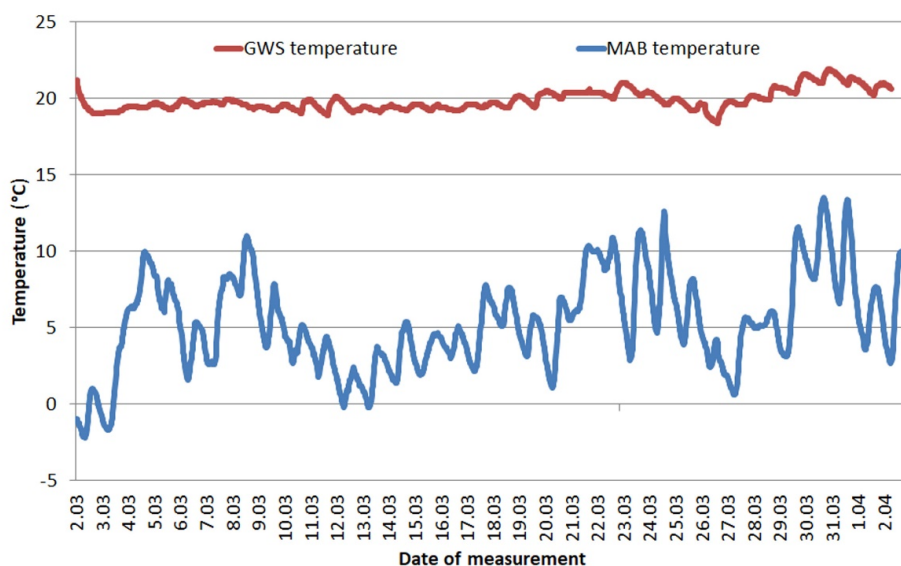
**Figure 2.** Ambient temperature changes during wires storage—Gdańsk welding site (GWS) and Mońki agricultural building (MAB)—1 month.

A comparison of temperature changes in GWS and in MAB is shown in the Figure 2. In addition, the Table 3 presents values of statistical measures and coefficients describing the temperature changes at each location in a given time period.

A clear difference is visible between the temperatures in MAB and GWS. For MAB, the temperature curve is always below the temperature curve measured in GWS. Storage conditions in GWS were stable in terms of temperature, temperature shocks are not visible.

The differences in recorded temperatures for studied areas result from both geographical and anthropogenic factors. The north-eastern part of Poland is an area where the continental climate with a higher temperature gradient begins to dominate. It results in clearly lower temperatures compared to Gdańsk, which is a port city, with a predominance of maritime climate. The second factor results from the degree of urbanization of both locations—Mońki is a small city and Gdańsk is a main city of a metropolitan area in northern Poland. The more specifically analyzed conditions in which the wires were stored may lead to the reason for differences in recorded relative humidity. The welding side is usually a drier place, there are not many sources of moisture. In contrast, unheated MAB may be exposed to increased air flow and water vapor supply from the environment. This analysis of the storage conditions is visible in Figures 2 and 3.

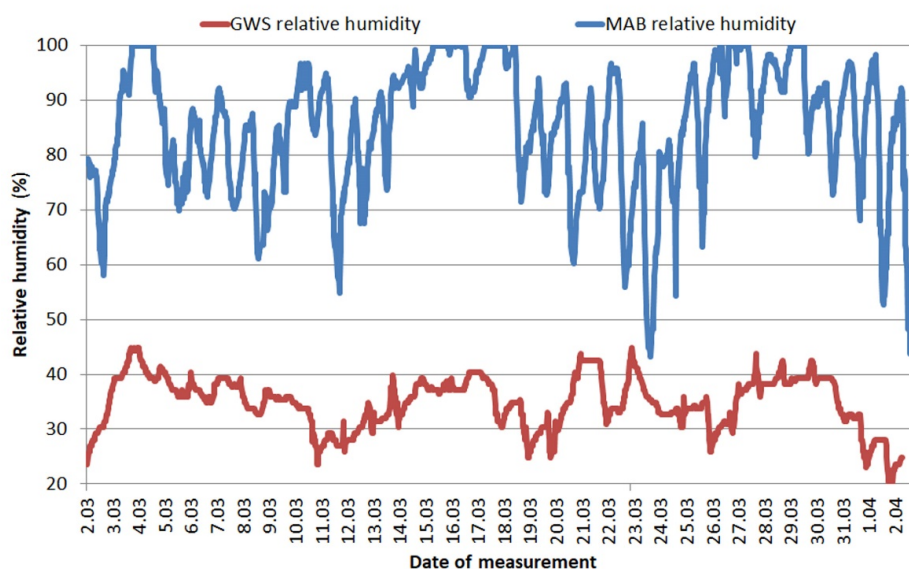
**Figure 3.** Ambient humidity changes during wires storage—Gdańsk welding site (GWS) and Mońki agricultural building (MAB)—1 month.

The Figure 3 shows a comparison of changes in relative humidity at the same time and for the same places. Coefficient values describing the change in this property are also given in Table 3.

For MAB, the registered humidity is very high, reaching up to 100%, which means that in the place where the wires were stored, the air was saturated with water vapor. The humidity was clearly lower in GWS. It did not exceed 50% at any time. Differences in the waveforms of temperature and relative humidity result, among others, from the fact that the GWS was heated.

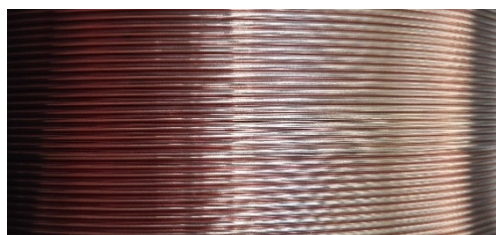
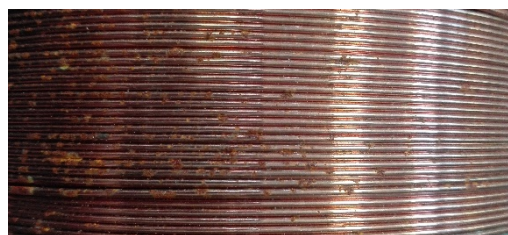
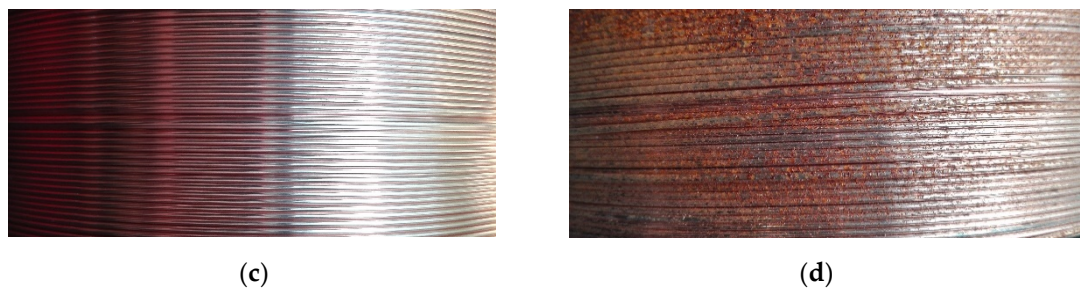
**Figure 4.** The surface layer of wire after storage: (a) A wire stored in Gdańsk welding site (GWS); (b) A wire stored in Mońki agricultural building (MAB); (c) B wire stored in Gdańsk welding site (GWS); (d) B wire stored in Mońki agricultural building (MAB).

Wires in delivery condition and wires stored for 1 month have been subjected to visual examinations. Photographs of the surface layer of those wires in delivery condition were already presented in the previous publication [20]. Pictures of the surface of the stored wires are shown in Figure 4. It can be clearly seen that the surface of wires stored in MAB has greater degradation than the surface of wires stored in GWS.

Differences can also be seen between the degradation that occurred in A wire and B wire. Both wires stored in the GWS have a shiny, smooth surface with no corrosion areas and no visible signs of degradation or environmental impact. In the MAB environment, A wire began to undergo surface corrosion—numerous corrosion areas of a small range are visible. The boundaries between the individual coils are clear, the non-corroded areas are still shiny and smooth. The B wire stored in the same environment was significantly more degraded. The entire surface is covered with corrosion products, which in some places have a significant thickness. Areas without a thick layer of rust were covered with a thin layer of corrosion products and there were no shiny areas.

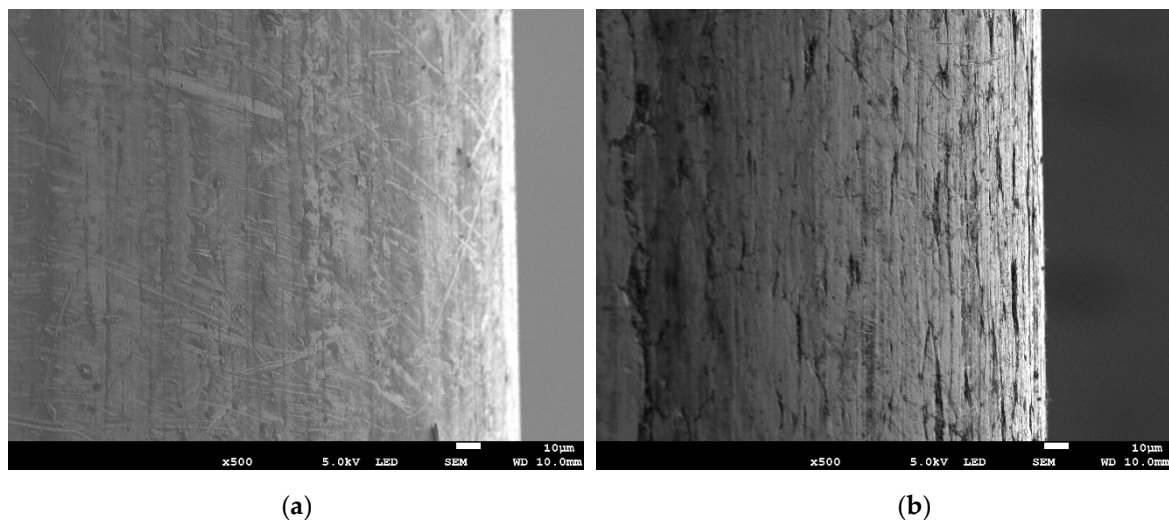
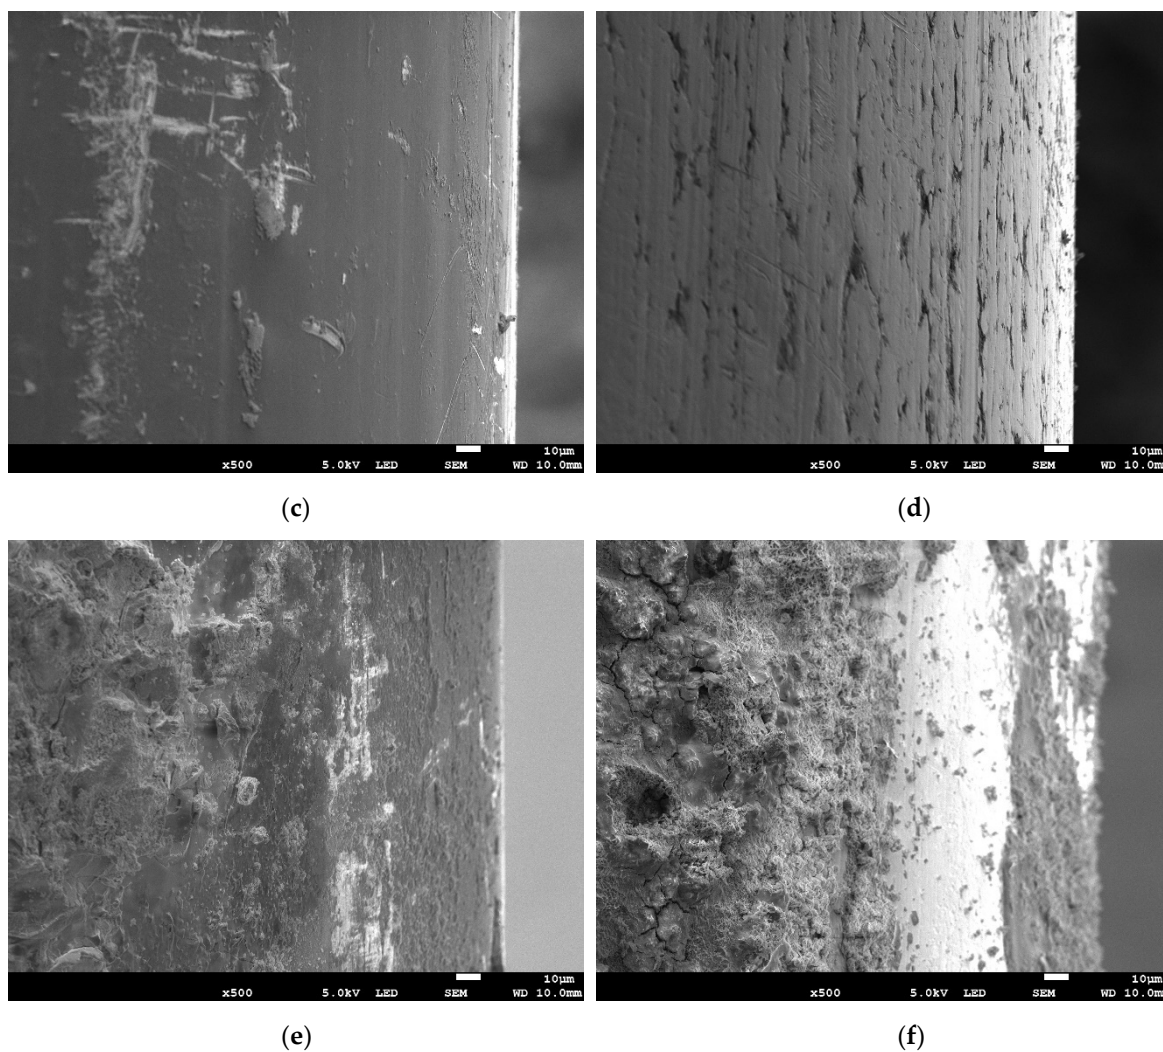
**Figure 5.** Surfaces of flux-cored wires: (a) A wire in delivery condition; (b) B wire in delivery condition; (c) A wire stored in GWS; (d) B wire stored in GWS; (e) A wire stored in MAB; (f) B wire stored in MAB.

SEM images show that the surfaces of both wires in delivery condition significantly differ (Figure 5a,b). The A wire is smooth, has a homogeneous surface without gaps in the continuity of the copper coating. On the contrary, B wire shows longitudinal grooves on the surface, located parallel to the axis of the wire and the direction of material forming. After storing the wires in GWS, A wire still has a smooth surface; only small precipitations can be observed on it (Figure 5c). The EDS analysis (Figure 6a) shows that these products mainly contain copper. B wire behaved similarly—in the grooves visible in Figure 5d, copper compounds accumulated (Figure 6c). Both wires from the MAB location are characterized by a high degree of degradation (Figure 5e,f). On their surface, precipitations of iron oxides were found, which was confirmed by the EDS analysis (Figure 6b,d). The differences between these wires can be seen in the SEM photos at higher magnification—A wire is only locally covered with a thicker layer of corrosion products, but a thin, brittle layer of iron oxides has formed on its surface (Figure 6b). A much thicker layer of corrosion products has accumulated on B wire. Figure 5e,f show the most degraded parts of the wires. Figure 5c–f also show the edge of the wires, which in each case shows no signs of corrosion other than atmospheric corrosion.

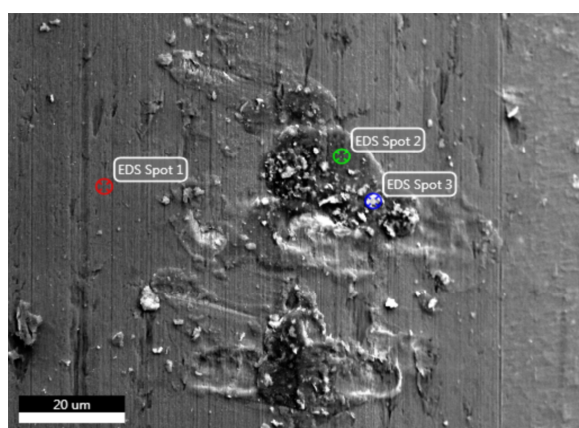
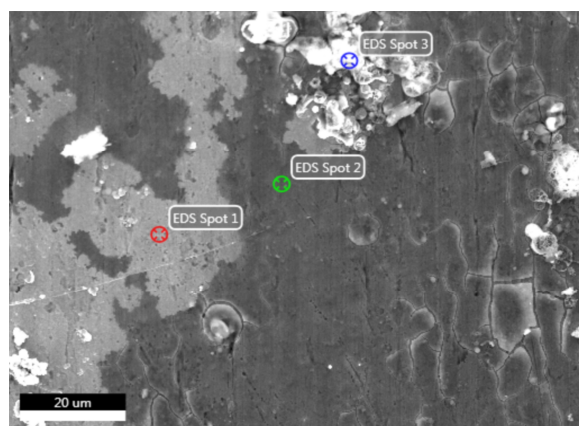
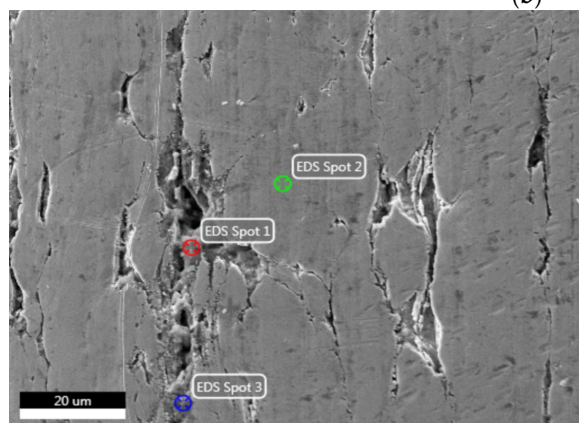
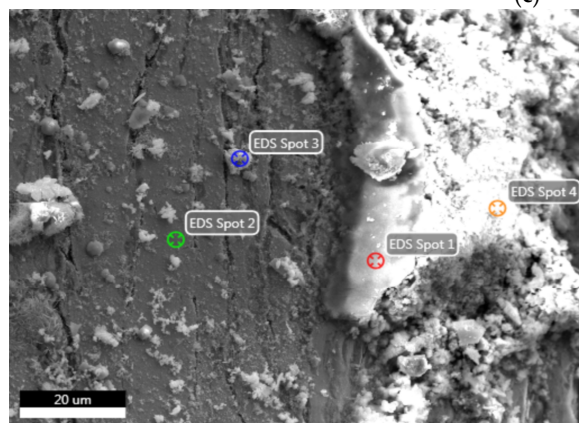
Zone	Fe	Cu	O	S
EDS Spot 1	5.01	91.44	3.55	-
EDS Spot 2	4.64	86.83	7.46	1.07
EDS Spot 3	4.19	90.68	4.48	0.65

Zone	Fe	Cu	O	S
EDS Spot 1	5.57	92.18	1.49	0.76
EDS Spot 2	43.53	53.44	2.45	0.58
EDS Spot 3	76.09	13.70	7.74	2.48

Zone	Fe	Cu	O	S
EDS Spot 1	22.38	65.55	9.43	2.68
EDS Spot 2	47.97	52.03	-	-
EDS Spot 3	22.37	58.85	19.48	4.30

Zone	Fe	Cu	O	S
EDS Spot 1	60.51	5.43	33.58	0.48
EDS Spot 2	66.30	33.70	-	-
EDS Spot 3	71.56	6.04	21.74	0.66
EDS Spot 4	60.68	6.26	32.61	0.45

**Figure 6.** SEM image and spot EDS analysis of flux-cored wires: (a) A wire stored in GWS; (b) A wire stored in MAB; (c) B wire stored in GWS; (d) B wire stored in MAB.

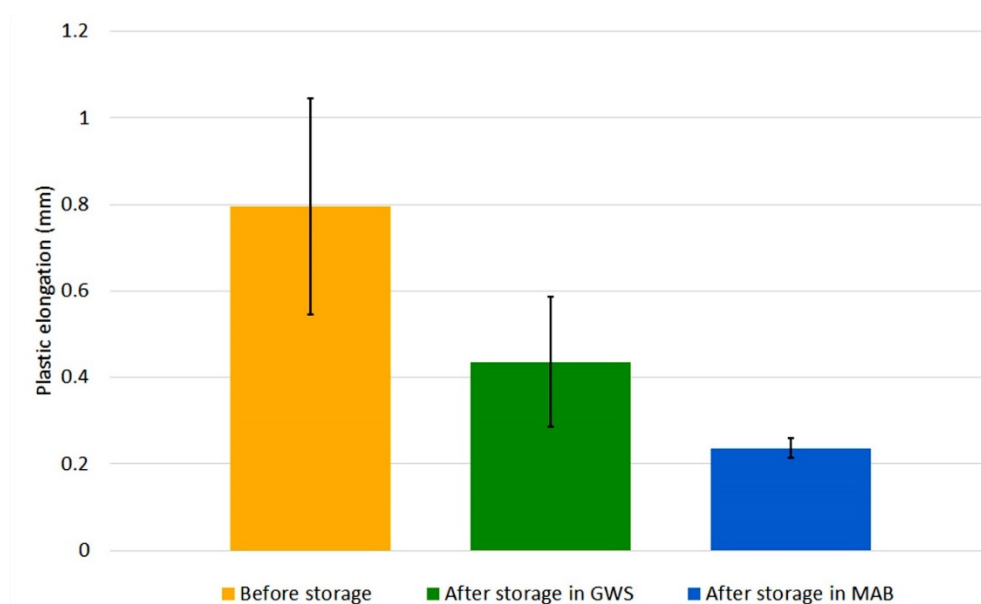
**Figure 9.** Change in plastic elongation of welds made with B wire, caused by storage for 1 month.

The obtained values of plastic elongation and standard deviation for all specimens confirm the statistical significance of the results. Although the wires have the same specification, their elongation values in the initial state differ. The A wire, regardless of its storage location, was characterized by an increase in plastic elongation. The increase was greater in the case of GWS—nearly twice. However, B wire showed a different trend. Each of the specimens, welded with both GWS and MAB wire, had a smaller plastic elongation compared to the specimen welded with the wire in delivery condition. A large drop was particularly visible in the wire from MAB—the plasticity of the weld metal dropped almost four times with a double drop for the wire stored in GWS.

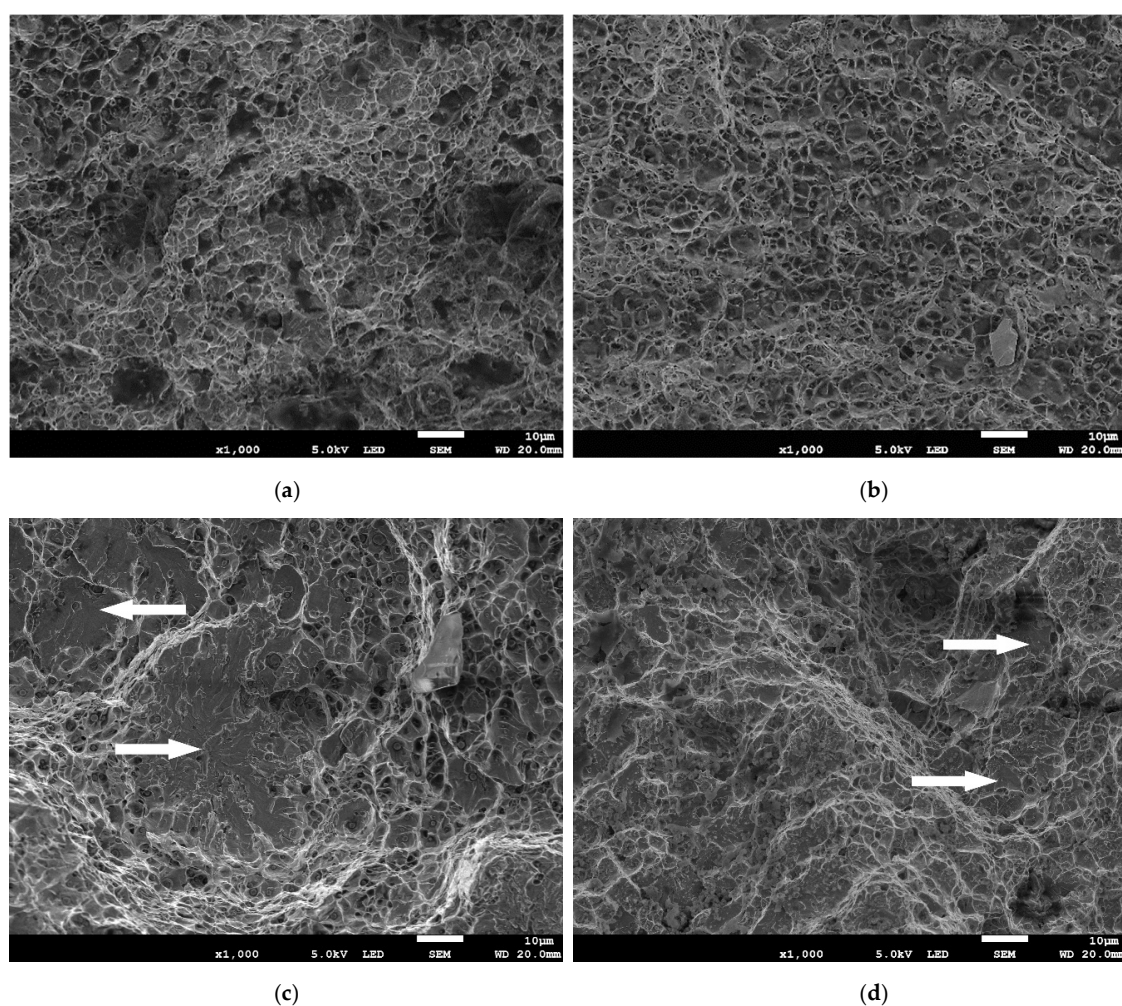
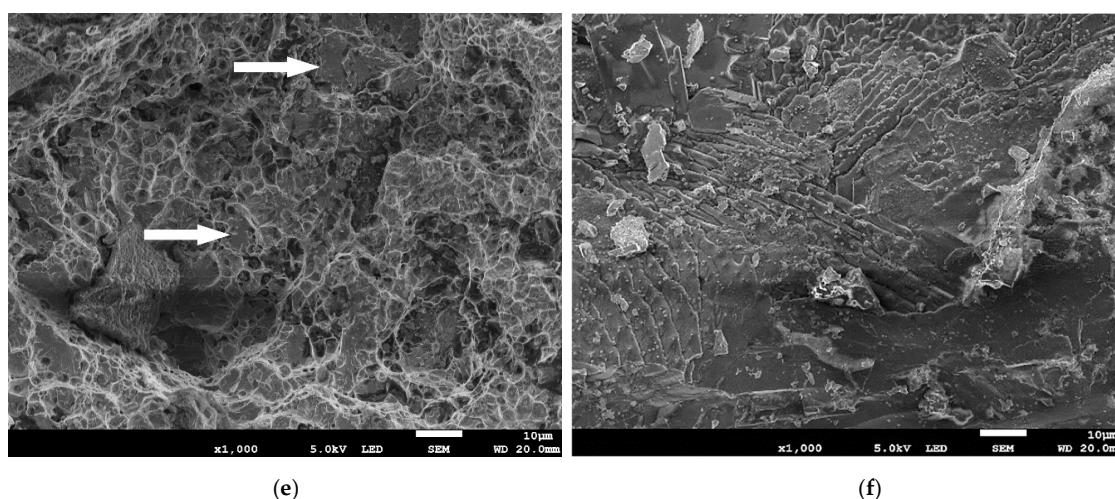
**Figure 10.** Fracture surfaces of specimens after tensile tests: (a) specimen made using A wire in delivery condition; (b) specimen made using B wire in delivery condition; (c) specimen made using A wire stored in GWS; (d) specimen made using B wire stored in GWS; (e) specimen made using A wire stored in MAB; (f) specimen made using B wire stored in MAB.

Figure 10 shows SEM images of fractures after tensile test. In Figure 10a,b, dimples, characteristic of the ductile microvoid coalescence fracture, are clearly visible. Such a fracture mode predominated in specimens made with wires in delivery condition. An increased share of the brittle fracture (marked with white arrows) was observed in specimens made of wire from the GWS and in the specimen made of A wire from MAB (Figure 10c–e). In this case, the quasi cleavage fracture was found. Three zones can be observed—at the face the fracture was more ductile, dimples appeared larger, in the middle zone between dimples flat cleavage areas appeared and at the root there were dimple clusters and larger areas of cleavage, with large steps. Figure 10f shows the fracture surface of a specimen made using B wire stored in MAB. In this specimen, cleavage fracture dominates. At 1000× magnification, only single dimples are visible, situated between large cleavage areas.

A change in plasticity can also be observed by comparing the mode of fracture of the tensile tested specimens (Figure 10). The most characteristic is the transition from the ductile microvoid coalescence fracture to the almost complete cleavage fracture for the specimen made using B wire stored in MAB. Such a great change is directly related to the results of plasticity indexes (Table 5), which also indicate a very intense degradation of bead-on-plate weld plasticity for this wire and location. In all fracture surfaces, at least some dimples were found and they were all equiaxed, which confirms that tensile loading was the main loading type responsible for breaking of specimens.
