Article

Optimization of Stabilizing Systems in Protection of Cultural Heritage: The Case of the Historical Retaining Wall in the Wisłoujście Fortress

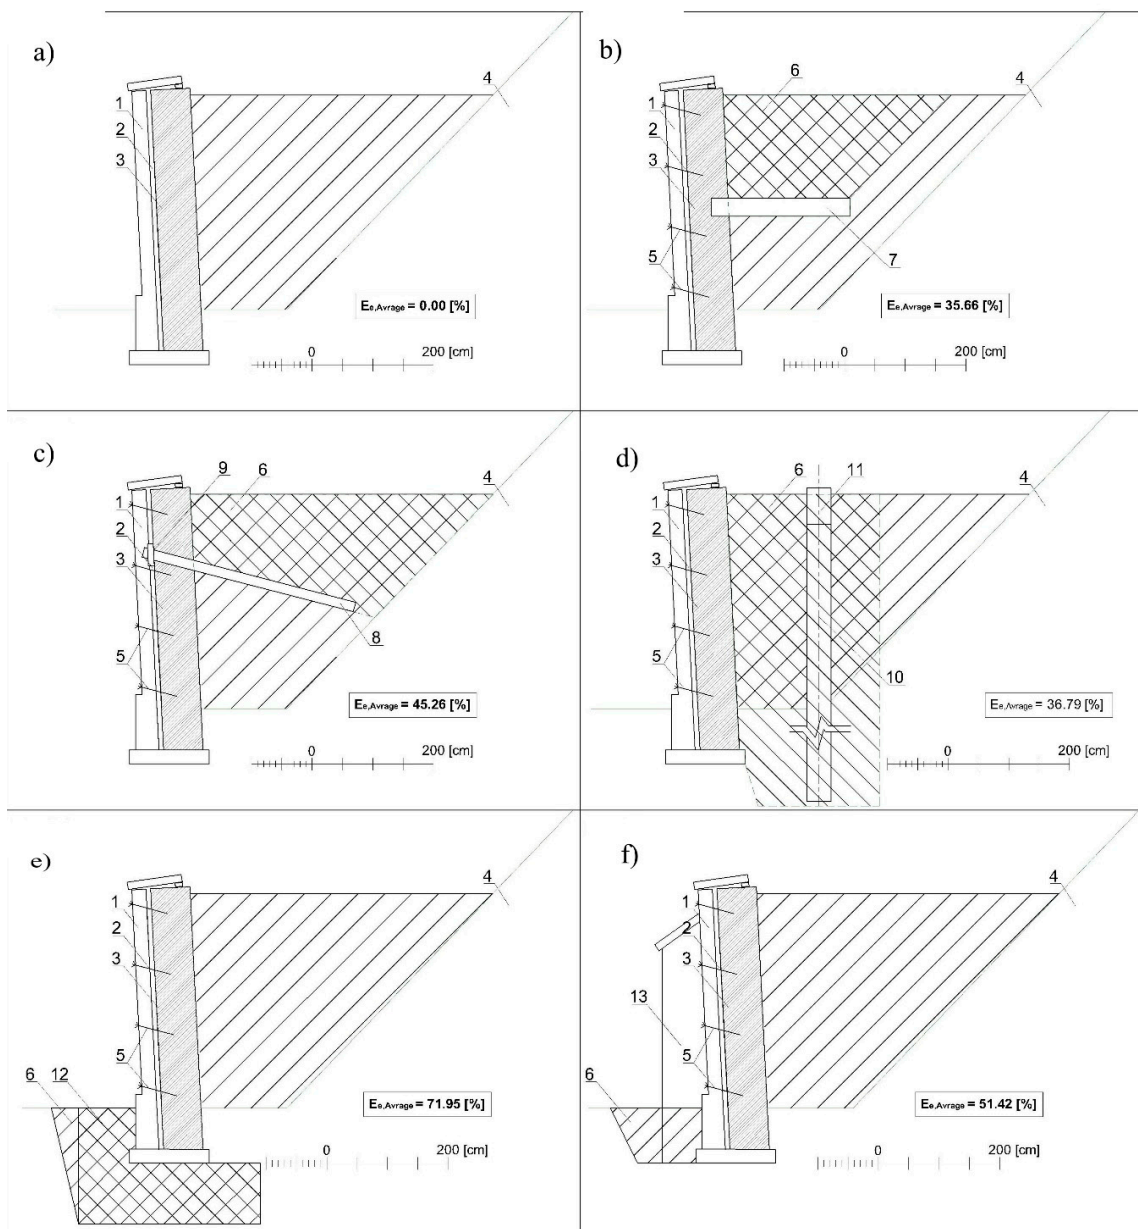
Figure 5. The repairing methods of the retaining wall. (a) Natural state; (b) relieving shelf; (c) passive anchors (nails); (d) CFA 3 CFA (continuous flight augering) piles; (e) jet grouting; (f) buttress.

No intervention (Figure 5a); the condition and appearance of the wall will not change. A measured and calculated deflection of 15.0 cm means that there is a high probability of a construction disaster.

The relieving shelf is a slab 1.8 m long and 0.3 m thick, inserted 2.0 m below the ground surface. The shelf is anchored to the wall (Figure 5b) and reduces soil pressure. The reinforcement is laid in a previously prepared excavation, nested in the wall and then poured over with concrete. Finally, the excavation is filled up with soil. Making a groove in the wall destroys the structure of the

Installation of passive anchors requires drilling through the wall (Figure 5c). Each borehole is then filled with a cement paste. The anchor itself, in the form of a steel bar with a diameter of 6 cm and a length of 3.6 m, is cemented inside the hole. The hole has a diameter of 10 cm. The spacing between the anchors is 3.0 m. Drilling disturbs the original structure of the wall, leaves the head in its outer face and changes the structure of unexamined (not yet excavated) soil, which might have archeological value. The effect of anchoring on the appearance of the wall will be minimized by masking the anchors under a siding layer or by using eight masking plates. Adding an inappropriate, disproportionate or aesthetically unpleasant feature may affect the visual assessment. Due to the control of the anchor installation, this method is very safe and effective.

This method involves making a palisade of reinforced concrete piles approximately 1.5 m behind the wall (Figure 5d). The palisade decreases the soil pressure on the structure. Piles with a diameter of 0.40 m and a length of 7.0 m are spaced every 0.50 m. The piles themselves do not alter the structure of the wall but the insertion procedure disturbs the soil by drilling, stirring and pulling it to the surface when the drill bit is removed. Furthermore, if the drill bit encounters an object larger than its diameter, the object will be drilled through or pushed aside. This technology can cause an additional bulging of the wall resulting from the operation of the drill and the weight of the drilling machine. For these reasons, a temporary support of the wall should be put in place for the duration of the drilling. The piles will not be visible. There is a risk of damaging the wall during the installation of the piles.

This method is about reinforcing soil under the existing foundation of the wall by injection of cement paste at a very high pressure. The dimensions of the reinforced foundation are 0.80×2.30 m (Figure 5e). This technology does not damage the original surface of the wall as it affects only the soil under the wall foundation. In order to conduct archaeological excavations safely, it would be necessary to dig up the soil along successive sections of the wall, on its both sides. This is, however, hardly practicable as it involves extensive intervention in the ramparts, which remain under archaeological protection. The entire procedure is, therefore, costly. For these reasons, it was assumed that the excavations would be carried out in front of and under the wall (see Figure 5e). The changes will be invisible.

The buttress supporting the wall has the following dimensions: $0.65 \text{ m} \times 0.45 \text{ m} \times 3.0 \text{ m}$ (thickness \times width \times height); the buttress reaches 1.1 m deep into the ground. It is the oldest reinforcement method applied to retaining walls and it involves making a brick buttress, which counteracts both soil pressure and tilting of the wall (Figure 5f). Seven buttresses (one already exists) supporting the wall will affect its original structure over the surface area. The soil down to the buttress foundation needs to be examined so that excavations can be performed before bricklaying. The excavation for each of the buttresses will have a depth of 1.0 m and a surface area of 1.5×1.5 m. The new foundations will have dimensions of $0.5 \times 0.65 \times 0.45$ m. Technology makes it possible to determine the dimensions of buttresses that would be sufficient to prevent the wall from further tilting.

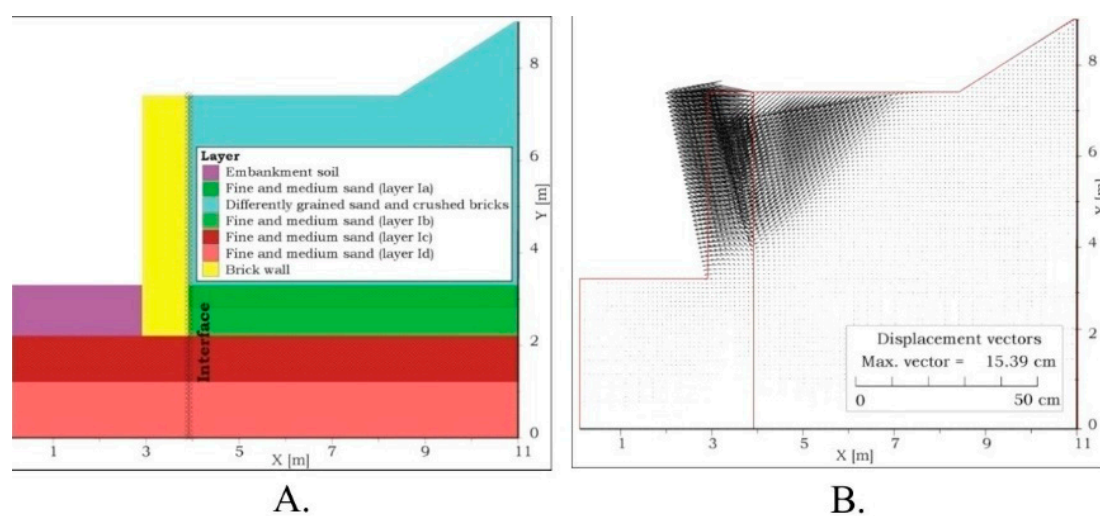
Figure 6. The numerical model of the retaining wall: (A) division of the model into geotechnical layers; (B) displacement vectors.

First, the current original state of the wall was examined by the “back analysis” method, i.e., the variant without wall stabilizing measures. The aim was to determine the values of strength parameters (cohesion and angle of internal friction of the soil constituting the earthwork that puts pressure against the wall), for which the measured and calculated displacements of the wall crown would be the same. It means that, by contrast to other parameters determined in the tests, these two strength parameters (i.e., cohesion and angle of friction) are found at the base of calculations using a “trial and error” approach and FLAC2D code. A numerical model and displacement vectors are shown in Figure 6. Calculated maximum displacement (u) of the wall’s crown was equal to 15.21 cm.
