Article

# Underwater Local Cavity Welding of S460N Steel

**Abstract:** In this paper, a comparison of the mechanical properties of high-strength low-alloy S460N steel welded joints is presented. The welded joints were made by the gas metal arc welding (GMAW) process in the air environment and water, by the local cavity welding method. Welded joints were tested following the EN ISO 15614-1:2017 standard. After welding, the non-destructive—visual, penetrant, radiographic, and ultrasonic (phased array) tests were performed. In the next step, the destructive tests, as static tensile-, bending-, impact- metallographic (macroscopic and microscopic) tests, and Vickers HV10 measurements were made. The influence of weld porosity on the mechanical properties of the tested joints was also assessed. The performed tests showed that the tensile strength of the joints manufactured in water (567 MPa) could be similar to the air welded joint (570 MPa). The standard deviations from the measurements were—47 MPa in water and 33 MPa in the air. However, it was also stated that in the case of a complex state of stress, for example, bending, torsional and tensile stresses, the welding imperfections (e.

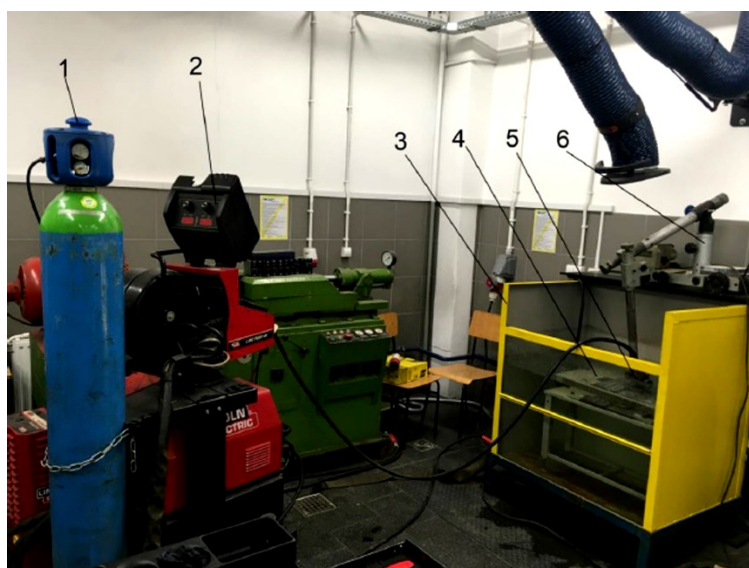
**Figure 1.** Welding test stand: 1-gas cylinder, 2-welding power source and wire feed unit, 3-tank, 4-welding table, 5-specimen, 6-welding trolley (tractor).

20 °C), using the local cavity method. Specimens were taken in the welding position PA (1G)—welding in flat position. The welding test stand is presented in Figure 1.

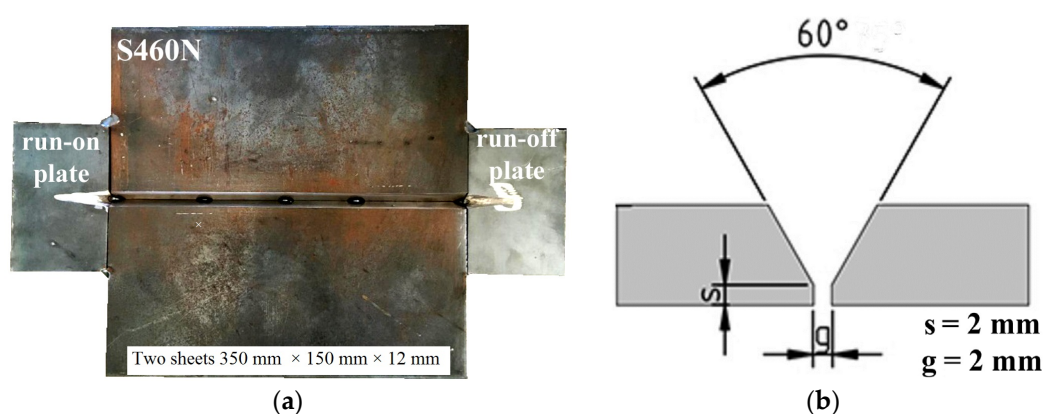
**Figure 2.** (a) The real view of the specimen before welding and (b) schematic cross-section of the specimen.

The dimensions of S460N steel plates were  $350 \times 150 \times 12$  mm, as is required in the qualification of welding procedures for butt welded joints following the EN ISO 15614-1:2017 standard [38]. Pieces of material were prepared with a “Y groove” and were joined by tack welds at the root site. The run-on and run-off plates (S460N steel,  $60 \times 100 \times 12$  mm) were used to obtain constant parameters in the tested area. The vertical view of the specimen and the schematic cross-section view are presented in Figure 2.

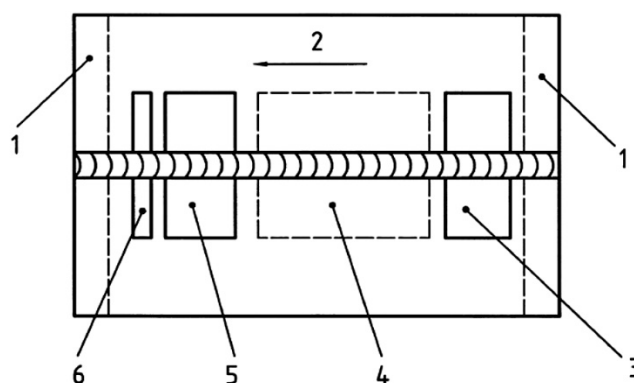
**Figure 3.** The location of test samples for destructive (DT); 1—discard 25 mm, 2—welding direction, 3—area for one tensile test specimen and bend test specimens (one for bending with tensile from the face of the weld, one for bending with tensile from the roof of the weld), 4—area for impact test specimens, 5—area for one tensile test specimen and bend test specimens (one for bending with tensile from the face of the weld, one for bending with tensile from the roof of the weld), 6—area for metallographic (macroscopic and microscopic) test specimens and one hardness test specimen.

Specimens were subjected to non-destructive (NDT) and destructive (DT) tests. In the first step, NDT was performed. The HSLA steels are characterized by high susceptibility to cold cracking in underwater conditions [8,10,20]. Cold cracks may occur up to 48 h after welding. Following this reason, the NDT was performed 48 h after welding. These kinds of tests are widely used for testing underwater constructions [40]. Both welded joints were tested using: a visual test (VT) following EN ISO 17637:2017 [41], a penetrant test (PT)—EN ISO 3452-1:2017 [42], a radiographic test (RT)—EN ISO 5579:2014 [43], and an ultrasonic test (UT), by use of an automated phased array (PA) technology—ISO 13588:2019 [44]. For RT, the ANDREX 300kV x-ray apparatus was used. During preliminary investigations, the optimal parameters were chosen: focal length 700 mm, exposure time 5 min 30 s, voltage 185 kV, anode current intensity 4.5 mA. UT was performed by PA technology with the use of a Phasor XS flaw detector (GE Research, New York, USA). For PA 16 an element head was used, with the angle of inclination at  $36^\circ$ . During tests, type A and S imaging were obtained. After NDT, both specimens were prepared for DT by cutting samples for each test. Investigated joints were cut following the requirements presented in the EN ISO 15614-1:2017 standard [38]. The location of test samples for DT is presented in Figure 3.

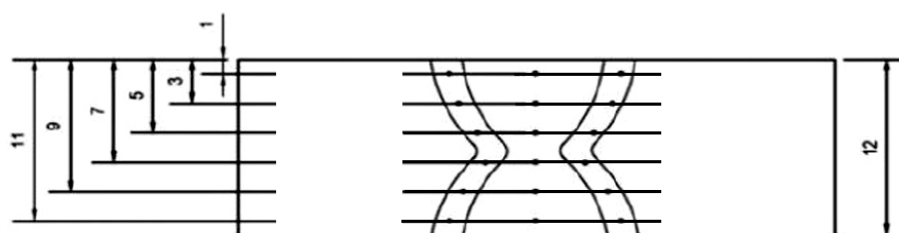
**Figure 4.** The distribution of Vickers HV10 hardness measurement points in the specimens.

(Nital 4%), to ensure the correct notch location. Two samples were tested from each joint with V-notch located in the HAZ and two with the V-notch located in the weld. The notch was V-shaped and has been made with an angle of 45° and a depth of 2 mm. The width and height of the sample were 10 mm. Tests were performed with requirements of the EN ISO 148-1:2017 standard [48]. The Vickers HV10 hardness was measured according to the (EN ISO 9015-1:2011 standard [49]). All tests were performed at room temperature (20 °C). The distribution of measurement points (each point in the picture means three measurements) in this test is presented in Figure 4.

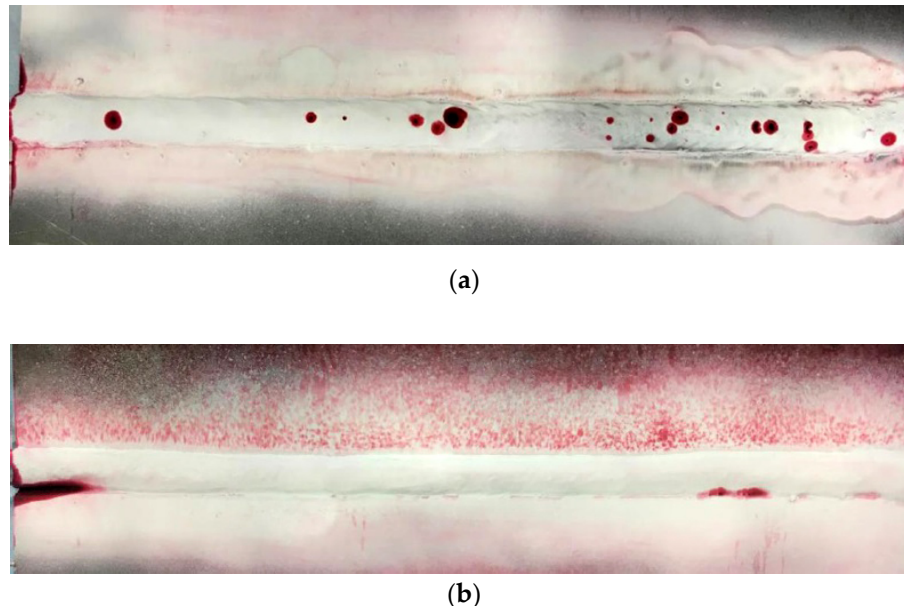
**Figure 6.** View of specimens after PT: (a) specimen SW and (b) Specimen SA.

The view of specimens after PT are presented in Figure 6. The presence of pores (specimen SW) and undercut (specimen SA) observed during VT has been confirmed in PT. Both of the mentioned tests allow observing only imperfections that occurred on the surface of the welded joints. Due to this reason, other NDT were performed.

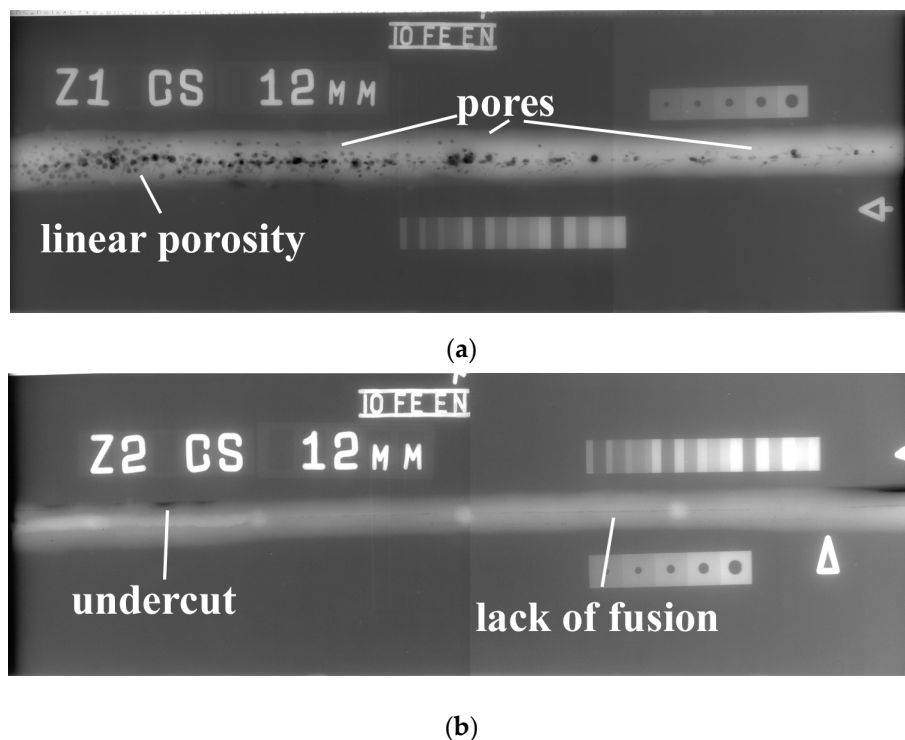
**Figure 7.** Radiograms: (a) specimen SW and (b) specimen SA.

The results of RT (radiograms) are presented in Figure 7. RT shows many differences in the quality of both tested joints. As stated in the previous investigation, S460N steel is characterized as a material with high susceptibility to the occurrence of welding imperfections [39]. The results of NDT confirms information from the literature. In the specimen welded by the local cavity method, many pores were found (Figure 7a). These imperfections occurred all along the specimen. However, the closer to the end

of the joint, the lower was the number of pores. In this area, they can be characterized as linear porosity. It was stated by Nathan et al. [52] that pores can occur in HSLA steel in GMAW welding conditions. This type of imperfection is also one of the typical in underwater welding [27,53]. It resulted from the steam near the welding arc, which comes from the surrounding environment. The RT also showed that specimen SA is potentially characterized by an inside lack of fusion (80 mm). It started in  $\frac{1}{4}$  length of the joint (Figure 7b). Also, the area of undercut mentioned during PT was confirmed during RT. It was stated by He et al. [54] that the preheating process can eliminate the lack of fusion defects in GMAW joints. The same process can decrease the susceptibility to cold cracking of HSLA steel. This suggests that S460N steel should be preheated before welding; this process will improve the quality of the joints.

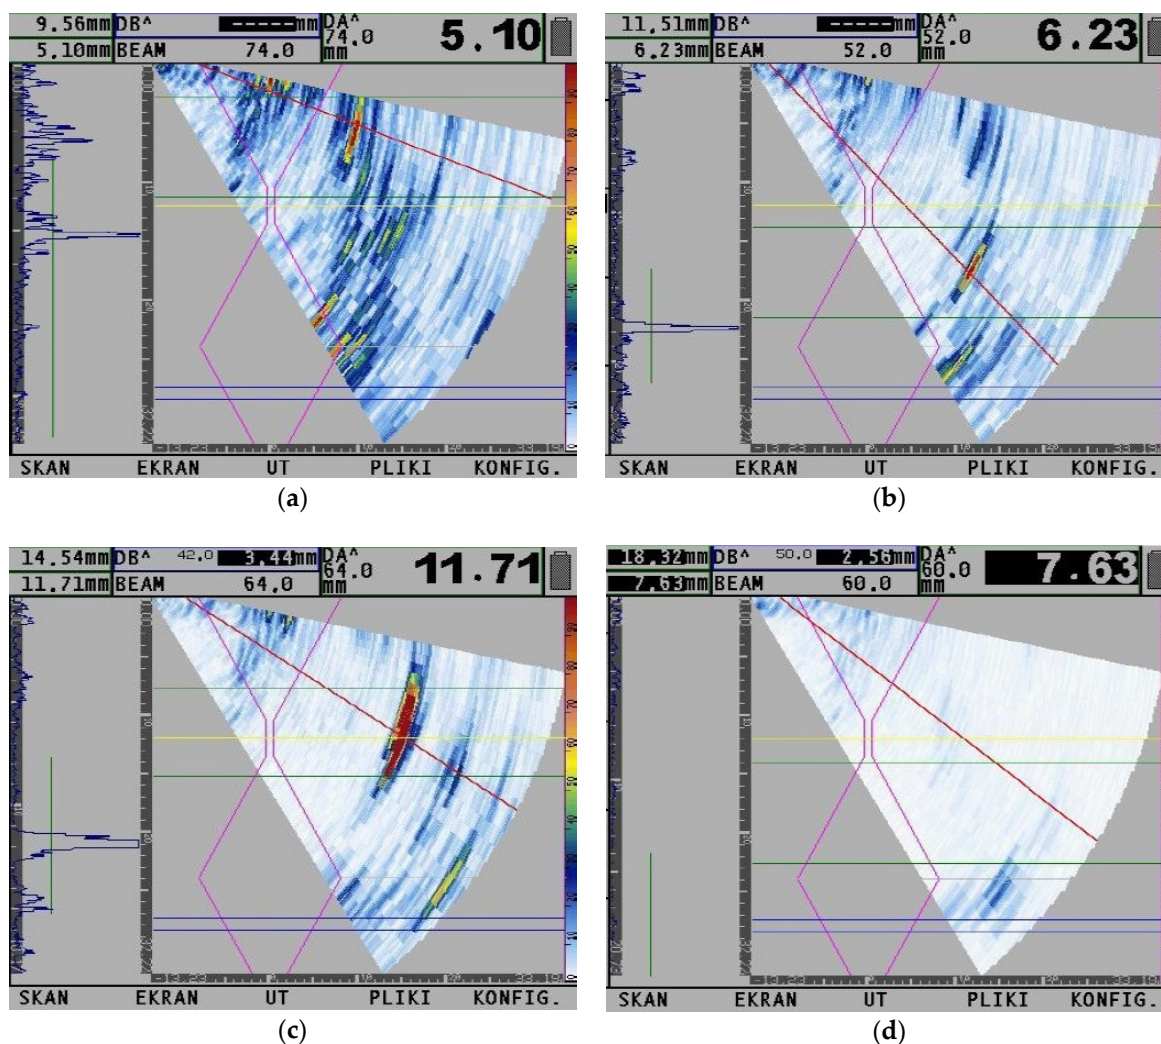
**Figure 8.** Results of the ultrasonic test (UT) by phased array (PA) technology: (a) beginning area of specimen SW; (b) finishing area of specimen SW; (c) lack of fusion area in specimen SA and (d) the area without imperfections in specimen SA.

Figure 8 presents the results of UT by PA technology. Tests were performed in areas with the highest number of indications observed during RT (specimen SW) and in the area of indication and area without any indication in the specimens welded in the air (specimen SA). For a specimen welded by the local cavity method, the differences were observed near the beginning and near the end of the joint. In the beginning, the pores were located through the whole thickness of the specimen (Figure 8a). Their number was similar from beginning of the joint to the 203 mm of its length. In the rest of the joint (from 203 to 350 mm), this number decreased, and pores changed their shape to linear. This confirmed results from RT. They were located near the root area of the weld (Figure 8b). The joint welded in the air is characterized by a lack of penetration at depth 2.5–3.8 mm (Figure 8c). However, an area without any imperfection was observed in specimen SA (Figure 8d).

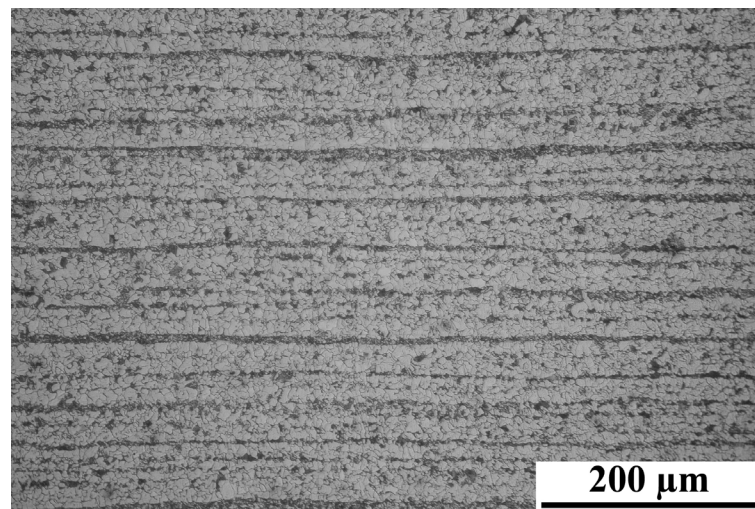
**Figure 10.** Optical micrographs of: (a) specimen SA; (b) specimen SW; (c) middle area of specimen SW—the tempering effect and (d) S460N microstructure.

The microstructures of the specimens welded in different environments are shown in Figure 10. During microscopic testing, the differences were observed for specimens welded in the air and in water. Water as a welding environment increases the cooling rate. It resulted in the formation of complex structures in the HAZ. The microstructure in HAZ of specimen SA consists of a mixture of martensite and bainite (Figure 10a). Specimen SW welded in the water is characterized by the typical structures formed in this environment. The microstructure in HAZ is coarse-grained and exhibits a martensitic morphology (Figure 10b). The weld metal of both specimens was built of dendrites. The strong effect of tempering of brittle structures in HAZ has been observed in the middle of specimen SW (Figure 10c). The heat from the weld passes has accumulated in this area, which provides the tempering of microstructures. A similar effect was presented in our further investigations [18]. The results of microscopic testing of the joint (HAZ) performed on S460N steel welded in the water by the wet welding method were presented in previous investigations [39,55]. In the presented experiments [39,55], cold cracks were found in the HAZ of the joint performed in the high cooling rate conditions. However, during the microscopic testing of specimen SW, no cracks were found. This showed the advantages of local cavity welding in comparison to the wet welding process in thermal and metallurgical conditions. The microstructure of the S460N steel is composed of banded ferrite and banded pearlite (Figure 10d).

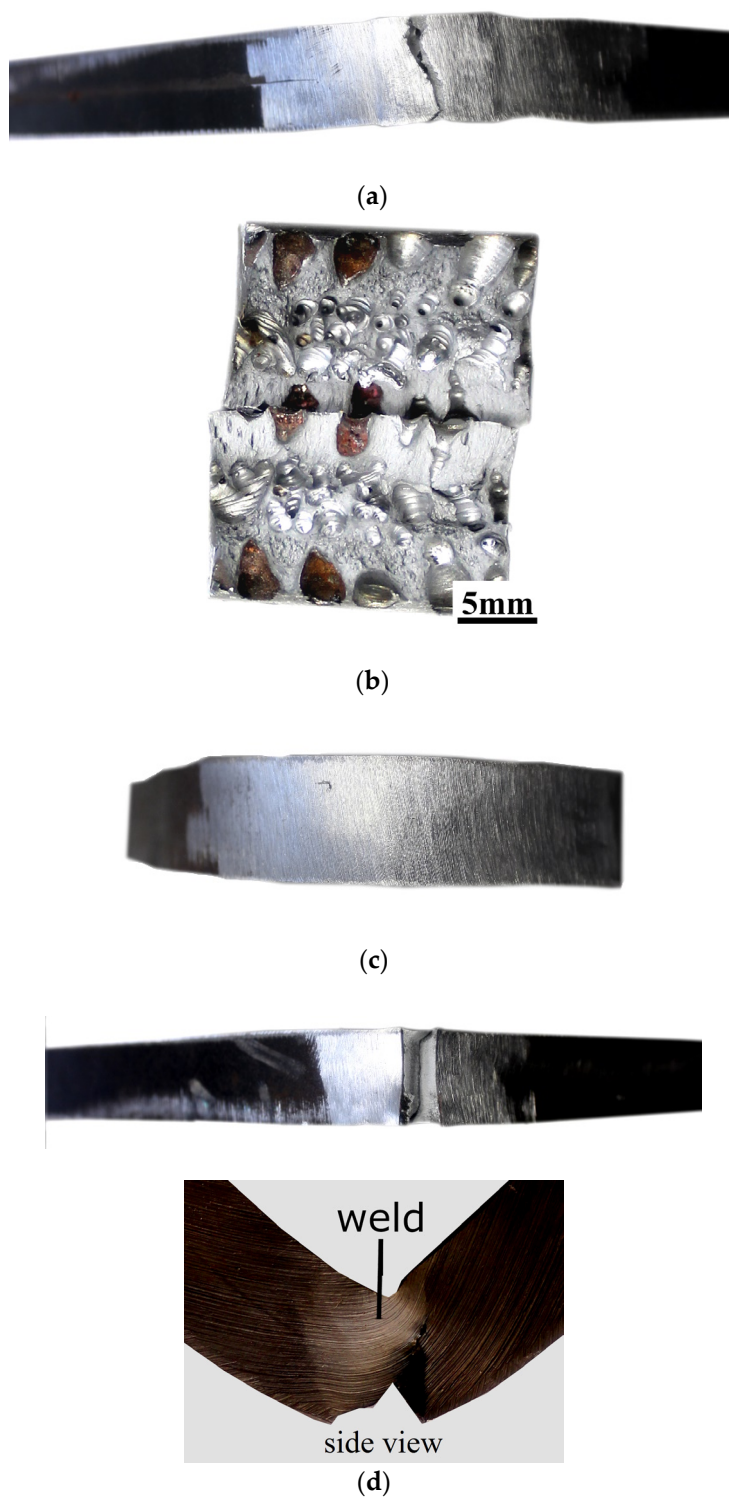
**Figure 12.** Specimens after bending test: (a) Sample 3 performed in the water, bent with tensile from the root of the weld; (b) Sample 4 performed in the water, bent with tensile from the face of the weld; (c) Sample 2 performed in the air, bent with tensile from the root of the weld; (d) Sample 3 performed in the air, bent with tensile from the root of the weld.

near the end of the joint (following the scheme presented in Figure 3). The exemplary photographs of the bending results of the bending test are presented in Figure 12. The main aim of the bending test is to determine the plastic properties of welded joints. However, it also allows checking the influence of the welding imperfections on the properties of the welded joints, as it was stated by Rogalski et al. [58]. The criterion of acceptance was defined as a bend angle of 180°. During NDT, imperfections were found in areas, from which samples for the bending test were taken. Samples from specimen SW were broken into two parts. A maximum bending angle equal to 60° was observed for the samples bent with tensile from the root of the weld (Figure 12a), which was cut from the area close to the end of the joint. The second sample (area near the beginning of the joint), which was bent under the same conditions, broke with an angle of 10°. The cross-section observation showed that almost 60% of the weld was characterized by porosity (Figure 12b). The same was noticed for a sample bent with tensile from the face of the weld, which broke with angle 35°. The second sample (area near the end of the specimen SW) has been broken with an angle of 45°. Different results have been observed for bending the samples from the joint welded in the air. Both samples cut from the area without imperfections reached the aimed angle of 180° (Figure 12c). Specimens performed from an area characterized by the lack of fusion broke through the fusion line. The sample bent with tension from the face of the weld reached a bend angle of 110°. A sample bent with tension from the root of the weld reached bend angle 90° (Figure 12d). The results that were obtained allow for a comparison of the properties of specimens welded in both environments. The bending test results allow drawing the statement that there is no connection between tensile strength and resistance for the bending process. Both specimens could obtain similar results in the tensile test. However, there are significant differences in their behavior during bending. The cooling rate is an important factor influencing the metallurgical changes. The water environment increases the intensity of heat dissipation from the welding area in relation to the air welding conditions. It leads to formation of brittle structures in the HAZ of underwater welded joints [39,55], which was proved in this paper. Therefore, it can be assumed that the simultaneous presence of a welding imperfection and a quenched structure affects the bending test results.
