Article

Underwater Local Cavity Welding of S460N Steel

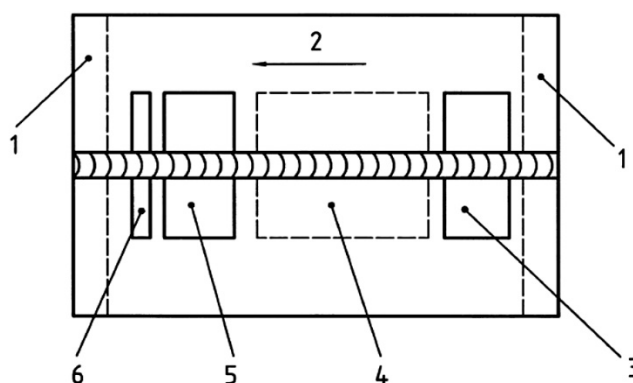
Figure 3. The location of test samples for destructive (DT); 1—discard 25 mm, 2—welding direction, 3—area for one tensile test specimen and bend test specimens (one for bending with tensile from the face of the weld, one for bending with tensile from the roof of the weld), 4—area for impact test specimens, 5—area for one tensile test specimen and bend test specimens (one for bending with tensile from the face of the weld, one for bending with tensile from the roof of the weld), 6—area for metallographic (macroscopic and microscopic) test specimens and one hardness test specimen.

Specimens were subjected to non-destructive (NDT) and destructive (DT) tests. In the first step, NDT was performed. The HSLA steels are characterized by high susceptibility to cold cracking in underwater conditions [8,10,20]. Cold cracks may occur up to 48 h after welding. Following this reason, the NDT was performed 48 h after welding. These kinds of tests are widely used for testing underwater constructions [40]. Both welded joints were tested using: a visual test (VT) following EN ISO 17637:2017 [41], a penetrant test (PT)—EN ISO 3452-1:2017 [42], a radiographic test (RT)—EN ISO 5579:2014 [43], and an ultrasonic test (UT), by use of an automated phased array (PA) technology—ISO 13588:2019 [44]. For RT, the ANDREX 300kV x-ray apparatus was used. During preliminary investigations, the optimal parameters were chosen: focal length 700 mm, exposure time 5 min 30 s, voltage 185 kV, anode current intensity 4.5 mA. UT was performed by PA technology with the use of a Phasor XS flaw detector (GE Research, New York, USA). For PA 16 an element head was used, with the angle of inclination at 36° . During tests, type A and S imaging were obtained. After NDT, both specimens were prepared for DT by cutting samples for each test. Investigated joints were cut following the requirements presented in the EN ISO 15614-1:2017 standard [38]. The location of test samples for DT is presented in Figure 3.

near the end of the joint (following the scheme presented in Figure 3). The exemplary photographs of the bending results of the bending test are presented in Figure 12. The main aim of the bending test is to determine the plastic properties of welded joints. However, it also allows checking the influence of the welding imperfections on the properties of the welded joints, as it was stated by Rogalski et al. [58]. The criterion of acceptance was defined as a bend angle of 180°. During NDT, imperfections were found in areas, from which samples for the bending test were taken. Samples from specimen SW were broken into two parts. A maximum bending angle equal to 60° was observed for the samples bent with tensile from the root of the weld (Figure 12a), which was cut from the area close to the end of the joint. The second sample (area near the beginning of the joint), which was bent under the same conditions, broke with an angle of 10°. The cross-section observation showed that almost 60% of the weld was characterized by porosity (Figure 12b). The same was noticed for a sample bent with tensile from the face of the weld, which broke with angle 35°. The second sample (area near the end of the specimen SW) has been broken with an angle of 45°. Different results have been observed for bending the samples from the joint welded in the air. Both samples cut from the area without imperfections reached the aimed angle of 180° (Figure 12c). Specimens performed from an area characterized by the lack of fusion broke through the fusion line. The sample bent with tension from the face of the weld reached a bend angle of 110°. A sample bent with tension from the root of the weld reached bend angle 90° (Figure 12d). The results that were obtained allow for a comparison of the properties of specimens welded in both environments. The bending test results allow drawing the statement that there is no connection between tensile strength and resistance for the bending process. Both specimens could obtain similar results in the tensile test. However, there are significant differences in their behavior during bending. The cooling rate is an important factor influencing the metallurgical changes. The water environment increases the intensity of heat dissipation from the welding area in relation to the air welding conditions. It leads to formation of brittle structures in the HAZ of underwater welded joints [39,55], which was proved in this paper. Therefore, it can be assumed that the simultaneous presence of a welding imperfection and a quenched structure affects the bending test results.

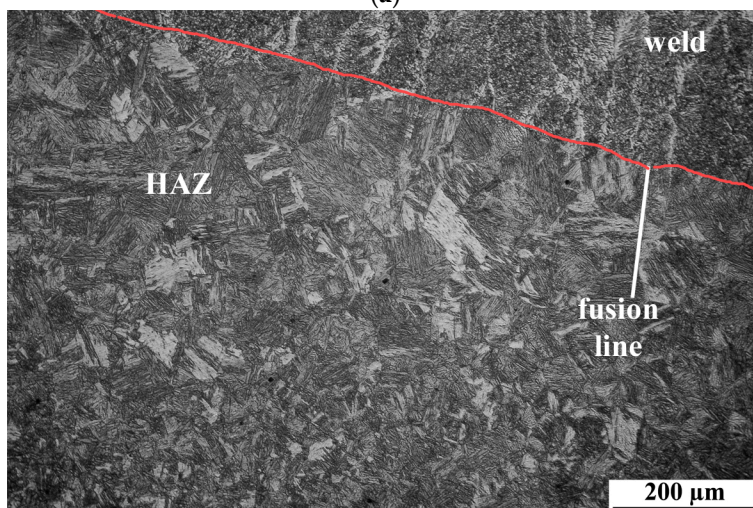
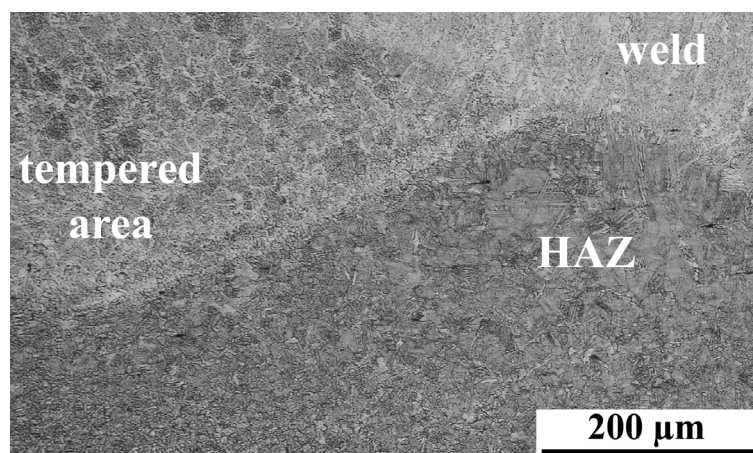
Figure 10. Optical micrographs of: (a) specimen SA; (b) specimen SW; (c) middle area of specimen SW—the tempering effect and (d) S460N microstructure.

The microstructures of the specimens welded in different environments are shown in Figure 10. During microscopic testing, the differences were observed for specimens welded in the air and in water. Water as a welding environment increases the cooling rate. It resulted in the formation of complex structures in the HAZ. The microstructure in HAZ of specimen SA consists of a mixture of martensite and bainite (Figure 10a). Specimen SW welded in the water is characterized by the typical structures formed in this environment. The microstructure in HAZ is coarse-grained and exhibits a martensitic morphology (Figure 10b). The weld metal of both specimens was built of dendrites. The strong effect of tempering of brittle structures in HAZ has been observed in the middle of specimen SW (Figure 10c). The heat from the weld passes has accumulated in this area, which provides the tempering of microstructures. A similar effect was presented in our further investigations [18]. The results of microscopic testing of the joint (HAZ) performed on S460N steel welded in the water by the wet welding method were presented in previous investigations [39,55]. In the presented experiments [39,55], cold cracks were found in the HAZ of the joint performed in the high cooling rate conditions. However, during the microscopic testing of specimen SW, no cracks were found. This showed the advantages of local cavity welding in comparison to the wet welding process in thermal and metallurgical conditions. The microstructure of the S460N steel is composed of banded ferrite and banded pearlite (Figure 10d).

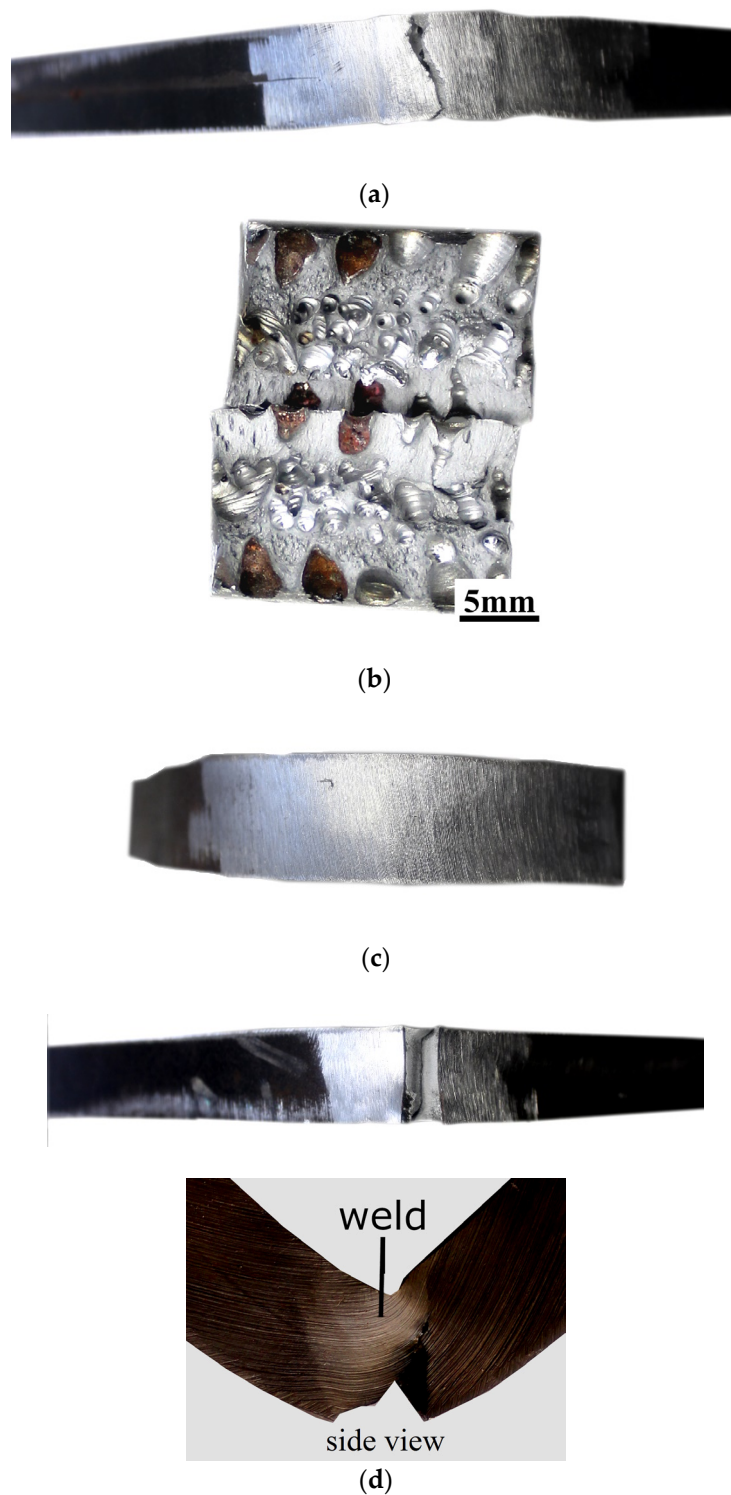
Figure 12. Specimens after bending test: (a) Sample 3 performed in the water, bent with tensile from the root of the weld; (b) Sample 4 performed in the water, bent with tensile from the face of the weld; (c) Sample 2 performed in the air, bent with tensile from the root of the weld; (d) Sample 3 performed in the air, bent with tensile from the root of the weld.
