INFLUENCE OF PROCESS OF STRAIGHTENING SHIP HULL STRUCTURE MADE OF 316L STAINLESS STEEL ON CORROSION RESISTANCE AND MECHANICAL PROPERTIES

Keywords: 316L steel, flame straightening, corrosion resistance, mechanical properties

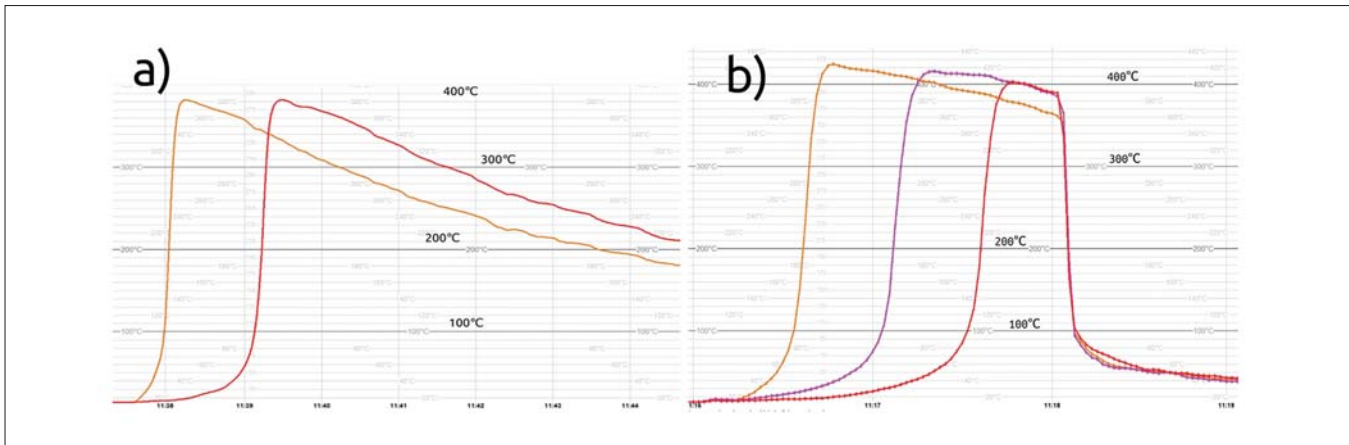
Fig. 3. Temperature record during cooling: a) natural, b) rapid (water bath)

In order to control the temperature during both heating and cooling, thermocouple sensors are mounted on each of the plates. The process record is shown in Fig. 3a for natural cooling and in Fig. 3b for rapid water cooling.

From the records of the temperature during the test it is clearly seen that the time required for natural cooling is many times longer than that required for cooling in a water bath. According to the record, during heating, in both cases, the temperature of the plate oscillated around 400°C. It should be noted that, for technical reasons, the temperature was measured on the side opposite to the heated side of the sheet. After the process was completed, clear plastic deformation (bending) appeared on the metal sheet in a form corresponding to the method of introducing heat into the sheet.
