INFLUENCE OF PROCESS OF STRAIGHTENING SHIP HULL STRUCTURE MADE OF 316L STAINLESS STEEL ON CORROSION RESISTANCE AND MECHANICAL PROPERTIES

ABSTRACT

Keywords: 316L steel, flame straightening, corrosion resistance, mechanical properties

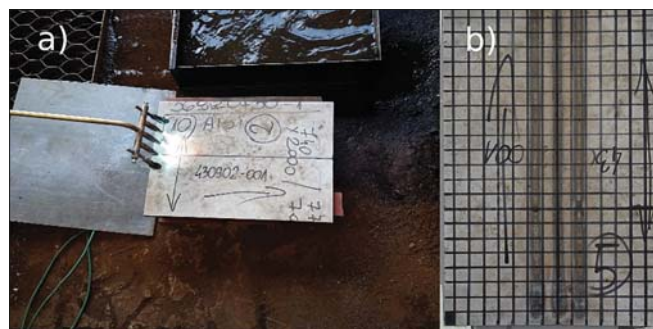
Fig. 2. Test plate during straightening process (a) and surface after process (b)

Eight test plates were provided for testing: two reference ones made of material not subjected to flame straightening (reference material), three straightened and naturally cooled ones, and three straightened and water-cooled ones (All panels had dimensions of 300×450 mm and a thickness of 10 mm. Straightening was carried out using triple flame burners. Figure 2 shows the plate during straightening. The straightening direction was perpendicular to the rolling direction.

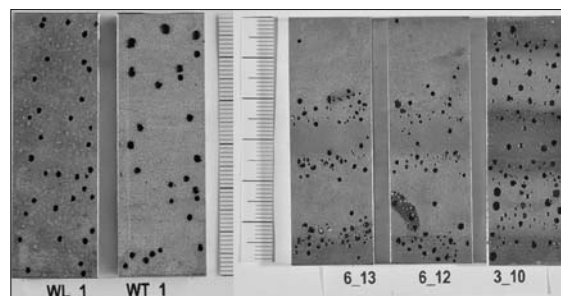
Fig. 8. Pitting corrosion

Similarly to the tensile strength test, for comparative purposes, the reference material tests were performed. As a result of the observations, a concentration of pits in the area of the burner passage was noticed. The phenomenon is particularly visible for the naturally cooled sheets. For the

reference samples, the obtained pitting corrosion distributions are shown in Fig. 8. All images of corroded specimens were taken with Nikon D7100 camera with macro photography lens (focal length equal to 60 mm).

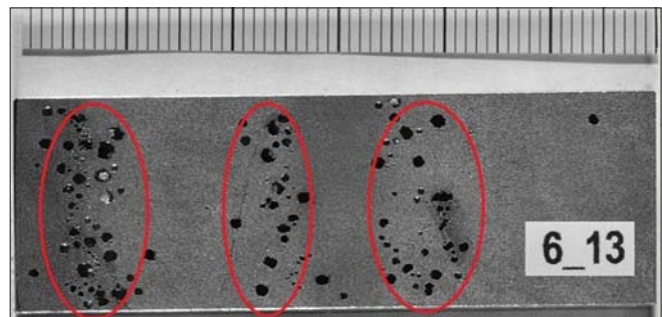
Fig. 11. Pitting corrosion concentration regions

a burner. The ferrite-δ content is similar in each case and is typical for the tested material. The method of cooling does not affect the internal structure of the material. These observations also indicate that the straightening process took place at temperatures below 1000°C, as it had no effect on the structural change. The conducted corrosion tests indicate, however, a clear increase in the pitting corrosion rate for plates heated by the burner compared to the corrosion rate of the reference material. The concentration of corrosive pitting was observed at the junction of the burner trace and the “unchanged” material (see Fig. 11).

This indicates that the flame straightening process was carried out at a temperature above 500°C, which led to the phenomenon of dechromination of areas adjacent to the austenite grain boundaries. When heating steel to a temperature higher than about 500°C, the diffusion rate of Cr is less than that of C; this process was described in the initial part of the publication.
