# INFLUENCE OF PROCESS OF STRAIGHTENING SHIP HULL STRUCTURE MADE OF 316L STAINLESS STEEL ON CORROSION RESISTANCE AND MECHANICAL PROPERTIES

<sup>1</sup> Gdańsk University of Technology, Poland

<sup>2</sup> CRIST S.A., Gdynia, Poland

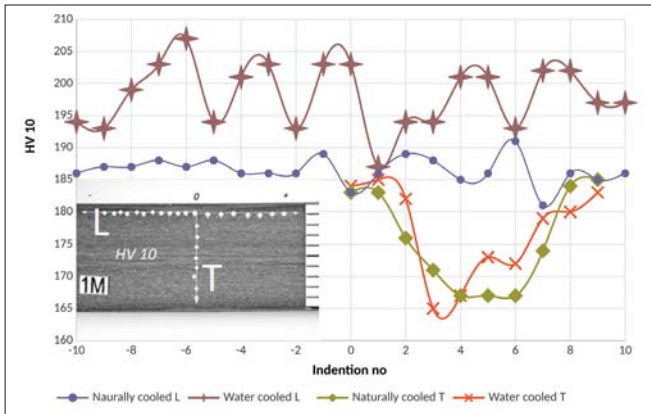
Fig. 6. Vickers hardness test results

To determine whether the observed changes in the hardness distribution are purely surface in nature, a cross-sectional study was performed. Two measuring lines were made for each case. For the line marked “L”, the measurement was made at a depth of about 1 mm from the heated surface of the test plates, and the measuring points were numbered and arranged as for a surface test. For the line marked “T”, the measurement was made according to the material thickness, with measuring points spaced approximately every 1 mm. The measurement lines and test results are depicted in Fig. 6.

As can be seen in Fig. 6, the hardness values measured 1 mm under the heated surface of the sheet show significantly lower fluctuations. The nature of the graph caused the results to be averaged, and the standard deviation was calculated. For the naturally cooled sheets, the average hardness was  $186.5 \pm 2.0$  HV10, while for the water-cooled sheets it was

$198.0 \pm 4.8$  HV10. Analysing the T lines, in both cases, one can notice a certain regularity – the hardness reaches higher values at the material surfaces. This is the result of metallurgical processes – rolling and the effect of the greater pressure on the surface of the sheet (compared to its interior). For sheets cooled after straightening in a natural way, the hardness distribution over the sheet thickness is practically symmetrical. In the case of test plates cooled in a water bath, the effect of the thermal process is clearly visible – the hardness distribution is asymmetrical and its minimum is clearly shifted towards the heated surface.
