Article

Chemical, Physical, and Mechanical Properties of 95-Year-Old Concrete Built-In Arch Bridge

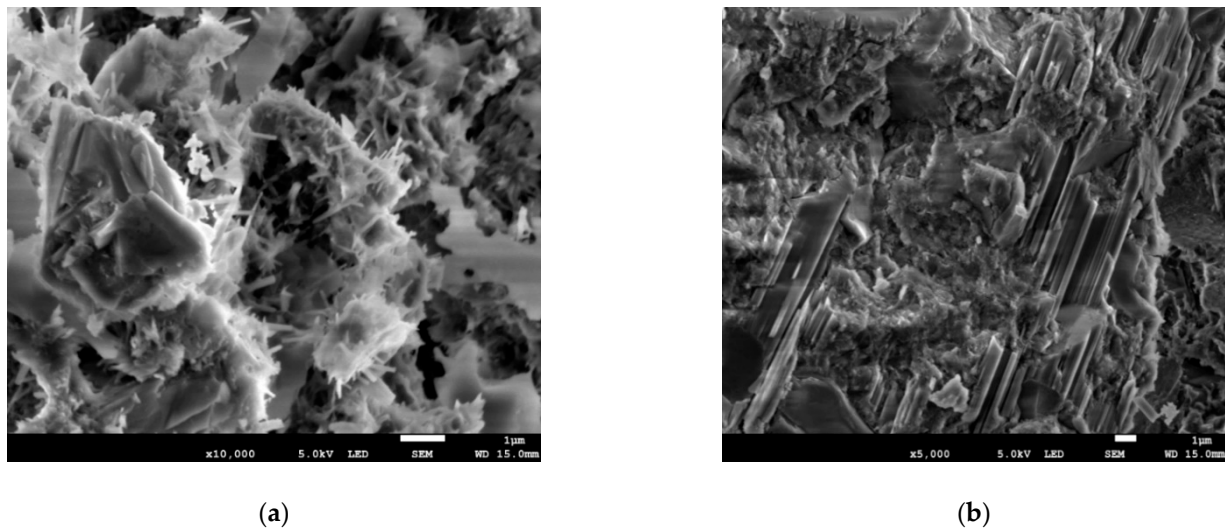
Figure 6. SEM images of the samples taken from center layer of the concrete structure: (a) $\times 10,000$; (b) $\times 5000$.

Based on the specified chemical properties, samples from 1s and 1c concrete specimens were chosen for XRD analyses to assess the presence of crystalline compounds and identify them. For the tests, specimens measuring 10 × 10 × 10 mm were taken from the cover layer and the center layer (about 7.5 cm below the surface of the concrete) of the tested concrete element. Microstructure tests were carried out for four samples (two samples from the cover and two samples from the center layer of old concrete specimens). Element composition tests (EDS) were carried out for four samples (three samples from the cover and three samples from a depth of about 7.5 cm below the surface). The results of the microstructure (SEM images) and element composition of the tested samples are shown in Figures 5 and 6.

- Portlandite crystals were found in the tested samples, shaped most often as hexagonal platelets. Both isolated and clustered occurrence was noted. The visible portlandite occurred in the form of large pseudohexagonal crystals, forming columnar conglomerates arranged in parallel. In both cases, the resulting products (phases CSH and CH) were due to cement hydration reactions with water. The microstructure of the concrete has a significant influence on its properties, such as its strength and durability.

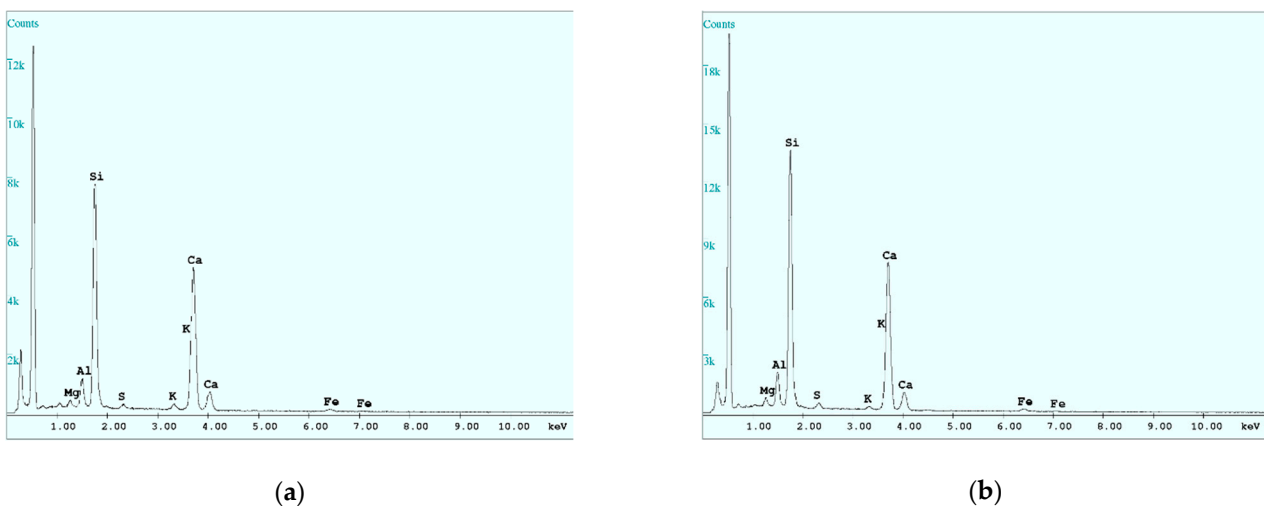
Figure 7. Energy-dispersion X-ray spectrometer (EDS) spectra of samples taken from the (a) cover layer; (b) center layer.

The results of element composition tests are presented in Tables 8 and 9. They indicated the dominance of two main elements in the microstructure of the tested samples: Si (silica) and Ca (calcium) (see Figure 7). The content of these elements for samples taken from the cover layer was 29.4 to 34.7% for silica and 54.1 to 57.5% for calcium. For the specimen samples taken from center layer, the content was 25.6 to 36.8% for silica and 51.6 to 60% for calcium. The content of other elements, such as Al, Fe, Mg, K, and Na, was definitely lower compared to the Si and Ca content in all samples.
