Article

Chemical, Physical, and Mechanical Properties of 95-Year-Old Concrete Built-In Arch Bridge

Abstract: This research aimed to determine the durability and strength of an old concrete built-in arch bridge based on selected mechanical, physical, and chemical properties of the concrete. The bridge was erected in 1925 and is located in Jagodnik (northern Poland). Cylindrical specimens were taken from the side ribs connected to the top plate using a concrete core borehole diamond drill machine. The properties of the old concrete were compared with the present and previous standard requirements and guidelines. The laboratory testing program consisted of the following set of tests: measurements of the depth of carbonated zone and dry density, water absorption tests, determination of concrete compressive strength and frost resistance, determination of modulus of elasticity, measurement of the pH value, determination of water-soluble chloride salt and sulfate ion content, and X-ray diffraction analyses. Large variations in the cylindrical compressive strength (14.9 to 22.0 MPa), modulus of elasticity (17,900 to 26,483 MPa), density (2064 to 2231 kg/m³), and water absorption (3.88 to

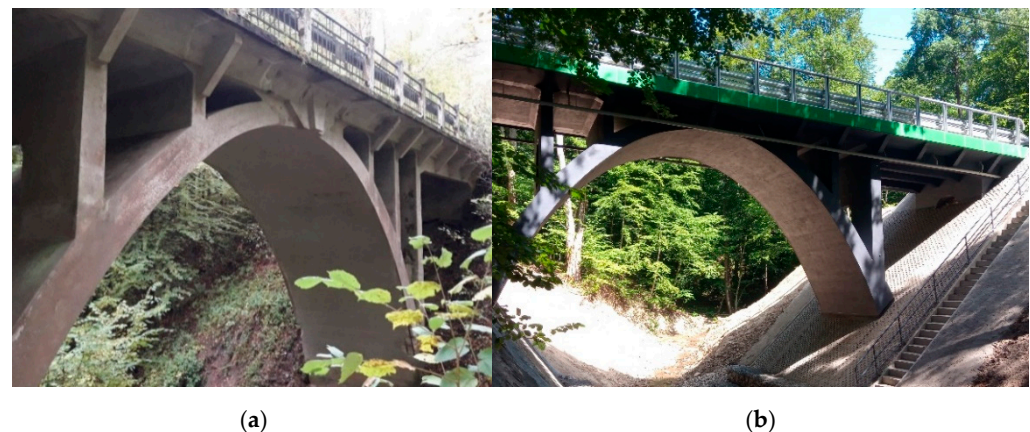
Figure 1. Jagodnik arch bridge before (a) and after (b) reconstruction.

The arch bridge investigated in this study is located above a forest canyon and the Kumieli river (watercourse) (see Figure 1). The structure of the center span bridge (about 12.95 m) is a reinforced concrete slab, monolithically connected to reinforced concrete shields supported on a plate arch. The arch bridge was built in 1925 in Jagodnik (Poland) by Karl Metzger & Co. building company (see p. 181 in [24], where a photo of the investigated arch bridge is inserted). In 1925, Jagodnik (Berendshagen) was part of the district of Elbing in Germany (present-day Elbląg in Poland). The arch bridge was erected under the guidelines of the German Committee for Structural Concrete issued in January 1916 [25] for structural use of concrete, design, and construction. This guideline was in force until September 1925, when the German standard DIN 1045 [26] was introduced.

The design team of the Jagodnik arch bridge made a decision on the possibility of reconstructing the 95-year-old arch bridge and designing it for car traffic to a limited tonnage. On top of the existing old structure, a new deck slab with pavement covers was made. The entire surface of the old concrete was protected with repair mortars.
