Weldability of Underwater Wet-Welded HSLA Steel: Effects of Electrode Hydrophobic Coatings

Abstract: The paper presents the effects of waterproof coatings use to cover electrodes on the weldability of high-strength, low-alloy (HSLA) steel in water. With the aim of improving the weldability of S460N HSLA steel in water, modifications of welding filler material were chosen. The surfaces of electrodes were covered by different hydrophobic substances. The aim of the controlled thermal severity (CTS) test was to check the influence of these substances on the HSLA steel weldability in the wet welding conditions. The visual test, metallographic tests, and hardness Vickers HV10 measurements were performed during investigations. The results proved that hydrophobic coatings can reduce the hardness of welded joints in the heat-affected zone by 40–50 HV10. Additionally, the number of cold cracks can be significantly reduced by application of waterproof coatings on the filler material. The obtained results showed that electrode hydrophobic coatings can be used to improve the weldability of HSLA steel in underwater conditions.

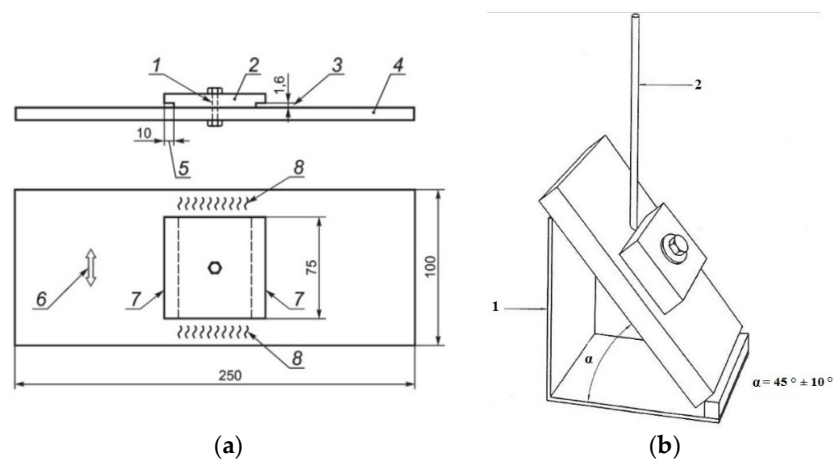
Figure 1. Control thermal severity (CTS) specimen: (a) scheme of CTS test; 1—hole 13 mm diameter, 2—top plate, 3—root notch gap, 4—bottom plate, 5—root notch depth, 6—rolling direction, 7—test welds, 8—anchor welds; (b) the location of the specimen during welding; 1—jig, 2—covered electrode.

For this research, the control thermal severity (CTS) test was selected, which resulted from the fact that fillet welds are the most commonly used in underwater-welded structures. Additionally, the CTS test assesses susceptibility to cold cracking in all regions of welded joints. A scheme of the CTS specimens is presented in Figure 1a. The specimen was housed in a special jig. The test welds were deposited symmetrically in the flat position (PA) in a single pass and in a single direction, across the full width of the block (Figure 1b).

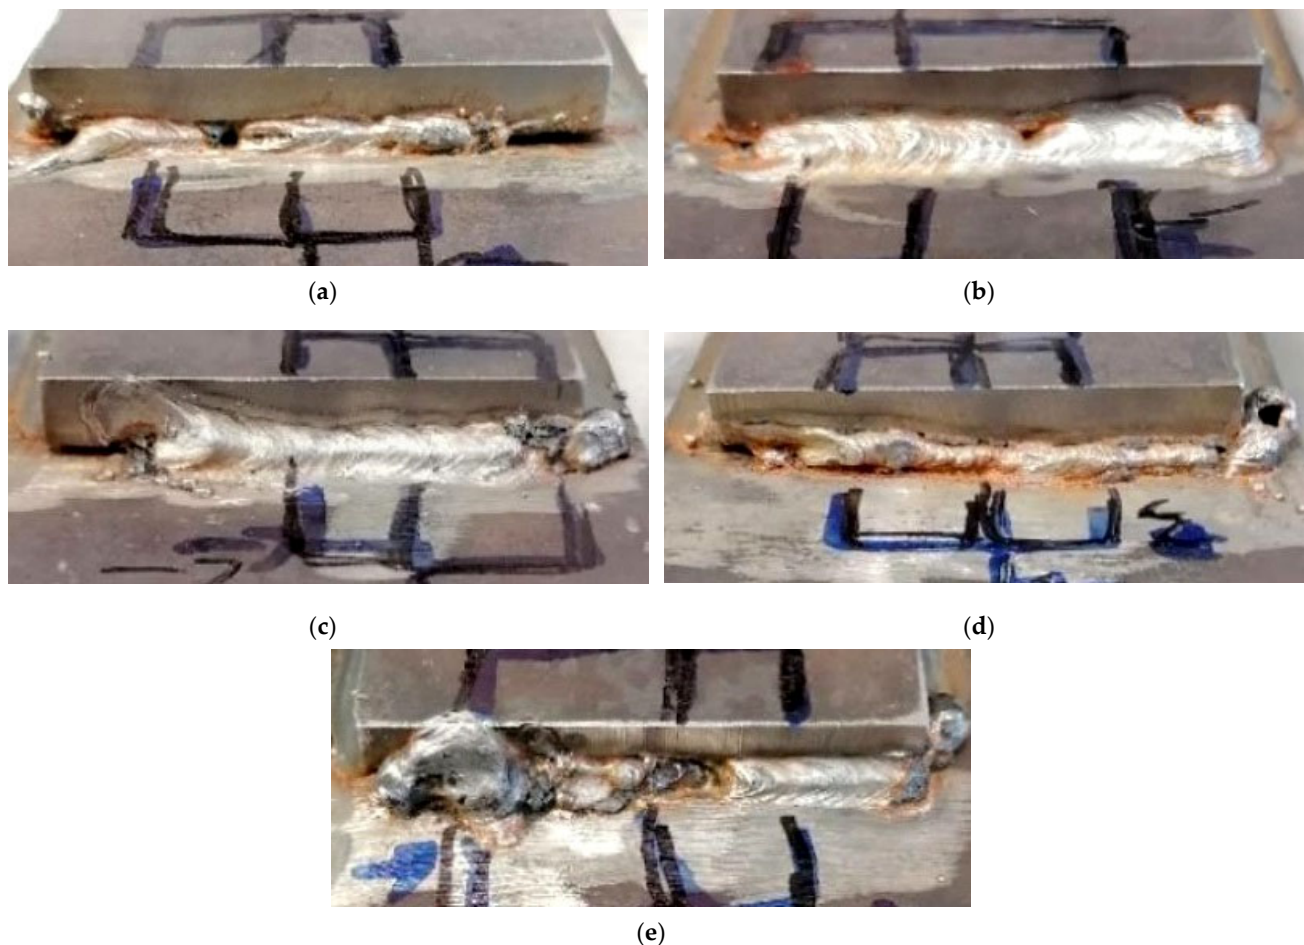
Figure 2. The exemplary results of the visual test (VT): (a) weld 1—specimen 1 (non-modified electrode), pores, weld length 60 mm; (b) weld 2—specimen 2 (underwater electrode), weld length 70 mm; (c) weld 1—specimen 3 (concrete impregnate), spatter, weld length 60 mm; (d) weld 2—specimen 4 (liquid foil), lack of fusion, undercuts, shape defects, weld length 70 mm; (e) weld 1—specimen 5 (paraffin wax), shape defects, pores, weld length 70 mm.

Exemplary photos of the VT are presented in Figure 2. The lines mark places identified for sample cutting in further investigations. The VT focused on the selection of

cutting locations for further investigations, due to the fact that underwater wet welding in most cases is treated as a repair method. Our observations showed differences between specimens performed using electrodes with different surface coatings. Both test welds in specimens 1 and 2 are characterized by their proper geometry. However, pores were observed in one weld in each specimen (Figure 2a,b). Welding of specimen 3 generated excessive spatter (Figure 2c), which was not observed for other specimens. The worst results were observed for the specimen welded using electrodes coated with liquid foil. The width of the weld was two-fold smaller than in other specimens. Additionally, a lack of fusion and undercuts was observed (Figure 2d). The biggest difference between two welds in the same specimen was observed for specimen 5. Weld 2 performed with higher heat input and was characterized by its proper geometry. Moreover, no imperfections were observed. The VT for weld 1 showed many imperfections, such as shape defects and pores, which started in the middle of the weld (Figure 2e). Guo et al. [49] proved that the heat input value is crucial to the quality of offshore welded steel joints. Additionally, in the author's previous investigations [25], it has been shown that higher heat input values lead to improvement of the quality of S460N steel wet-welded joints.

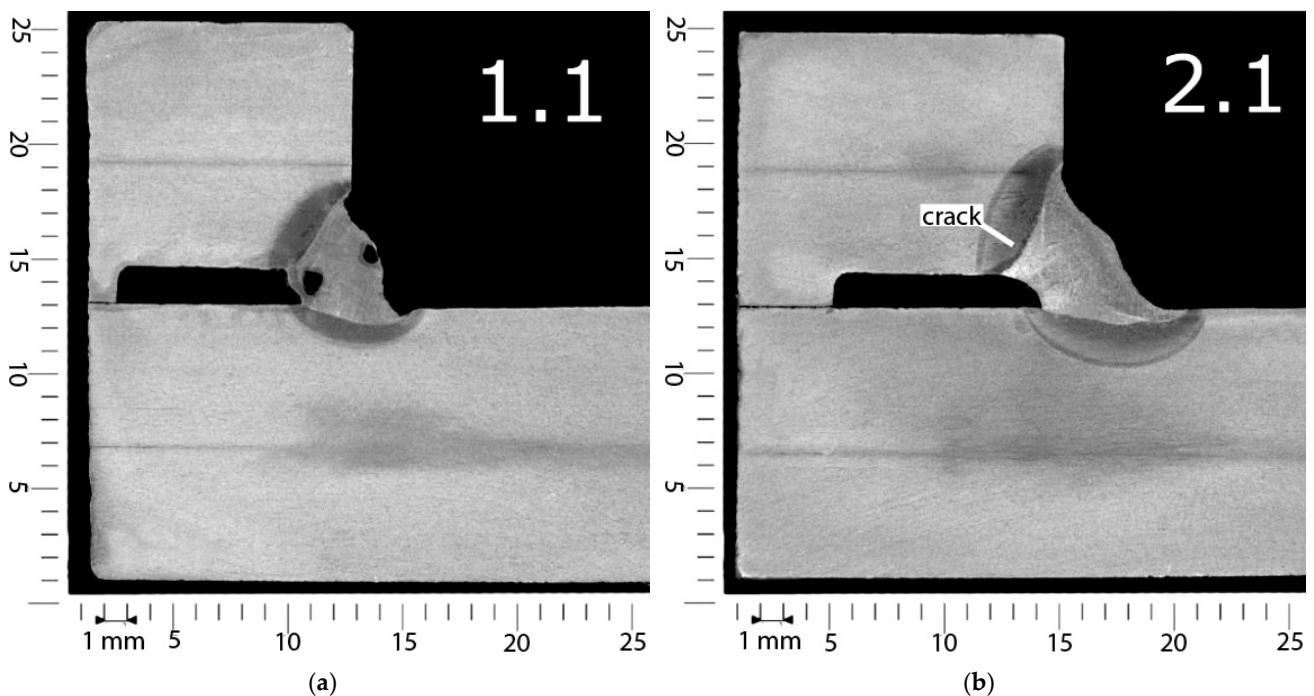
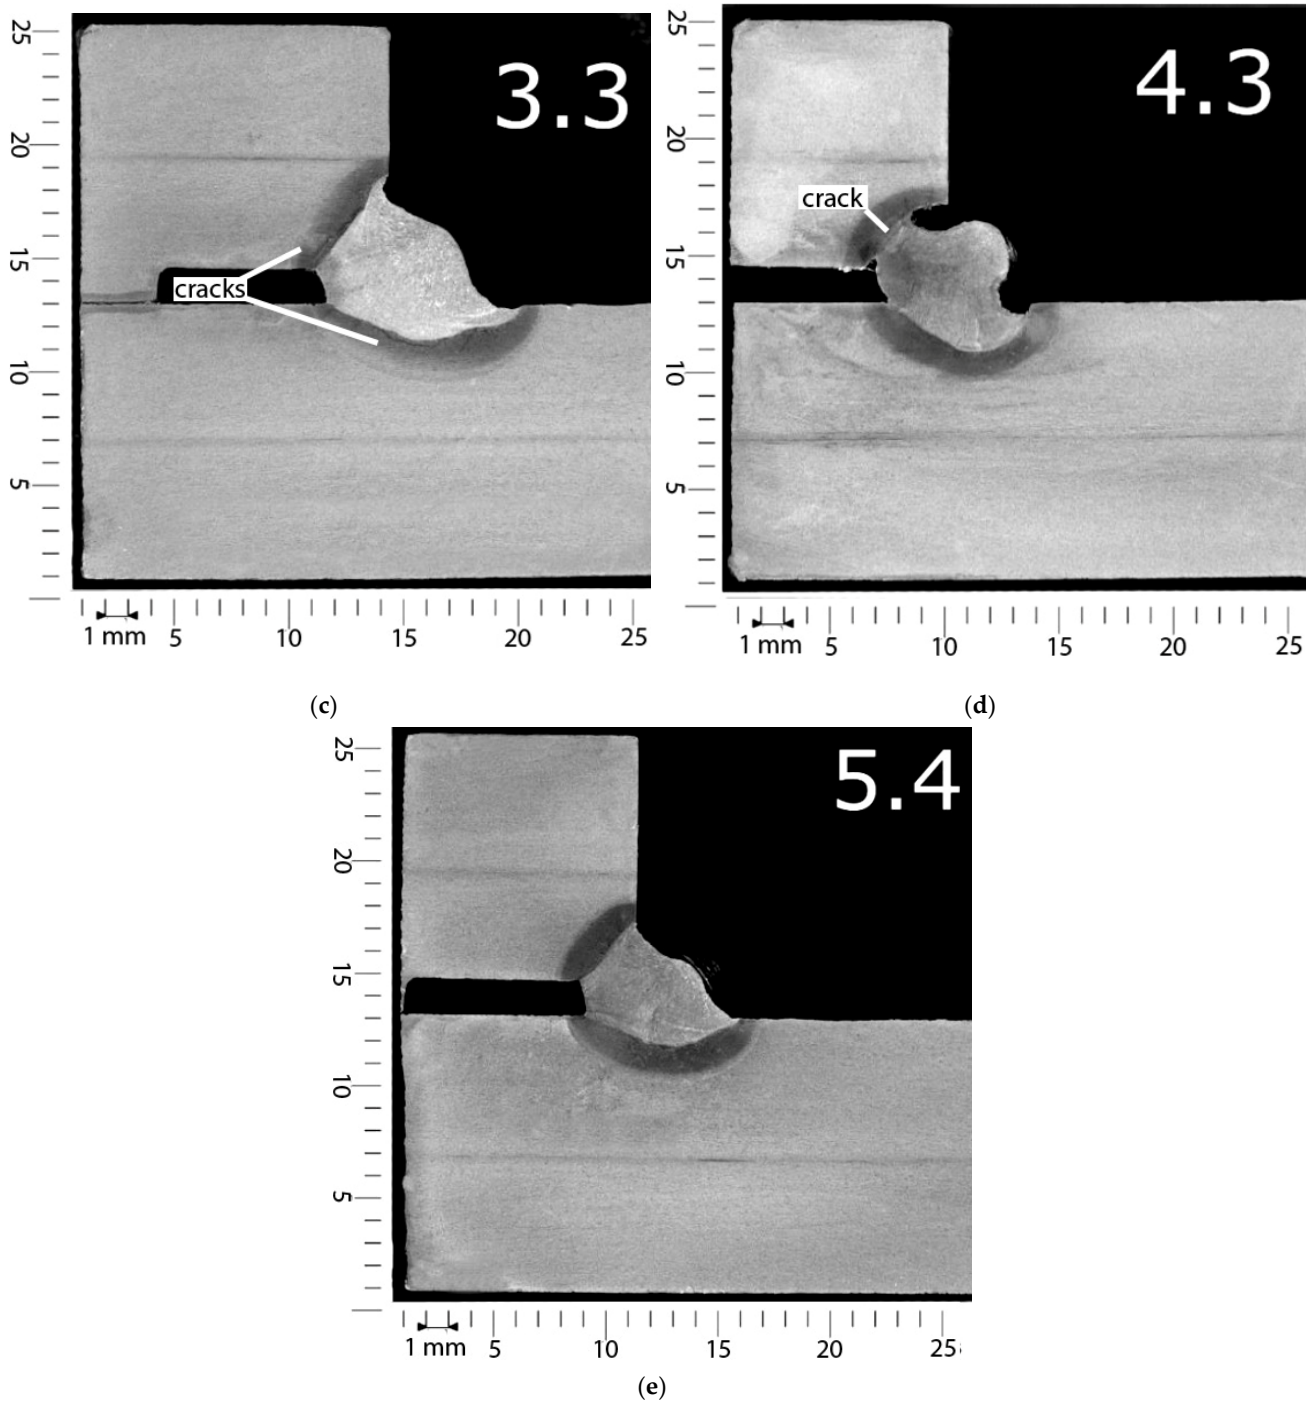
Figure 3. Exemplary results of macroscopic testing: (a) weld 1—specimen 1 (non-modified electrode), pores and undercuts; (b) weld 1—specimen 2 (underwater electrode), cracks in the heat-affected zone (HAZ); (c) weld 2—specimen 3 (concrete impregnate), cracks in the HAZ and undercuts; (d) weld 2—specimen 4 (liquid foil), cracks in the HAZ and deep undercuts; (e) weld 2—specimen 5 (paraffin wax), no imperfections.

Exemplary macroscopic photos are presented in Figure 3. The macroscopic observations also showed differences in specimens welded with different electrodes. Specimen 1, welded using non-modified electrodes, is characterized by the existence of porosity in the weld, which proved the results of VT (Figure 3a). Additionally, undercuts were observed. However, no cracks occurred. These cracks were observed in weld 1 (Figure 3b), which was performed using underwater electrodes (specimen 2). These cracks were located in the HAZ, parallel to the fusion line. This location is characteristic of cold cracks occurring in wet welding conditions, as stated for the investigated S460N steel in previous investigations [39]. Cracks were observed in joints welded (specimen 3) using electrodes coated with concrete impregnate (Figure 3c). These cracks were longer and wider than in specimen 2. Additionally, small undercuts occurred in two welds of this specimen. The biggest imperfections were observed in specimen 4, performed with the use of liquid-foil-coated electrodes. The quality of both welds was poor, with cracks and deep undercuts observed in each cross-section (Figure 3d). The macroscopic observations of specimen 5 showed no imperfections in three out of four observed cross-sections (Figure 3e). The last cross-section was cut from locations characterized by many imperfections (Figure 2e), so the macroscopic test confirmed the poor quality of the joint in this location.

Macroscopic tests showed the presence of many imperfections in all welded joints, which is typical for underwater conditions [5,7,9]. The most often observed were undercuts and cracks. Garg et al. [50] stated that increasing the cooling rate results in an increasing number of undercuts in electric welded joints. The high cooling rate in wet welding conditions leads to the presence of undercuts in all specimens. The macroscopic tests of CTS specimens showed differences in comparison to the pad weld observations performed in previous investigations [39]. No cracks were observed for pad welds. The presence of cold cracks in joints with filled welds resulted from the different thermal conditions. These differences are connected to the different shapes of the specimens and the presence of notches in CTS samples [42].

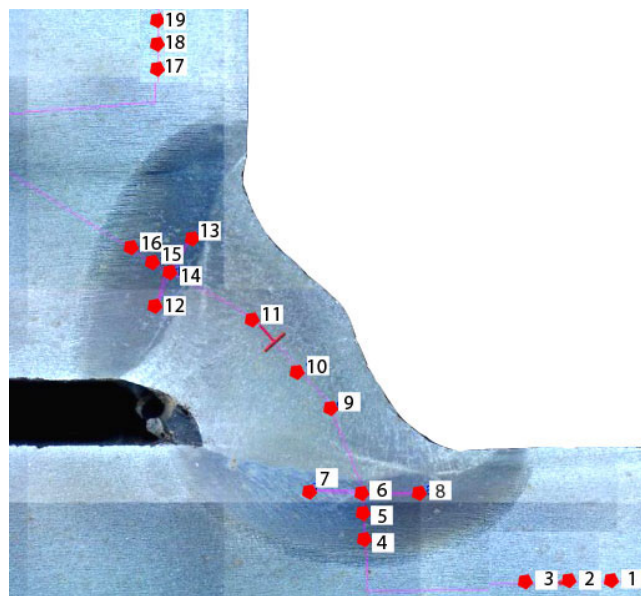
Figure 4. The distribution of measurement points.

Hardness measurements were performed in one cross-section from the test weld at 19 points: 3 in the weld metal, 6 in the BM, and 10 in the HAZ (5 in each side of the joint). A schematic of the distribution of the measurement points is presented in Figure 4.

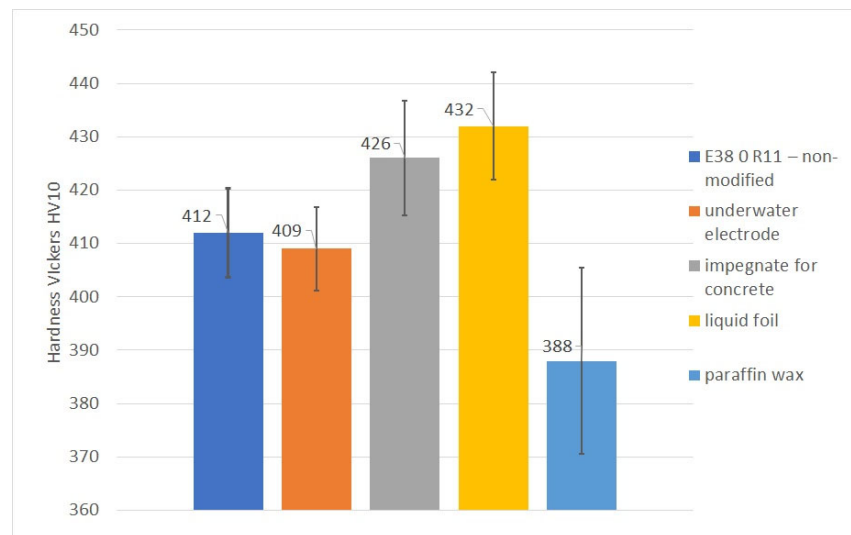
Figure 5. The average HV10 hardness values in the HAZ.

Hardness measurements showed that the HAZ hardness values in specimen 1 (non-modified electrode) and specimen 2 (underwater electrode) were similar, with both being in the range of 400–430 HV10. Previous investigations performed for pad welds [39] showed that the average hardness for non-modified electrodes was 479 HV10 and for underwater electrodes was 472 HV10. This resulted from the greater dilution in pad welds than in welded joints with fillet welds, as stated in the literature by Sun et al. [52]. The same differences between pad welds and CTS specimens were observed for other specimens welded using different electrodes. Additionally, it was observed that usage of concrete impregnate and liquid foil resulted in increased hardness. The hardness of specimen 3 increased to 448 HV 10, while that of specimen 4 increased to 454 HV 10. The measurements of specimen 5, which was welded with electrodes, confirmed the results of previous experiments [39]. The hardness in the HAZ of the joint welded using an electrode with paraffin was significantly lower. Moreover, some measurements were lower than 380 HV10, which is minimum value required for joints welded in air. It had been proven previously [25] that higher-quality S460N steel joints are characterized by lower HAZ hardness. The same effect was observed in the presented investigations. Previous investigations [39] showed that high HAZ hardness could be observed in structures characterized by the presence of a greater number of cold cracks. This suggests that the different hydrophobic coatings investigated in this paper may result in differing susceptibility of HSLA steels to cold cracks. The Vickers HV10 hardness measurement results are listed in Table 5. Values higher than 380 HV10 are shown in bold. It was proven that paraffin wax as a coating on covered electrodes provides significantly decreases the hardness in the HAZ. The average hardness was higher than 380 HV10, however that value is recommended for air welding, in which the cooling rate is much lower than in

wet welding. A graphical comparison of average HAZ hardness values is presented in Figure 5.

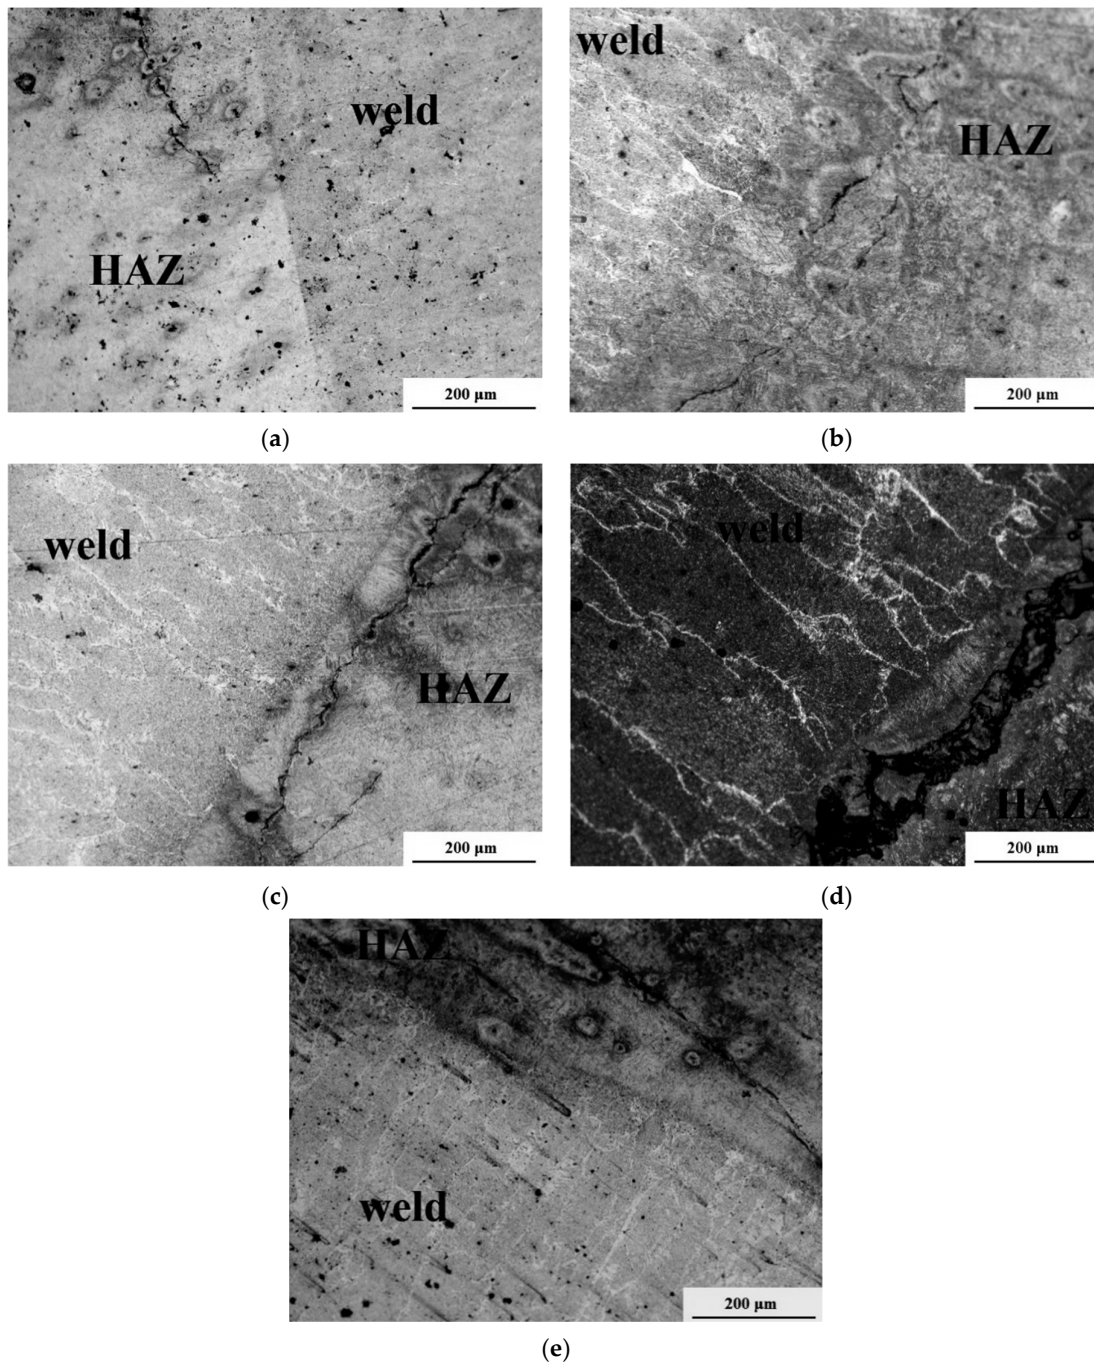
Figure 6. Optical micrographs of: (a) specimen 1 (non-modified electrode); (b) specimen 2 (underwater electrode); (c) scheme 3 (concrete impregnate); (d) specimen 4 (liquid foil); (e) specimen 5 (paraffin wax).

The microstructures are shown in Figure 6. The main aim of the microscopic test was to evaluate the specimens for the occurrence of cold cracks. It had been proven in previous investigations [39] that the use of electrodes coated with concrete impregnate and liquid foil generated 85–95 mL/100g diffusible hydrogen in deposited metal. In comparison, the non-modified electrode generated 75 and the underwater electrode 65 mL/100g diffusible hydrogen. However, the use of paraffin wax decreased the hydrogenation below 50 mL/100g diffusible hydrogen. These results and the hardness measurements presented in Section 3.3 suggest differences in specimens welded with different filler materials. From each specimen, four cross-sections were observed in the HAZ and in the weld metal. Each joint was characterized by typical microstructures for the underwater-welded HSLA joints [5,9,25]. The weld metal presented a dendritic structure. The HAZ consists of brittle structures such as martensite and bainite. There were no significant microstructural differences in specimens 1–4. In specimen 5, the dimension of coarse-grained martensite area in HAZ was the lowest. Microscopic observations of specimen 1, which was welded with non-modified electrodes, showed long cracks in the HAZ running parallel to the fusion line along 30–40% of its length. (Figure 6a). Additionally, short cracks were found

in the weld metal. Lower numbers of cracks were observed in the HAZ of the specimen welded using underwater electrodes (Figure 6b). These cracks ran through 15–20% of the fusion line length. Both specimens were characterized by similar hardness in the HAZ. The differences in the number of cracks resulted from different hydrogen amounts in the deposited metal [38]. No cracks were found in the weld metal. Microscopic tests showed that concrete impregnate as an electrode coating leads to increased numbers of cracks, both in the HAZ and the weld metal (Figure 6c). HAZ cracks ran parallel and vertical to the fusion line. They started in the weld root and propagated along 70–80% of the fusion line length. The worst results were found during observations of test welds in specimen 4 (Figure 6d). Cracks in the HAZ were wide and long (90–100% of the fusion line length). However, the number of cracks in the weld was smaller than in specimen 3. It can be stated that liquid foil and concrete impregnate cannot be used as protective coatings during wet welding of HSLA steels. Microscopic testing of the specimen welded using electrodes coated with paraffin wax showed much different results than for other hydrophobic substances. No cracks were found in the weld metal. In the HAZ, only one short crack running parallel to the fusion line was found (Figure 6e). Microscopic observations proved that cold cracks occurred in wet-welded joints. A number of cold cracks resulted from the presence of brittle structures in the HAZ, characterized by high hardness, with the highest amount of diffusible hydrogen in the deposited metal [39]. It was also proven that HSLA steels are materials in which the high cooling rate leads to creation of the brittle martensitic microstructure [53].
