# Effect of Thermal Treatment and Erosion Aggressiveness on Resistance of S235JR Steel to Cavitation and Slurry

Alicja K. Krella <sup>1,\*</sup>, Dominika E. Zakrzewska <sup>1</sup>, Marta H. Buszko <sup>1</sup> and Artur Marchewicz <sup>1</sup>

Institute of Fluid Flow Machinery PAS, Fiszerka 14, Gdańsk, Poland; dzakrzewska@imp.gda.pl (D.E.Z.); mbuszko@imp.gda.pl (M.H.B.); artur.marchewicz@imp.gda.pl (A.M.)

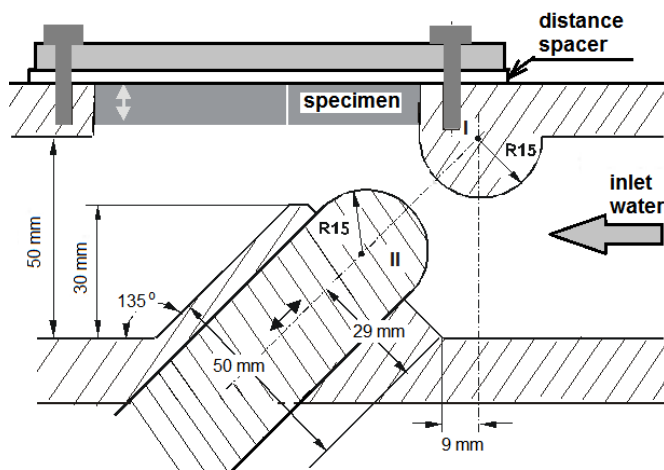
**Figure 1.** Scheme of the cavitation tunnel.

In order to investigate the effect of cavitation intensity on the erosion process, four tests were carried out using a cavitation tunnel equipped with a system of barricades. The scheme of the cavitation tunnel is shown in Figure 1 and it has been described by Krella et al. [18]. As a working fluid tap water with a temperature of  $20 \pm 2$  °C was used. The intensity of cavitation is governed by the fluid flow rate, which is controlled by the inlet and outlet pressures, which in turn are regulated by the inlet and outlet valves. Flow speed was measured using a portable ultrasonic flowmeter Fluxus® model ADM 6725 (FLEXIM, Edgewood, NY, US) with a measurement accuracy of  $\pm 0.5\%$  of the measured value. In the presented investigations, the water flow velocities were 35 m/s, 37.9 m/s, 40.5 m/s, and 43 m/s in the slot between the barricades. The total duration of the test was 600 min.

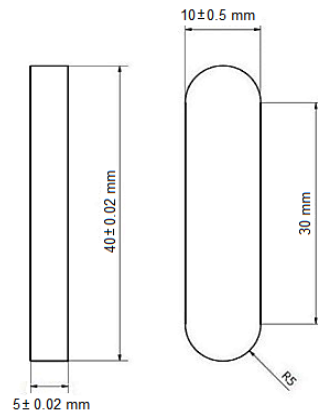
**Figure 4.** The shape and dimensions of a specimen for slurry erosion tests.

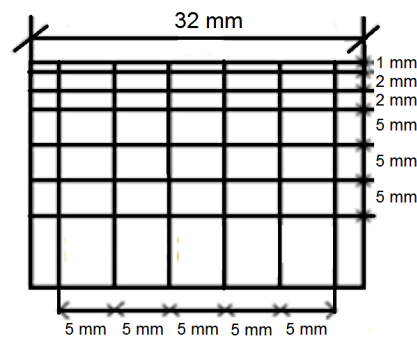
**Figure 5.** The scheme of the network for surface roughness measurements.

After each erosion test, the microscopic studies were carried out using a scanning electron microscope EVO-40/Zeiss (Oberkochen, Baden-Württemberg, Germany) and a SU3500 scanning electron microscope, Hitachi (Tokyo, Japan), in the Research Centre in Jablonna, Poland. Moreover, the microhardness measurements on the cross-sections were carried out using the FALCON 401 Vickers Hardness (INNOVATEST, Shanghai, China) tester with 300 gf load and dwell time of 10 s. The first measurement was made 35  $\mu\text{m}$  from the eroded surface and the measurements were carried out at the distance of 200  $\mu\text{m}$  to eliminate an influence of the other indents on the result obtained. Moreover, to characterize the eroded surfaces, surface roughness (Ra parameter) was determined using the SJ-301 Mitutoyo Surface Roughness Tester (Mitutoyo Corporation, Kanagawa, Kawasaki-shi, Japan). The Ra parameter is an arithmetical mean of the absolute values of the profile deviations from the mean line of the roughness profile. In the case of the cavitation erosion tests, the surface roughness was measured after the tests along the scheme of the network shown in Figure 5. In the case of slurry erosion tests, the specimen surface was eroded evenly. Therefore, the surface roughness was measured at five arbitrary chosen places. Additionally, surface roughness measurements were performed after each test exposure.

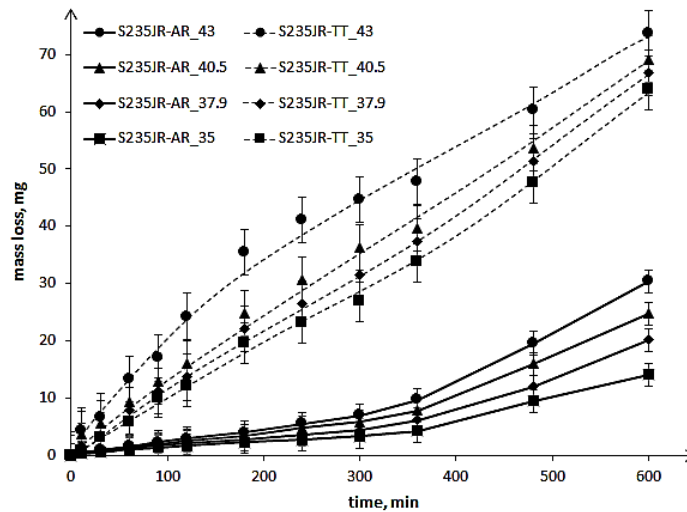
These curves show that a decrease in steel hardness and an increase in flow velocity increased the mass losses and erosion rates. These results are consistent with the expectation and investigation obtained by Kahraman et al. [6]. The decrease in steel hardness by 34.2 HV as a result of thermal treatment caused an increase in mass loss after the entire tests by about 43 mg to about 49.7 mg, depending on the test conditions. Thus, the high impact of the hardness of this steel on the erosion resistance was confirmed, although the tests carried out were tests of cavitation erosion, not slurry. However, an

increase in flow velocity did not cause a proportional increase in mass loss of the tested steel, either in the as-received state or after thermal treatment (Figure 6). Moreover, the shape of the cavitation erosion curves indicates the different degradation processes. In the case of the S235JR-AR steel, the cavitation erosion curves indicate two main erosion periods: the first one lasting about 300 min and the second starting from about 360 min. While in the case of the S235JR-TT steel after thermal treatment, the mass losses increased more or less evenly throughout the cavitation erosion tests. This also confirms a high effect of the hardness of this steel on the degradation process.

**Figure 6.** Cavitation erosion curves of S235JR steel in as-received state and after thermal treatment.

The results of cavitation erosion tests are shown in the form of the cavitation erosion curves (Figure 6) and the cavitation erosion rate curves (Figure 7).

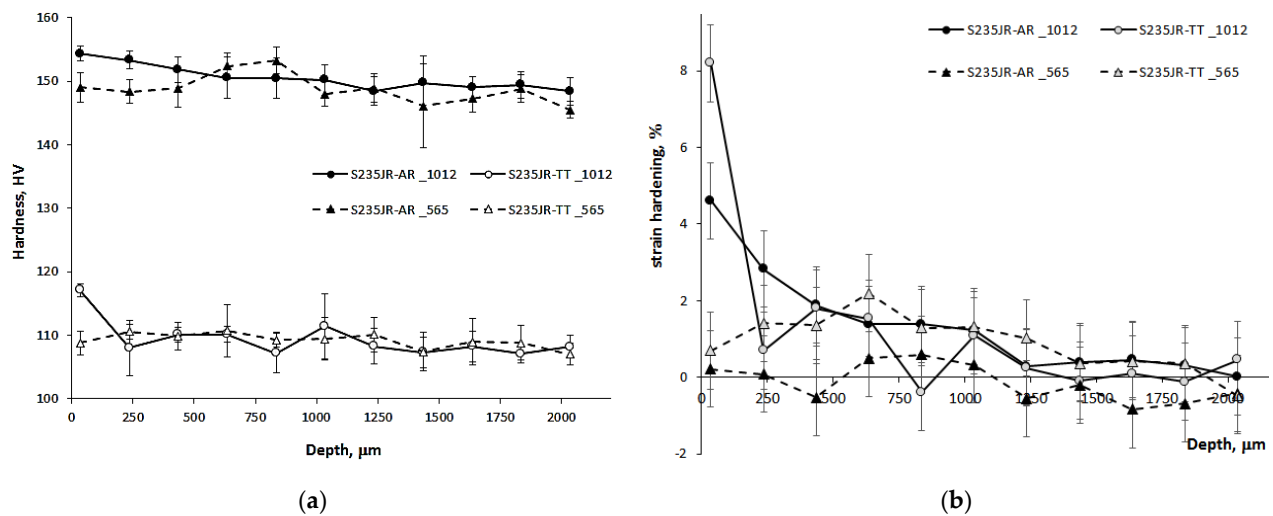
In the case of the slurry erosion tests performed at the highest rotational speed of 1012 rpm, the hardness of the as-received steel and the thermally treated steel increased to about 159 HV and 120 HV at a depth of 35  $\mu\text{m}$  (Figure 11a). Thus, the strain hardening effect was about 5% and 8%, respectively (Figure 11b). This indicates that a higher strain hardening effect was obtained for the thermally treated steel, which had lower initial hardness. This effect was in opposition to that obtained during cavitation erosion tests at the flow velocity of 43 m/s. Moreover, the strain hardening of the as-received steel was much lower than that obtained in cavitation erosion tests, while the thermally treated steel was comparable to that obtained in cavitation erosion tests (Figure 10b). The depth of strain hardening was about 1800  $\mu\text{m}$  and 1400  $\mu\text{m}$ , respectively. However, the biggest decrease in strain hardening occurred at a distance of about 200  $\mu\text{m}$  (from 8.2% at 35  $\mu\text{m}$  to 0.7% at 235  $\mu\text{m}$ ). These depths are much smaller than those obtained in cavitation tests (about 4 mm). This indicates the different degradation mechanism. In cavitation erosion, cavitation pulses impact the surface with a wide range of amplitudes, from a few kPa to GPa. In slurry erosion, all erodents impact with comparable energy, so the dispersion of impact energy is small. Due to the high rotational speed, which influenced the high impact velocity, the impact energy is used mainly on the initiation and development of cracks, resulting in a significant mass loss and less strain hardening than in the case of cavitation erosion, where low energy impacts also occurred.

Figure 11. Hardness (a) and strain hardening effect (b) along the specimen depth caused by slurry

In the case of tests carried out at the lowest slurry erosion intensity, i.e., at a rotational speed of 565 rpm, the hardness of the S235JR-AR steel at a depth of 35  $\mu\text{m}$  was about 152 HV. It means that the hardness increase did not occur. All changes in hardness oscillated around the initial value. In the case of S235JR-TT steel, the impacts of solid

particles caused a slight increase in hardness to about 112 HV at a depth of 35  $\mu\text{m}$ . The strain hardening effect was about 1%. The highest hardness (113.4 HV) was obtained at a depth of 635  $\mu\text{m}$ . This makes that strain hardening increased to 2.2%. Then, hardness decreased to an initial value that was reached at a depth of about 1800  $\mu\text{m}$ . Thus, the depth of strain hardening was bigger than in the tests performed at the highest rotational speed. The likely reason for this was the lower impact energy supplied by erodents to the steel surface that caused significant less mass loss and much less removal of the hardened layer.

speed increases, this interaction is likely to increase. A low depth of strain hardening at the highest rotational speeds (Figure 11) is consistent with the assumption that the particles interact with each other.

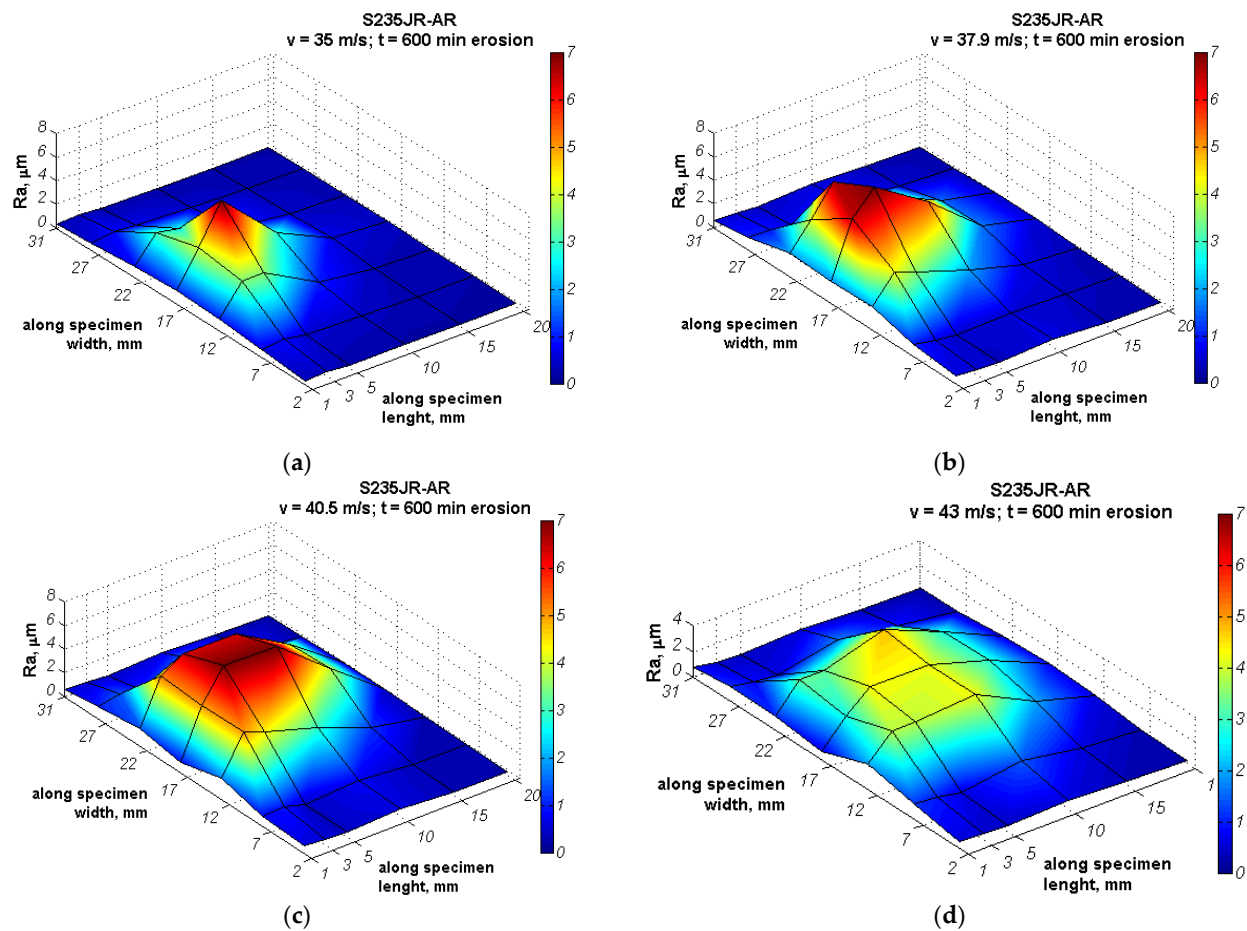
**Figure 12.** Distribution of the Ra parameter on the surface of the S235JR-AR steel tested for resistance to cavitation erosion at a flow velocity of (a) 35 m/s, (b) 37.9 m/s, (c) 40.5 m/s and (d) 43 m/s.

Roughness measurements of specimens tested in cavitation erosion tests revealed areas of high roughness  $Ra > 5 \mu\text{m}$  that are at approximately half the width of the

specimens close to the upper barricade (Figures 12 and 13), regardless of the hardness of the tested steel (steel state) and the flow velocity. With increasing flow velocity, the area with  $R_a > 1 \mu\text{m}$  also increases, but it is not followed by the increase in the maximum roughness value. Also, the distribution of  $R_a$  parameters changed its character depending on the flow velocity. In the case of tests conducted at a flow velocity of 35 m/s, the maximum  $R_a$  value was  $7.38 \pm 0.16 \mu\text{m}$  and  $8.71 \pm 0.21 \mu\text{m}$ , respectively for S235JR-AR and S235JR-TT steel. Thus, higher roughness was obtained on softer steel. The surface roughness increased rapidly to a maximum value, which was reached 5 mm from the specimen edge nearest to the upper barricade, and then decreased, regardless of the steel state. However, the rate of decrease in roughness was related to the hardness of the steel. In the case of softer steel after thermal treatment, this rate was lower. Although the maximum surface roughness had higher values, the roughness ( $R_a$  parameter) of less than  $1 \mu\text{m}$  was only recorded at a distance of 20 mm from the upper barricade. Nevertheless, in both steel states, the roughness distribution formed a sharp peak.

For the tests carried out at a flow velocity of 37.9 m/s, the maximum  $R_a$  value was  $8.47 \pm 0.15 \mu\text{m}$  and  $11.60 \pm 0.27 \mu\text{m}$ , respectively (Figures 12b and 13b). Thus, the maximum  $R_a$  value increased  $1 \mu\text{m}$  and nearly  $3 \mu\text{m}$ , respectively. Moreover, the area with  $R_a > 2 \mu\text{m}$  increased significantly. The roughness peak was still obtained and located 5 mm from the upper barricade. The roughness peak was sharp in S235JR-TT steel (Figure 13b), while slight in S235JR-AR steel (Figure 12b). Moreover, the eroded surface with  $R_a > 6 \mu\text{m}$  formed a large area indicating a zone of high erosion level.

In the case of tests carried out at a flow velocity of 43 m/s, surface roughness decreased even more (Figures 12d and 13d). The maximum  $Ra$  values were  $4.31 \pm 0.11 \mu\text{m}$  and  $5.48 \pm 0.12 \mu\text{m}$ , respectively. Thus, the  $Ra$  parameter decreased by nearly  $3.5 \mu\text{m}$  and  $4 \mu\text{m}$ , respectively. Besides, the  $Ra$  parameters were lower than those obtained in the tests carried out at the lowest flow velocity. This decrease was caused by the effect of overlapping damages. The surface with the highest surface roughness formed a large, flattened area with a comparable erosion level. The conducted tests showed that the steel of lower hardness was characterized by higher roughness regardless of the flow velocity. This is in agreement with the mass losses and erosion rates.

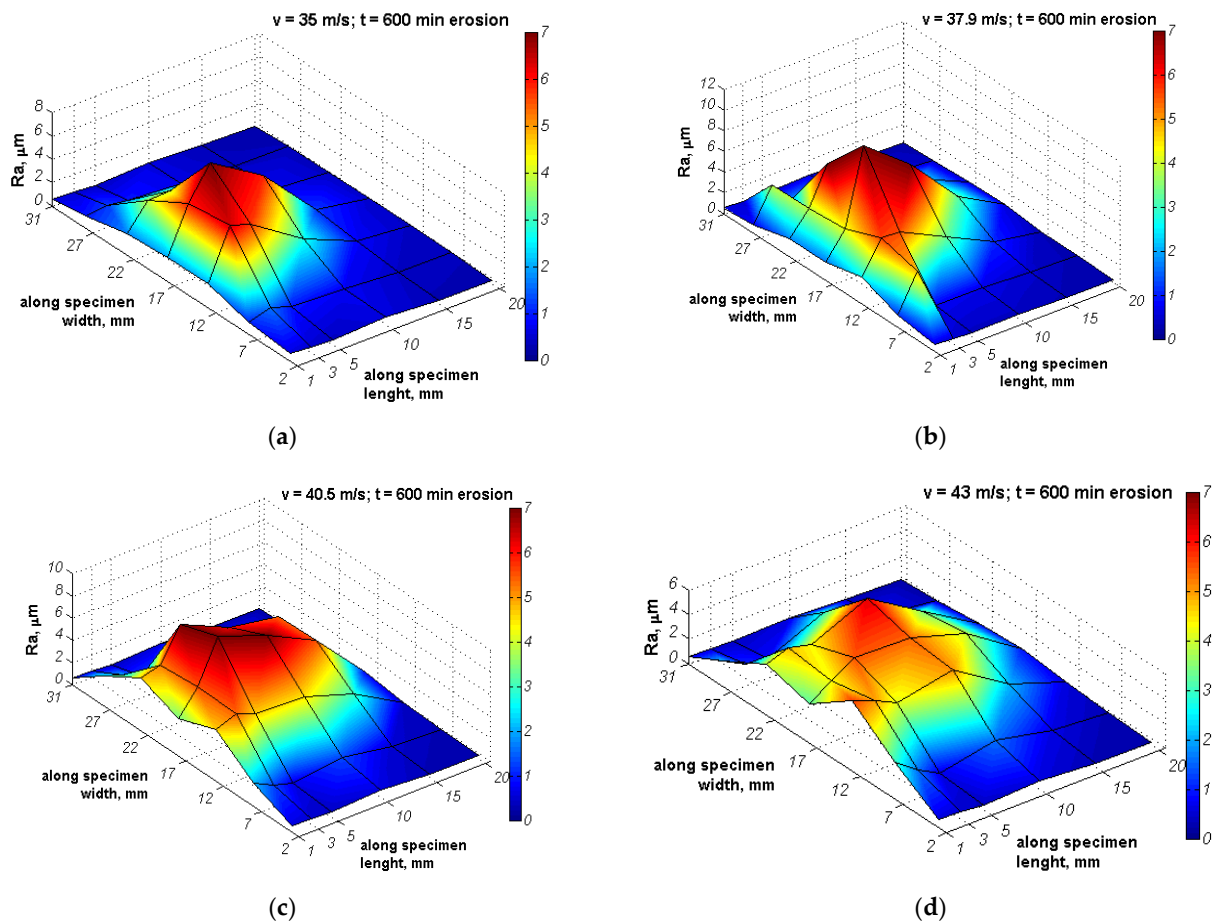
**Figure 13.** Distribution of the  $R_a$  parameter on the surface of the S235JR-TT steel tested for resistance to cavitation erosion at a flow velocity of (a) 35 m/s, (b) 37.9 m/s, (c) 40.5 m/s and (d) 43 m/s.

A further increase in a flow velocity to 40.5 m/s caused an increase in the area with  $Ra > 2 \mu\text{m}$ . However, the roughness values lowered concerning those obtained at a flow velocity of 37.9 m/s. The maximum  $Ra$  values of S235JR-AR and S235JR-TT steel were  $7.71 \pm 0.19 \mu\text{m}$  and  $9.38 \pm 0.28 \mu\text{m}$ , respectively. Thus, the maximum  $Ra$  value decreased by nearly  $0.8 \mu\text{m}$  and over  $2 \mu\text{m}$ , respectively. Considering that with increasing flow velocity the mass loss also increased (Figure 6), a decrease in surface roughness was caused likely by overlapping damages. However, the surface with  $Ra > 6 \mu\text{m}$  increased without any roughness peaks indicating a comparable erosion level.

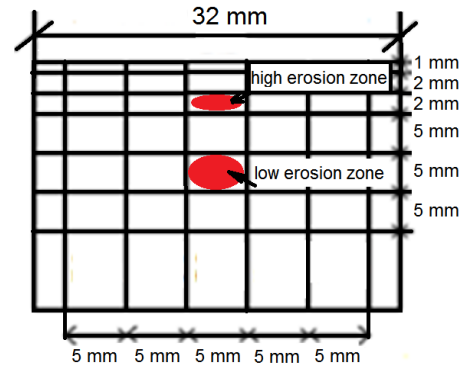
Based on the roughness measurements, the zones of low and high erosion in cavitation tests were determined and showed in Figure 15. The surface damages of the S235JR-AR and S235JR-TT steels developed during tests performed at the lowest (35 m/s) and highest (43 m/s) flow velocity in these zones are shown in Figures 16 and 17, respectively.

**Figure 15.** The observation areas of damage developed on the surface of S235JR steel during cavitation erosion tests.

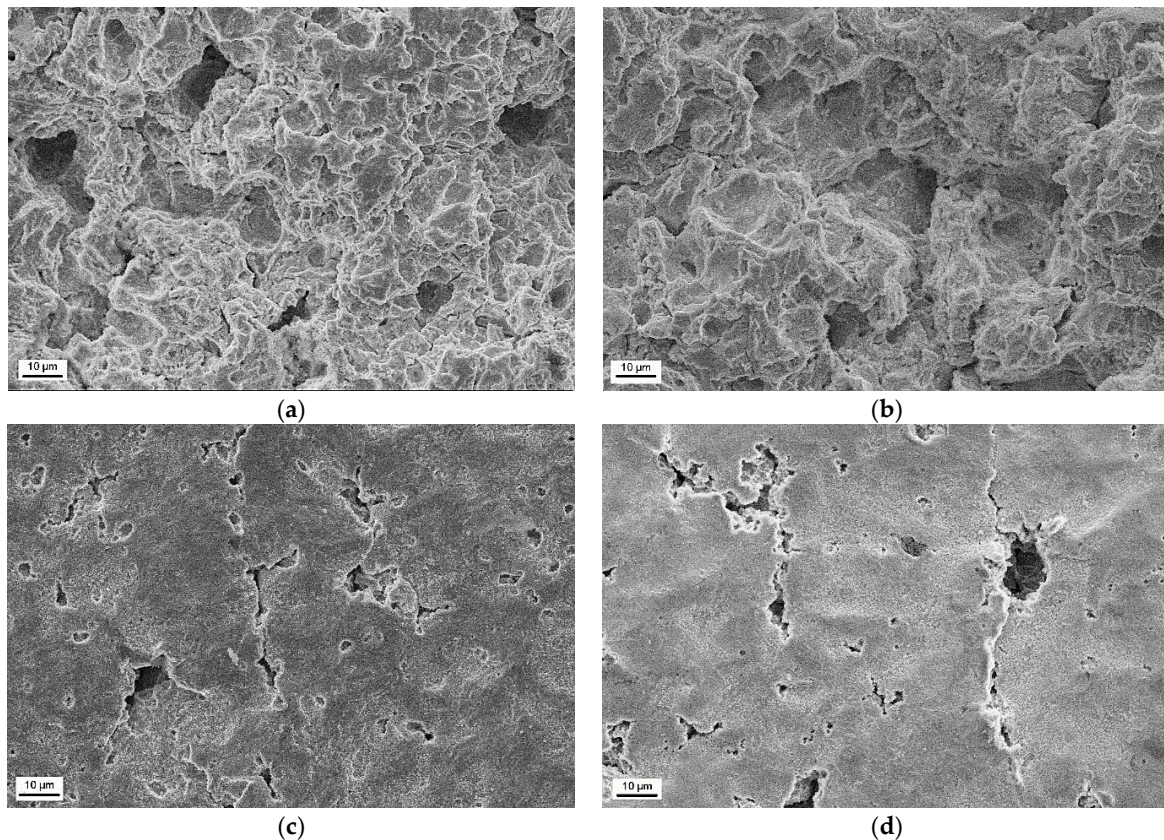
**Figure 17.** Surface damages developed during cavitation erosion tests carried out at a flow velocity of 43 m/s in the high erosion zone of (a) S235JR-AR steel and (b) S235JR-TT steel, and in the low erosion zone of (c) S235JR-AR steel and (d) S235JR-TT steel.

Damages on the surface of S235JR-AR and S235JR-TT steel in the strongly eroded zone and tested at a flow velocity of 43 m/s also have the form of ductile cracks, cavitation pits/tunnels and voids (Figure 17a,b). Thus, all these failures are typical of this steel and this erosion process. Nevertheless, the intensity of cavitation affected the number and width of the cracks, which are much narrower than those observed at a flow rate of 35 m/s. The diameter of some pits/cavitation tunnels in hard S235JR-AR steel ranges from about  $10 \mu\text{m}$  to  $20 \mu\text{m}$  (Figure 17a), but such pits are not seen in soft

S235JR-TT steel (Figure 17b). It is related to the hardness of the steel and the mass losses. Taking into account the greater loss of mass on the S235JR-TT steel in the cavitation test, the most likely reason for the lack of such pitting is the removal of such a heavily damaged surface layer. On the other hand, the damage size of the steel as received is smaller than that of thermal-treated steel, which is consistent with the hardness measurements (Figure 10). Also, more severe damage developed during tests with a flow velocity of 35 m/s is consistent with the hardness measurements. Moreover, the observation of the degree of destruction of S235JR steel in both states is consistent with the roughness measurements (Figures 12 and 13).

In the case of the low erosion zone (Figure 17c,d), the damage is mainly in the form of pitting, but several cracks and surface undulation are also observed. The cracks are likely developed along the grain boundaries. The length and width of cracks, as well as the size of pits, are much bigger for the thermal-treated steel. The pits were caused by shearing due to the impacts of high-velocity micro-jets. The bigger size of pits indicates that this steel is more susceptible to such impacts. However, damage density is much bigger for steel in the as-received state. The lower size of pits and cracks length are connected with a higher hardness of this steel.

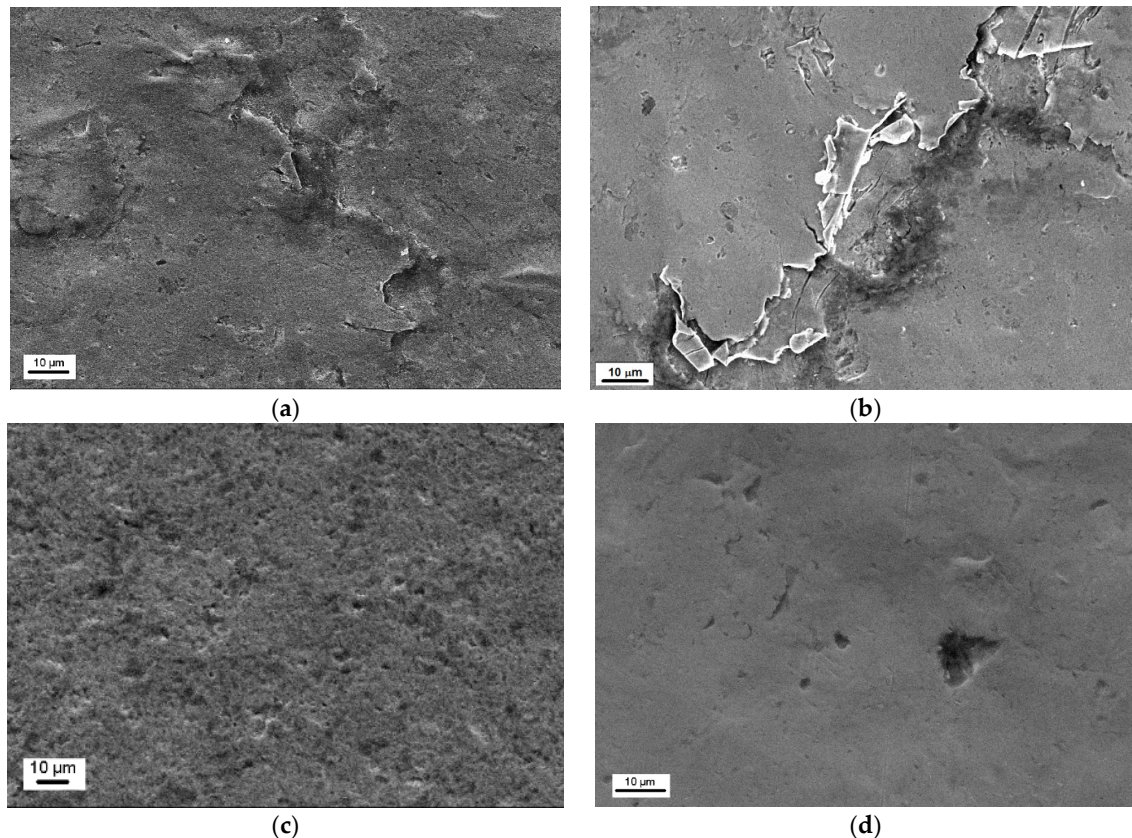
**Figure 18.** Surface damages developed during slurry erosion tests carried out at a rotational speed of 1012 rpm in (a) S235JR-AR steel and (b) S235JR-TT steel, and at a rotational speed of 565 rpm in (c) S235JR-AR steel and (d) S235JR-TT steel.

The damage from slurry erosion testing is completely different (Figure 18). In the case of tests carried out at a rotational speed of 1012 rpm (Figure 18a,b), flaking and undulation of the surface are visible, regardless of the steel state. There are also some tiny and shallow pits. The surface is much less degraded concerning that developed in cavitation tests (Figures 16 and 17). The level of surface degradation is consistent with the roughness results (Figure 14). Also, damage developed at a rotational speed of 565 rpm

degradation is consistent with the roughness results (Figure 14). As shown in Figure 18c,d, the surface of S235JR-AR steel is slightly undulated, similar to the surface of the thermal-treated steel. However, the undulation of the latter (Figure 18d) seems to be bigger. Yet, the surface looks much smoother. There is no flaking, but pits and short cracks. The number and size of pits depend on the steel state. In the case of the as-received state, pits are much smaller, but their number is much bigger than on the surface of S235JR-TT steel (Figure 18c,d). The pit seen in Figure 18d was likely due to steel removal and not shearing as with cavitation erosion.
