Article

# Effect of Thermal Treatment and Erosion Aggressiveness on Resistance of S235JR Steel to Cavitation and Slurry

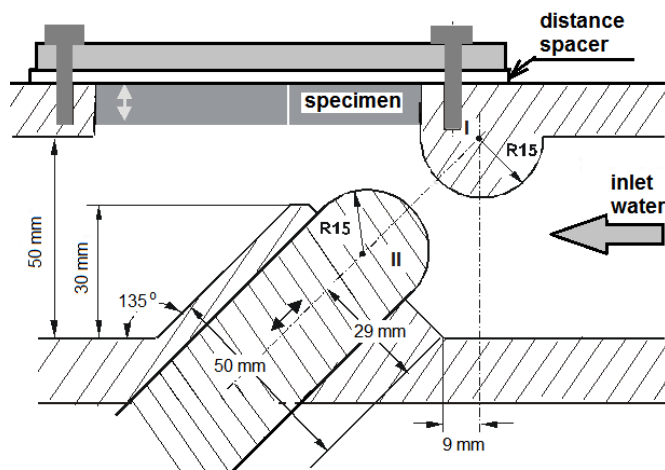
In order to investigate the effect of cavitation intensity on the erosion process, four tests were carried out using a cavitation tunnel equipped with a system of barricades. The scheme of the cavitation tunnel is shown in Figure 1 and it has been described by Krella et al. [18]. As a working fluid tap water with a temperature of  $20 \pm 2$  °C was used. The intensity of cavitation is governed by the fluid flow rate, which is controlled by the inlet and outlet pressures, which in turn are regulated by the inlet and outlet valves. Flow speed was measured using a portable ultrasonic flowmeter Fluxus® model ADM 6725 (FLEXIM, Edgewood, NY, US) with a measurement accuracy of  $\pm 0.5\%$  of the measured value. In the presented investigations, the water flow velocities were 35 m/s, 37.9 m/s, 40.5 m/s, and 43 m/s in the slot between the barricades. The total duration of the test was 600 min.

**Figure 1.** Scheme of the cavitation tunnel.

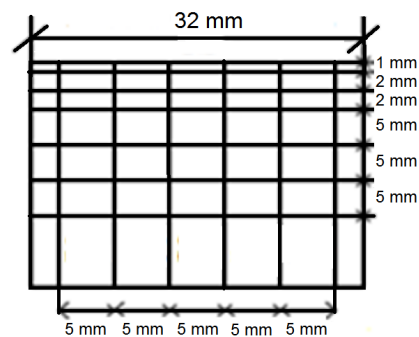
**Figure 5.** The scheme of the network for surface roughness measurements.

The distributions of surface roughness along the network shown in Figure 5 that developed during the entire cavitation erosion tests are shown in Figures 12 and 13, respectively for S235JR-AR and S235JR-TT steel. In order to show the effect of flow conditions on the roughness, the same maximum Ra value was used in the color bar despite the different maximum Ra values. During the slurry test, the entire surface of the specimens was uniformly eroded, so five measurements of the Ra parameter were taken after each exposure. The development of the Ra surface roughness parameter is shown in Figure 14.

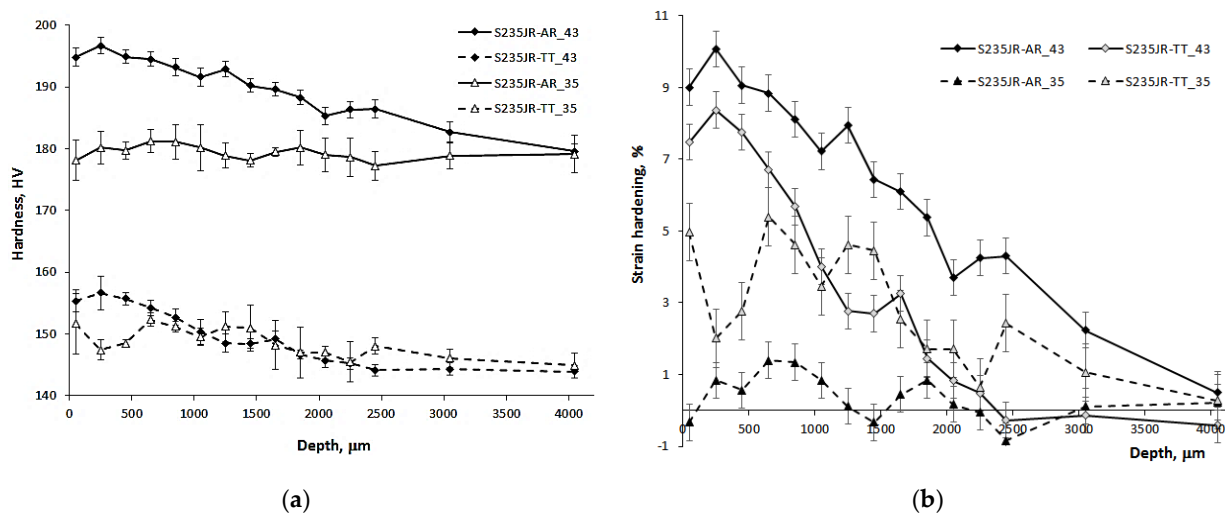
Although mass losses of S235JR-AR steel tested at the highest erosion intensity were comparable, the surface hardness changes and the hardening effect were different (Figures 10 and 11). The effect of cavitation on surface hardness was more pronounced than that of the slurry. This is evidence of the different degradation mechanisms involved in any erosion process.

**Figure 10.** Hardness (a) and strain hardening effect (b) along the specimen depth caused by cavitation

In the case of the cavitation erosion tests conducted at the highest flow velocity of 43 m/s, the hardness of the S235JR-AR steel increased up to 194 HV at a depth of 35 μm, but the maximum value was 197 HV at a depth of 235 μm (Figure 10a). Such a hardness peak underneath the surface was also obtained in the tests of Fe–Cr–Ni–Mn stainless steels [19,20]. This makes that the maximum strain hardening effect determined from Equation (1) was 10% at a depth of 235 μm (Figure 10b). Moreover, the hardening effect was noted down to a depth of 4 mm. In the case of the S235JR-TT steel tested for resistance to cavitation erosion in these conditions, the maximum increase in hardness was only about 8% (157 HV) at a depth of 235 μm and the hardening effect was noted down to a depth of 2.5 mm. Thus, the initial hardness of the steel prior to the cavitation test had an effect on the hardenability. Steel with lower initial hardness underwent less hardening, and steel with higher initial hardness - stronger. Moreover, as the strengthening of the surface layer increased, the mass loss (Figure 6) and the erosion rate (Figure 7) decreased.

depth of 35  $\mu\text{m}$ . With increasing depth, hardening ranged from 2% to 5%. The total depth of hardening was 4 mm. Thus, at the flow velocity of 35 m/s, the supplied impact energy resulted in the opposite development of the degradation process to that at the flow velocity of 43 m/s. This is due to a change in the distribution of the cavitation load - the number of high-amplitude pulses and the number of low-amplitude pulses. In the case of harder S235JR-AR steel, only the initiation and growth of cracks leading to mass loss was noted. It was caused by high-amplitude pulses, low-amplitude pulses were not able to cause any effect because of high hardness of the tested steel. Meanwhile, in the S235JR-TT steel with a lower hardness, strain hardening was also noted despite greater mass loss (Figure 6). Strain hardening was likely an effect of large number of low-amplitude pulses and low hardness of the tested steel.

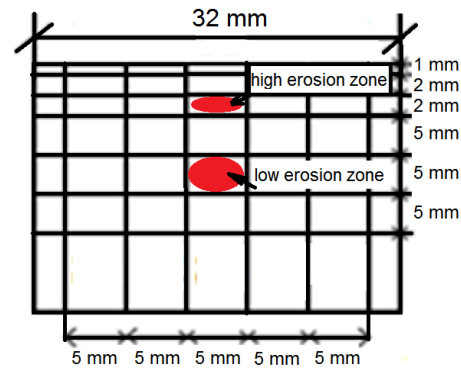
Based on the roughness measurements, the zones of low and high erosion in cavitation tests were determined and showed in Figure 15. The surface damages of the S235JR-AR and S235JR-TT steels developed during tests performed at the lowest (35 m/s) and highest (43 m/s) flow velocity in these zones are shown in Figures 16 and 17, respectively.

**Figure 15.** The observation areas of damage developed on the surface of S235JR steel during cavitation erosion tests.

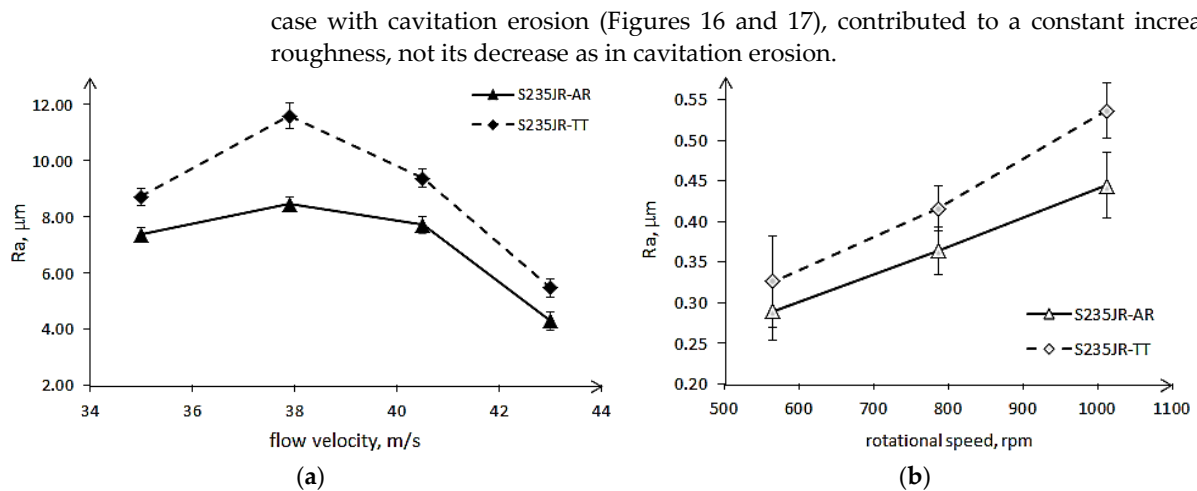
Although erosion processes concern mainly the degradation of the material surface layer, the investigations of surface roughness development in relation to erosion intensity are not so extensive. According to Chiu et al. [38], in cavitation erosion, surface roughness (Ra parameter) increases up to limit value that is related to the steel grade with increasing testing time and then remains unchanged. However, Dojcinovic et al. [39] showed that the mean surface roughness Ra of ductile cast iron exposed to cavitation increases with testing time, although the rate of roughness change decreases. In the presented results, in cavitation erosion, surface roughness depends also on the cavitation intensity, i.e., flow velocity (Figures 12 and 13). Taking into account the maximum Ra parameter obtained on the exposed surface after 600 min of testing and flow velocity, the correlations shown in Figure 21 a are obtained. As shown in Figure 21a, the Ra parameter increases with increasing flow velocity from 35 m/s to 38 m/s, but for flow velocities greater than 38 m/s, a decrease in surface roughness with increasing flow velocity was obtained. This decrease was probably due to the strain hardening (Figure 10b), the intensive development of surface damage and an increase in overlapping damage (Figures 16 and 17). Regardless of the flow rate, higher roughness values were obtained for thermally treated steel, probably due to its lower hardness. Taking into account the strain hardening, the greater the increase in hardness the lower Ra parameter is observed only for cavitation erosion tests conducted at 43 m/s, but not at 35 m/s. Intense overlapping damage and intensive mass loss may cause a decrease in surface roughness. As a result, the surface roughness obtained at 43 m/s was lower than that obtained at 35 m/s.

In the case of slurry erosion tests, a linear increase in surface roughness with increasing rotational speed was obtained (Figure 21b). This correlation was independent of the steel hardness. A similar correlation was obtained by Abedini et al. [40]. As in the case of cavitation erosion, higher Ra values were obtained for thermally treated steel that had lower hardness. Besides, the difference between Ra values increased with increasing rotational speed. Taking into account the changes in hardness (Figure 11b), the steel after thermal treatment underwent greater strain hardening than the steel in the as-received state. However, the surface roughness did not follow it. This was likely caused by more intensive mass loss (Figure 8). The lack of overlapping damage (Figure 18), as was the

**Figure 21.** Correlation between (a) the maximum Ra parameter and a flow velocity in cavitation erosion tests, and (b) the mean Ra parameter and a rotational speed in slurry erosion tests.
