# Deterioration and Protection of Concrete Elements Embedded in Contaminated Soil: A Review

Ginneth Patricia Millán Ramírez \*, Hubert Byliński \* and Maciej Niedostatkiwicz

**Citation:** Millán Ramírez, G.P.; Byliński, H.; Niedostatkiwicz, M. Deterioration and Protection of Concrete Elements Embedded in Contaminated Soil: A Review. *Materials* **2021**, *14*, 3253. <https://doi.org/10.3390/ma14123253>

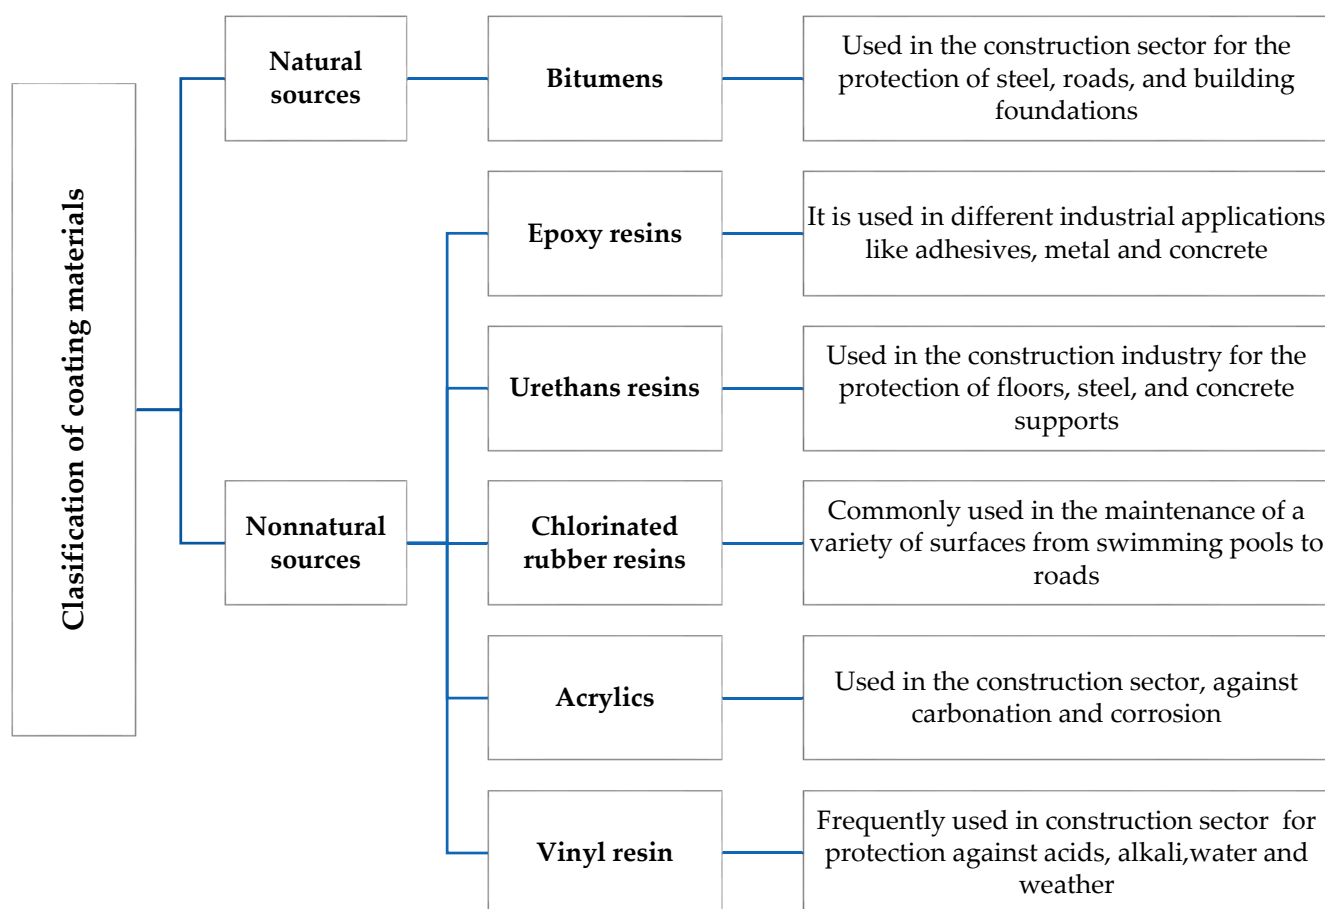
**Figure 1.** General classification of coating materials used in different industries [24–33].

Recently, different coating materials have been used to protect concrete structures in the construction industry. Among the most common ones, it is possible to find fire protection coatings used as a precautionary measure preventing buildings from collapsing during fire exposure [22] and waterproof coatings widely used in the protection of concrete against reinforcement corrosion, erosion, carbonation, silica reactivity in aggregates, and chemical attacks, such as acids, salts, alkalis, and sulfates [2,7,23]. The use of coatings also increases the structure's lifetime by preventing the appearance of cracks and reducing the maintenance cost. Figure 1 shows the general classification of coating materials for different industries.

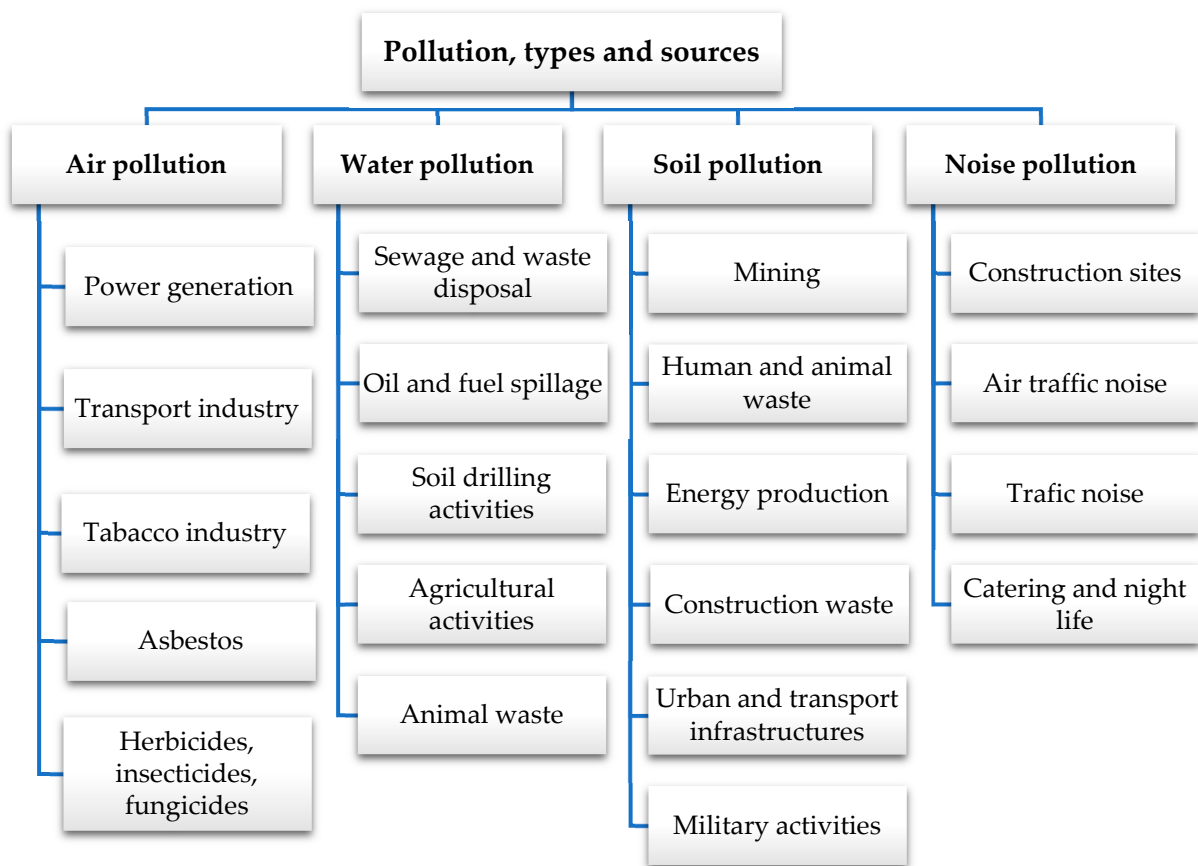
Figure 2. Main sources of soil pollution [10,43,45,47–49].

During the last few decades, the continuous growth of the human population has contributed towards increasing different industrial activities, such as agriculture, energy, transport, construction, technology, and mining. These, in turn, increase soil pollution [43], the loss of crop diversity, productivity, and soil quality by decreasing its mechanical and physical properties, such as electrical conductivity, bulk density, pH, moisture content, and hardness [43,44]. Figure 2 summarizes the main types and sources of soil pollution.

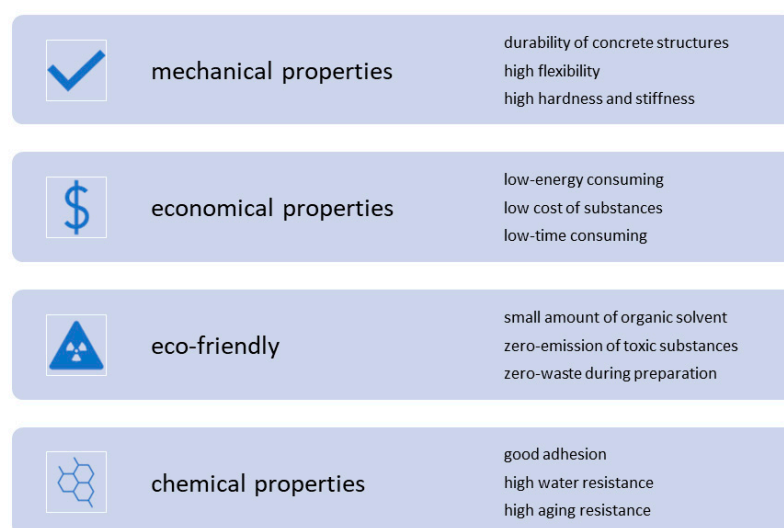
**Figure 3.** Critical aspects in the field of challenges of production of coating materials used for protection of concrete elements.

Protective coatings are present in most of the surfaces around us, used from the simple protection of food to the complex protection of steel and concrete. Nevertheless, most of these coatings go through a manufacturing process that generates contamination. Some of them use nonrenewable materials, such as bitumen obtained from petroleum refining, causing several environmental problems. In addition, some of the coatings use organic solvents that emit volatile organic compounds, producing air pollution that affect human health. Therefore, it is necessary to continue developing eco-friendly coating materials that contribute to environmental preservation without sacrificing the main properties of the materials, e.g., high durability, toughness, adhesion, strength, etc. Table 9 contains the main advantages and disadvantages of some of the most common coating materials used in the construction industry to protect concrete structures. Figure 3 shows the key aspects and challenges in the production of coating materials.
