SAFETY AND FUNCTIONALITY ASSESSMENT OF TRAM LOOPS IN WROCLAW

Abstract: *The article presents the implementation of the ISFTL method proposed by the authors consisting in an indicator assessment of the safety and functionality of tram loops. Five tram loops located in Wrocław were analyzed. Each of these loops has different characteristics. The components of each assessment are described in detail and further directions for improving the proposed assessment are indicated.*

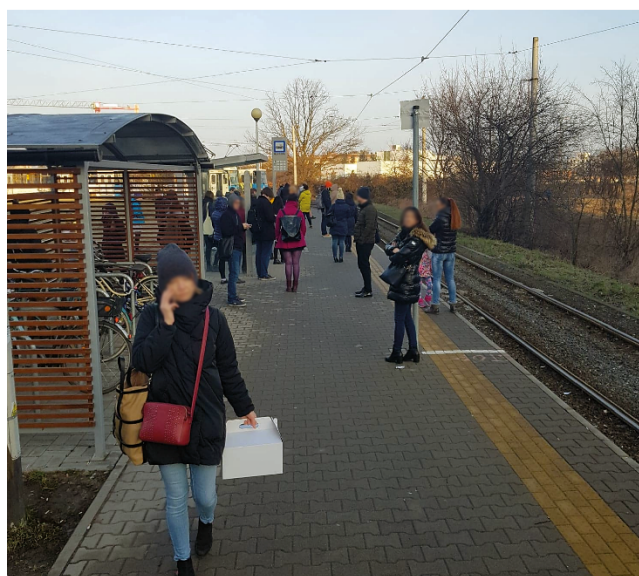
Fig. 8. Tram platform stop for getting on located in Klecina tram loop in Wrocław (Poland)

The Klecina loop (fig. 8.) is an example of a tram loop where the direction change takes place differently than on typical loops. As a standard, tramway traffic on the loop runs counter-clockwise and stops are located on the outside of the tram track. In the case of the Klecina loop, the tram traffic is clockwise and the stops are located inside the loop. The awarded point values depend on the selected parameters for: accessibility to different forms of transport (AD) - no P&R parking, the distance from the city bike station is about 80 m, bus stops located at the street adjacent to the loop at a short distance from the stop; type of stop infrastructure and facilities (TI) - no dynamic passenger information boards, service outlets and the ticket machine is located outside the tram loop.
