# Revitalization of Residential Buildings Dating Back to the Late 19th and Early 20th Century on the Example of “Willa Halina” in Sopot (Poland)

Antoni Taraszkievicz

**Citation:** Taraszkievicz, A. Revitalization of Residential Buildings Dating Back to the Late 19th and Early 20th Century on the Example of “Willa Halina” in Sopot (Poland). *Buildings* **2021**, *11*, 279. <https://doi.org/10.3390/buildings11070279>

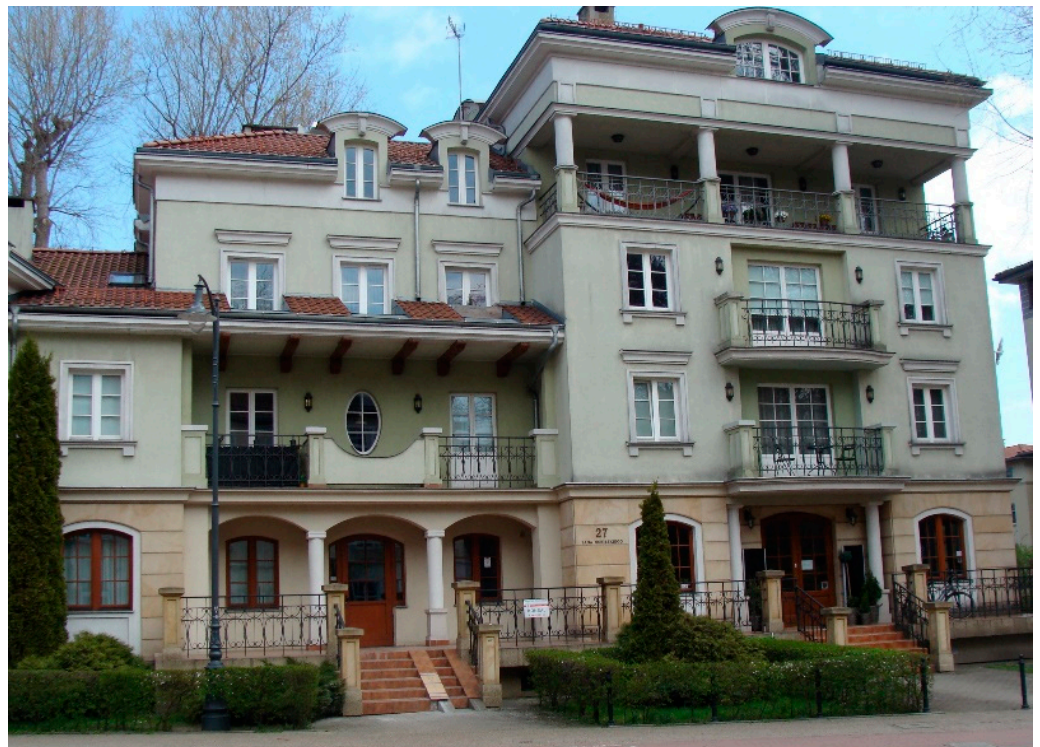
Figure 3. Residential building completed in 2003, Jana Sobieskiego street in Sopot. Source: A. Taraszkiewicz.

However, not all investment activities carried out nowadays in Sopot comply with the principles mentioned above. This can be particularly felt in the case of some completely new designs which, drawing directly and unreflectively on the achievements of the past, create “new monuments”. Although these objects are a complement to the urban tissue and not to individual historic buildings, and are set in the eclectic atmosphere of Sopot, they definitely falsify history. An example of this is the newly designed residential building completed in 2001, which is deceptively reminiscent of eclectic solutions from the late 19th and early 20th century (Figure 3).

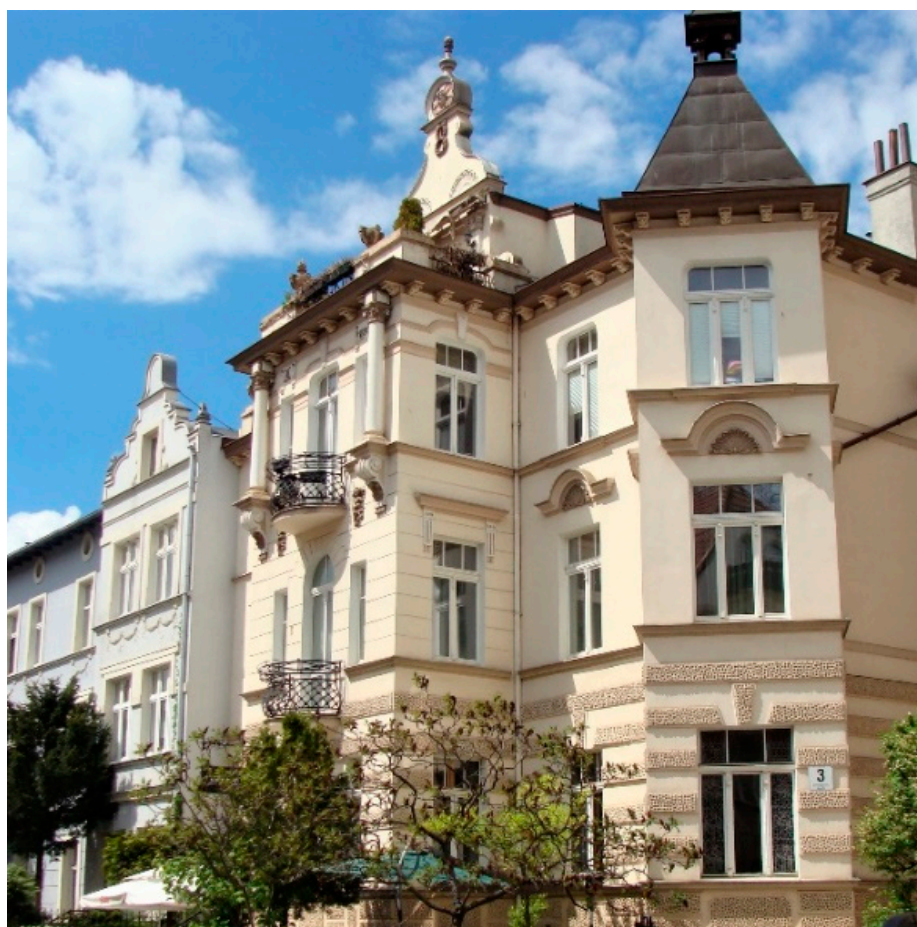
**Figure 4.** Tenement house, Władysława Jagiełły street in Sopot. Source: A. Taraszkiewicz.

In the first of these cases in Sopot, we usually deal with a complete and very blatant violation of the principles of the Venice Charter. Numerous architectural details as well as whole fragments of historical buildings are reconstructed in a way that makes it impossible to distinguish authentic elements from contemporary reconstructions and additions. The magnificent, eclectic Sopot buildings enchant the viewers with their fresh, renewed look, giving a false impression as if they had just been built (Figure 4). This is clearly an unnecessary falsification of history and a harmful blurring of the distinction between the authentic and the reconstructed [31,32].

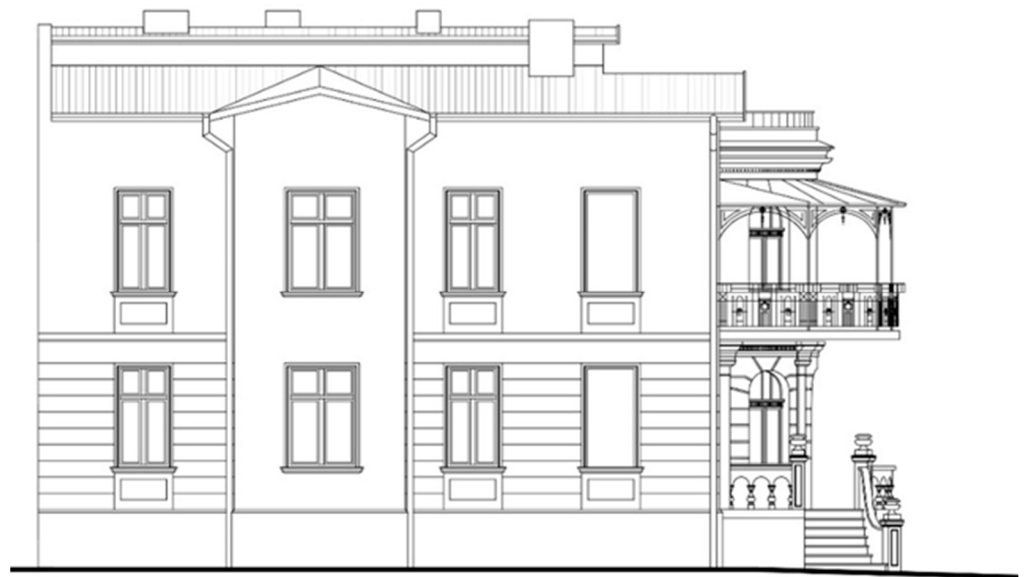
**Figure 7.** Willa Halina side elevation (south). Source: A. Taraszkiewicz.

The side and rear façades of the building were much more restrained in their expression, referring mainly to the Neo-Renaissance with features of the regional architecture (Figure 7).

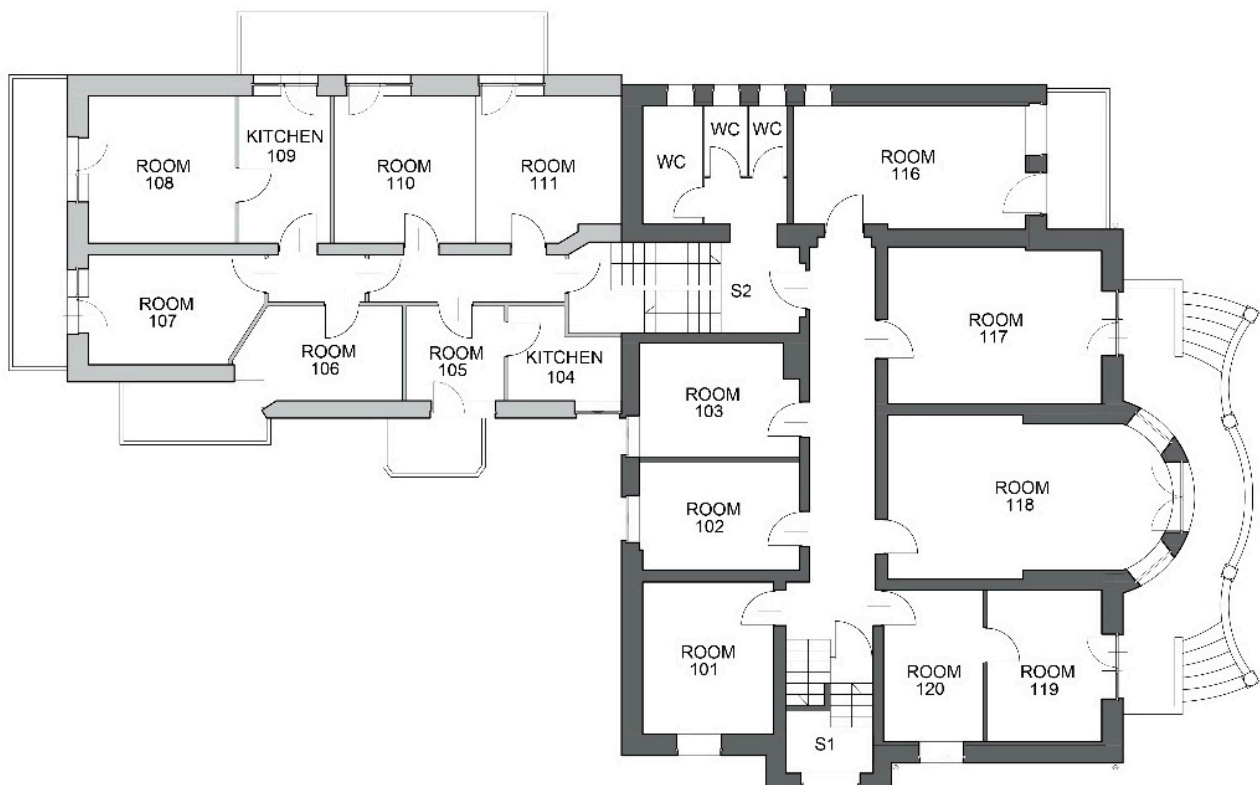
**Figure 8.** Willa Halina ground floor plan; building inventory 1999. Source: A. Taraszkiewicz.

In this condition, the villa survived until World War II. After the war, the villa changed owners several times and served as a multi-family residential building; however, its external appearance has not suffered much damage, apart from minor losses of architectural detail. In the 1950s, the building's interior was functionally divided into several small apartments and an annex of rather low architectural value was added to the villa's western side, creating dissonance with the finished and refined architectural form of the main building (Figure 8).

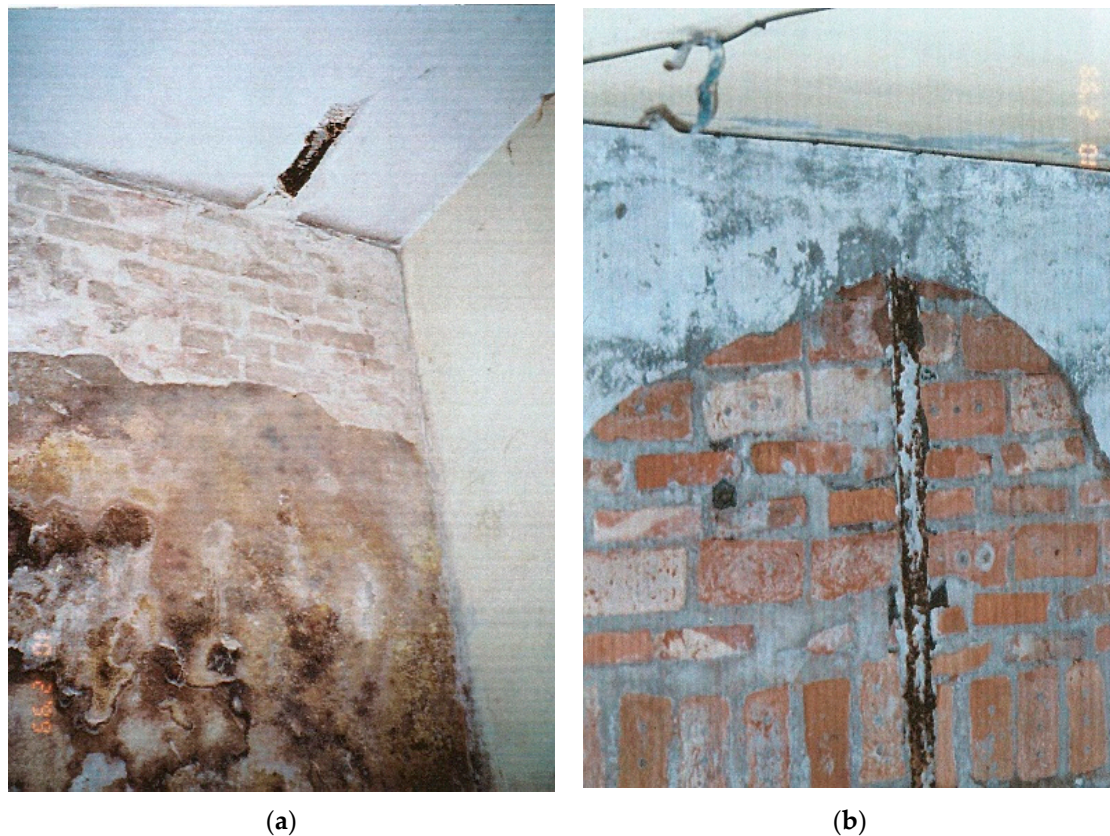
**Figure 9.** Willa Halina, view of degraded structural elements. (a) Mold on the outside wall; (b) moisture and corrosion of internal wall elements. Source: FORT Taraszkiewicz Architekci.

The multitude of users and the lack of proper care for the building caused its technical condition to deteriorate from year to year. There was severe degradation of the wooden ceiling beams and brick walls. There was fungus and severe dampness (Figure 9). Particularly serious technical degradation concerned the annex, whose technical condition could be described as woeful. As a result, by the end of the 20th century, the building was abandoned by residents and awaited revitalization.

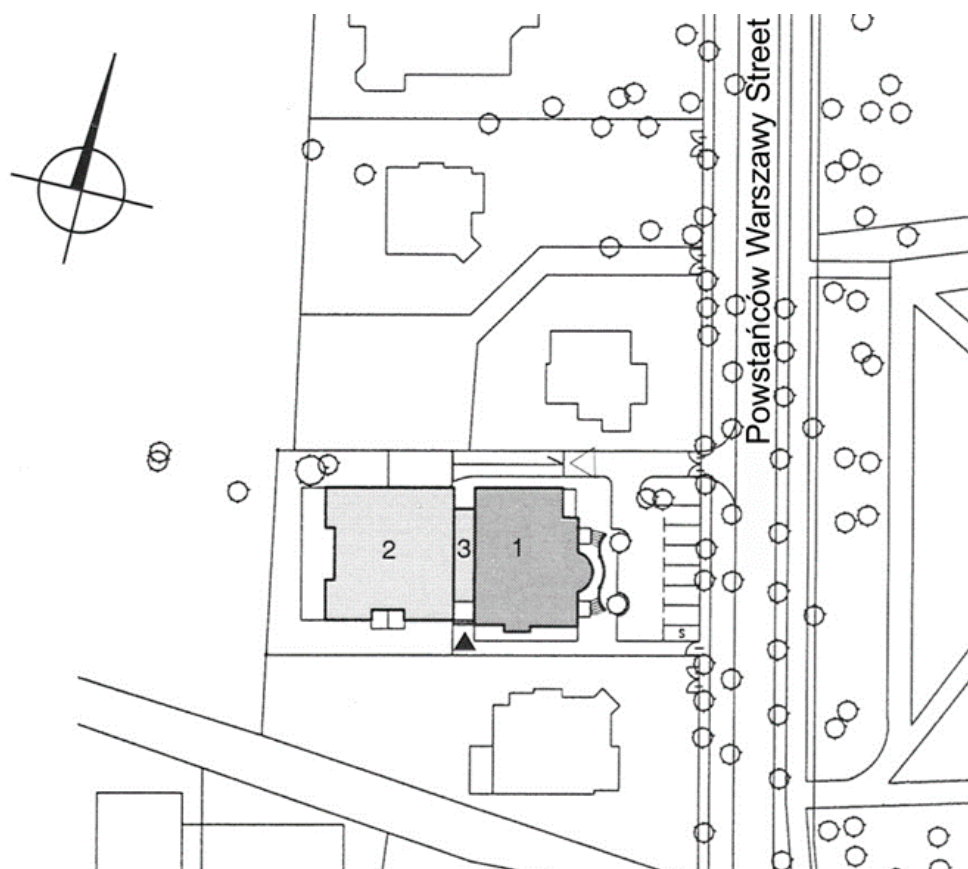
**Figure 10.** Willa Halina—(1) historic body of the building; (2) extended part; (3) Glazed hall. Source: A. Taraszkiewicz.

Between the extended part and the existing, historical building, a glazed entrance hall with a staircase was designed, allowing for exposing (despite the extension) the western elevation of the villa (Figure 10). These elements added to the building have been designed in a way that follows good practice of creating new sections that fit in well with the historic elements and yet are completely different from them, adding new value to existing ones. Such activities have been described in [42–44].

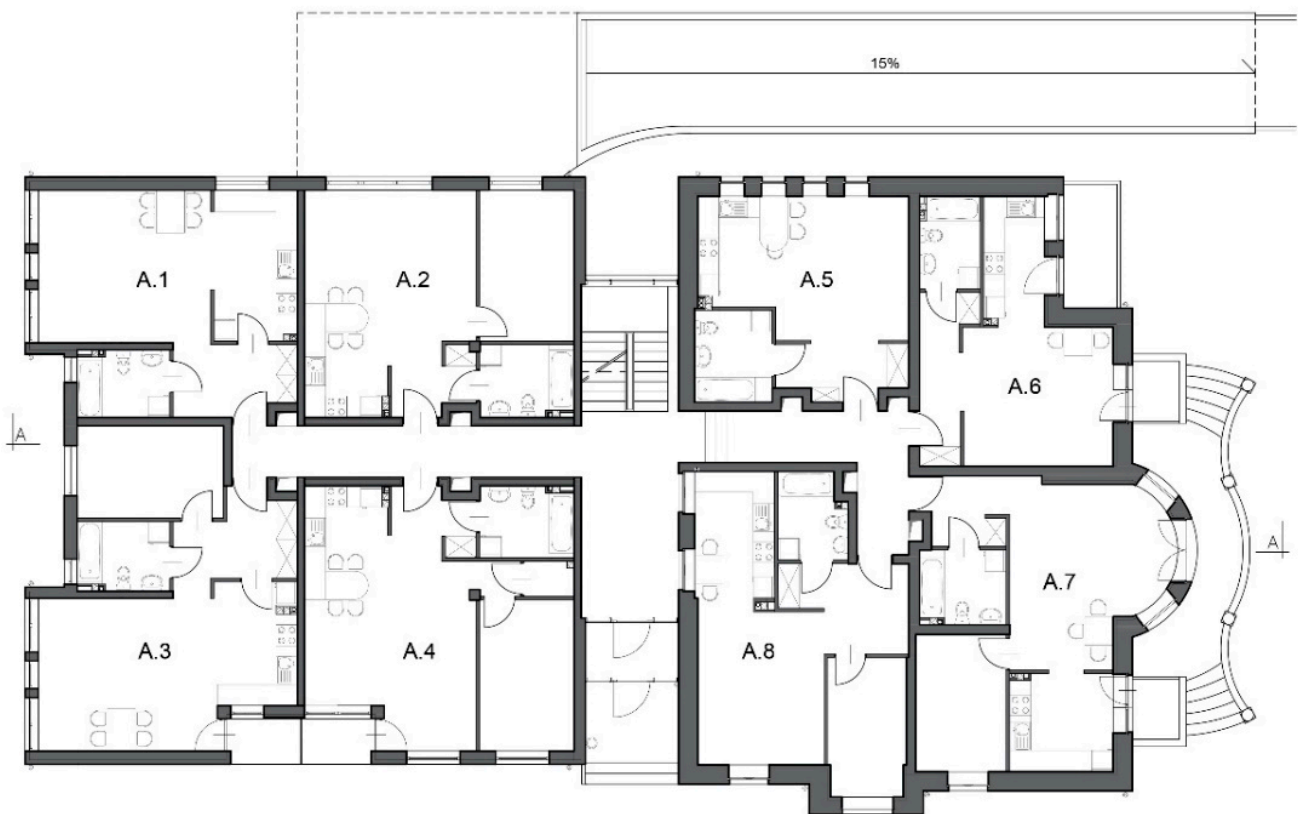
**Figure 11.** Willa Halina extension design; ground floor plan. Source: A. Taraszkiewicz.

Completely technically degraded, devoid of any historical elements, the interiors of the villa were designed in such a way as to enable the arrangement of six modern apartments. In the extended part 11, additional apartments have been designed. The revitalization and extension of the villa were designed in such a way that made it possible to turn it (according to the investor’s intention) into a multi-family residential building (Figure 11).

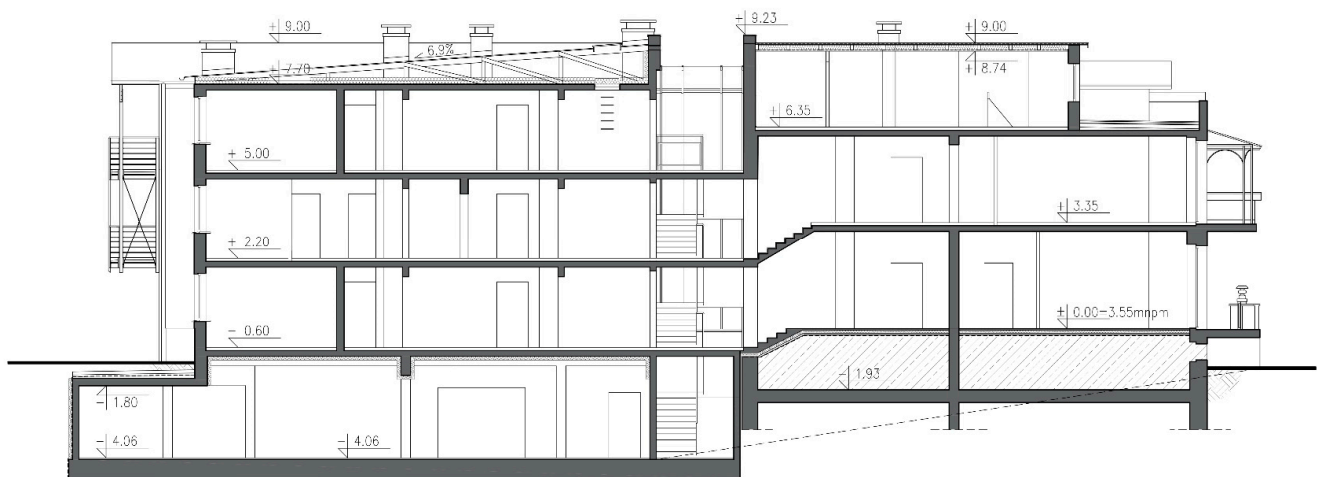
**Figure 12.** Willa Halina, longitudinal section through the building. Source: FORT Taraszkiewicz Architekci.

Many difficult structural decisions had to be made during the design of the villa's revitalization and expansion. These included the replacement of wooden rafter framing damaged by fungus and the replacement of ceilings. The biggest structural challenge, however, was the construction of the underground section in both the historic and the new, expanded part of the building. The high groundwater level caused by the proximity of the sea meant that the low (1.60 m), unusable cellar beneath the historic section was constantly flooded. This condition probably persisted from the beginning of the existence of the villa, due to the lack of waterproofing. On the other hand, excavation of an underground garage for the new part threatened to destabilize the foundations of the existing building, disturb the groundwater system, and create a cone of depression when water would be pumped from the excavations. This situation was remedied by using the diaphragm wall method [45] and the watertight concrete "bathtub" technology [46] in the underground part of the building. Moreover, in agreement with the conservation services, it was decided that the unused basement under the historical part of the building would be "lost" by filling it completely with waterproof concrete. The resulting concrete "plug" stabilized the foundation of the building and eliminated ground water accumulating under it (Figure 12).

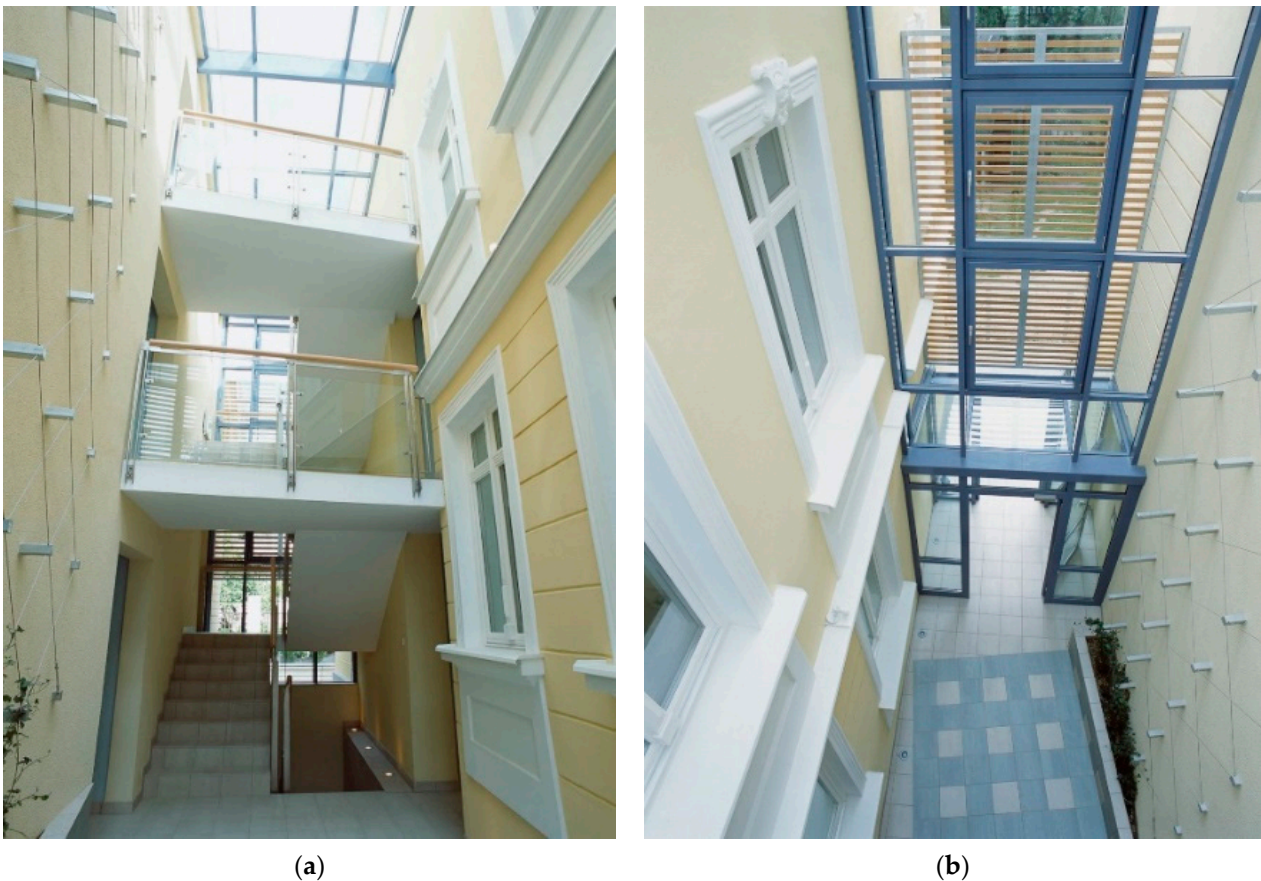
**Figure 15.** The glazed entrance hall of Willa Halina; (a) ground floor view; (b) view from the first floor. Source: FORT Taraszkiewicz Architekci.

The aforementioned glass entrance hall plays a very important role in the spatial composition of the revitalized and extended building. It connects both parts of the building and at the same time constitutes a clear boundary between what is historical and what is contemporary. This hall also allows for the exposure and daylight illumination of the western façade of Willa Halina (despite the extension). Thanks to the open staircase located in the hall, the historic façade of the villa may be viewed from many new, previously unknown perspectives, showing its undoubted beauty (Figure 15).
