Article

Analysis of the Possibility of Using New Types of Protective Coatings and Abrasion-Resistant Linings under the Operating Conditions of the Spiral Classifier at KGHM Polska Miedź S.A. Ore Concentration Plant

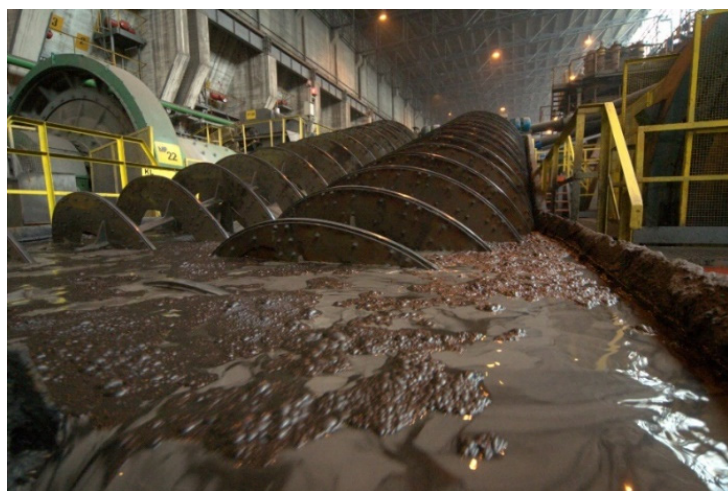
Figure 1. View of a working two-winding classifier.

Corrosion-erosion phenomena may occur on the working surfaces of the spiral where there is continuous contact (friction) with the ground feed (Figure 1). The research is therefore focused on protective materials in the form of paint coatings and wear-resistant linings.

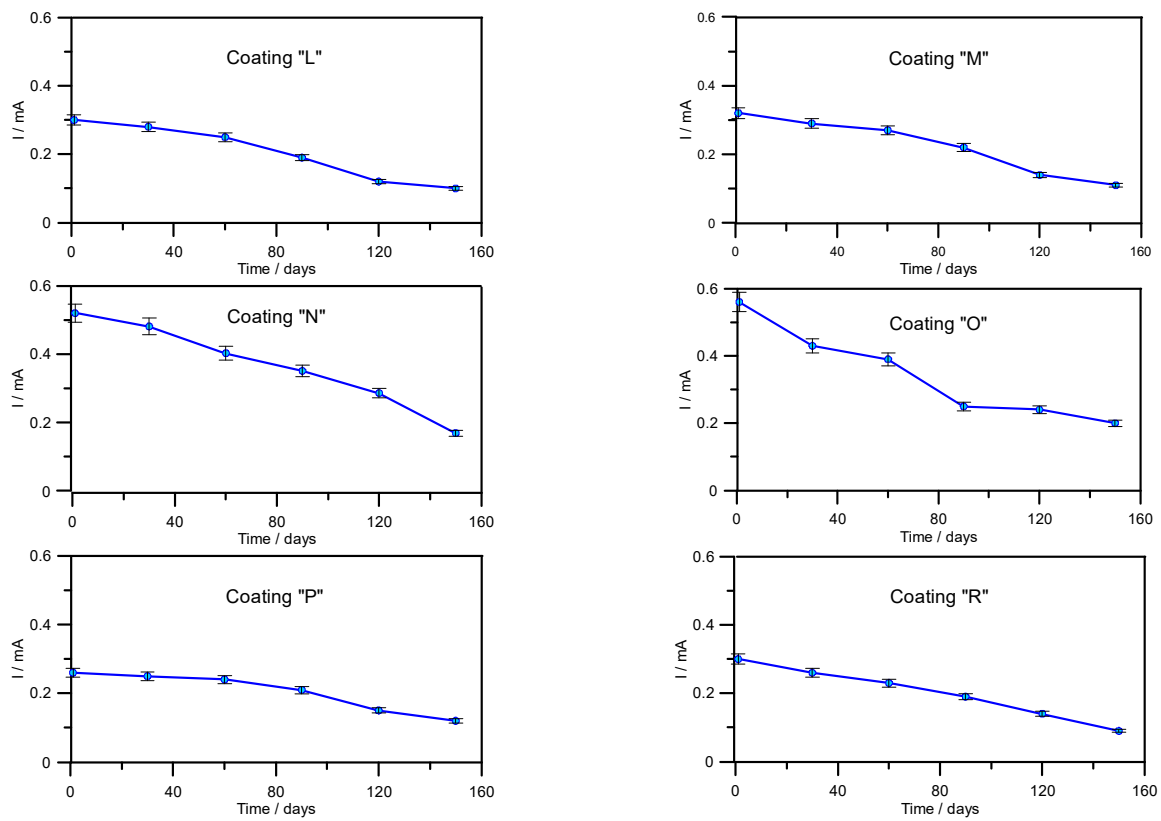
Figure 17. Changes in polarising current during exposure of samples in potentiostatic mode (cathodic protection).

At the end of the exposure, a layer of cathodic deposits was found on the surface from which the organic coating had been removed, effectively reducing the surface area polarised during the tests. The plots of the polarising current versus time (Figure 17) show a continuous decrease in the current value. This also demonstrates the lack of negative interaction between cathodic and coating protection, as any loss of adhesion of the coating to the substrate would result in an increase in the current required to polarise the sample. An attempt to mechanically remove the organic coating from the steel surface at the artificial failure boundary also failed. The tested coatings were therefore resistant to environmental alkalisation resulting from the application of cathodic protection.

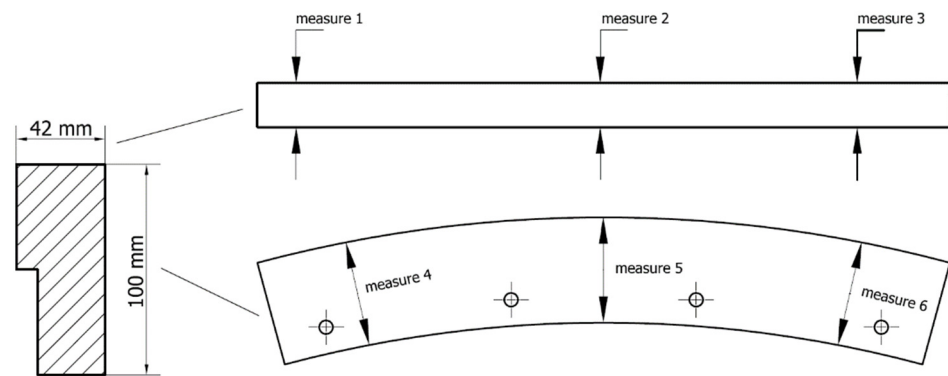
Figure 18. Measurement points for the wear of the classifier lining. Side section (measurements 1, 2 and 3). Frontal part (measurements 4, 5 and 6).

Measurements of the degrees of wear of the spiral-mounted linings were taken according to the points indicated in the sketch below (Figure 18). A view of the linings after exposure is illustrated in Figure 19.

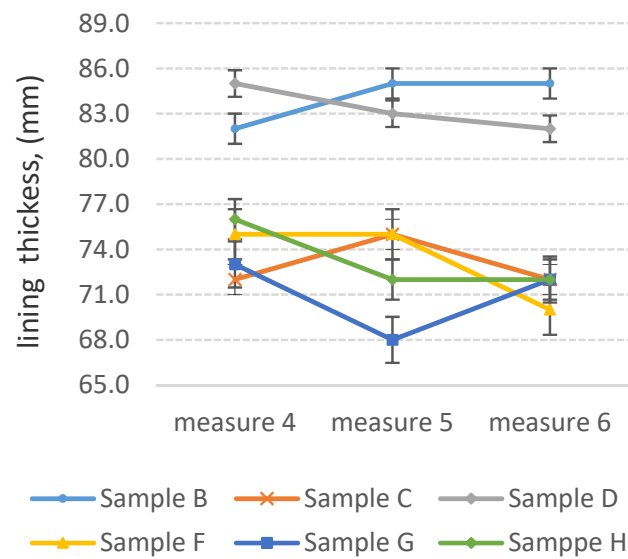
Figure 20. Lining width at three measurement points (side part).

An analysis of the degrees of wear of the tested linings based on the wear measurements shown in Figures 20 and 21 shows that linings made of polyurethane and polymer produced on the basis of MDI and PTMG achieved some of the lowest wear values, which is particularly evident for measurement numbers 4, 5 and 6 (Figure 21).

The elastic structure of both materials means that they are able to absorb some of the energy from the pressure force generated by the slurry in the classifier. Additionally noteworthy is the lining made of ultra-high-molecular-weight polyethylene with anti-stick additives, which achieved the lowest wear according to measurement numbers 1 and 2 (Figure 20), which may indicate the low coefficient of friction of this material. The remaining samples achieved a wear (relative to baseline values) above 1 mm for measurements 1, 2 and 3 (Figure 20) and above 23 mm for measurements 4, 5 and 6 (Figure 21).
