Article

Study on Microstructure and Mechanical Properties of Laser Welded Dissimilar Joint of P91 Steel and INCOLOY 800HT Nickel Alloy

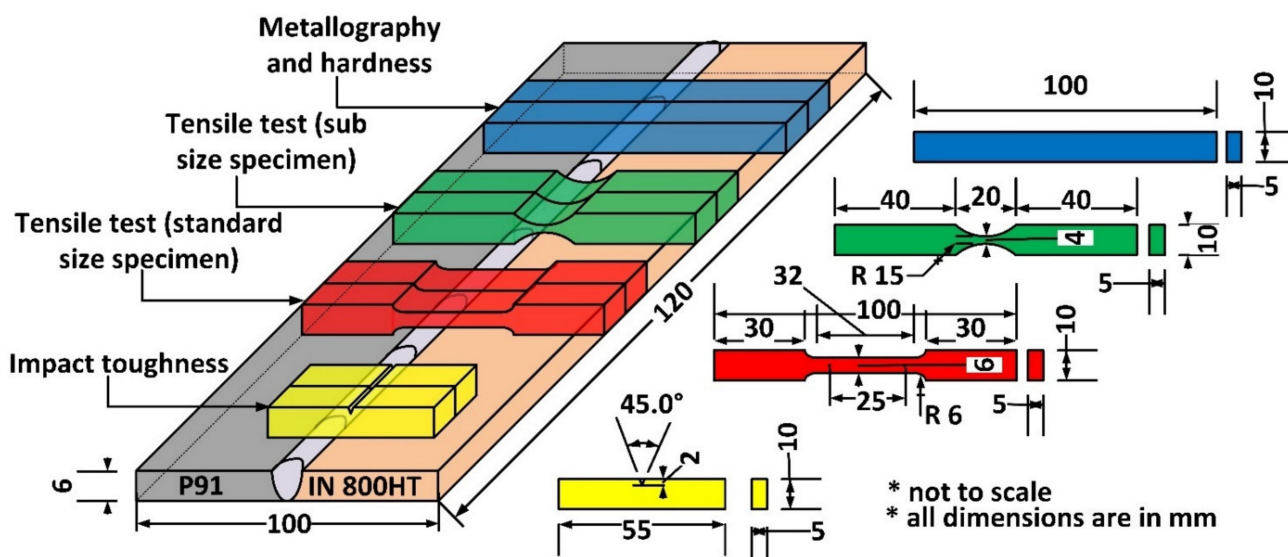
Figure 1. Schematic representing the extracted specimen's dimensions.

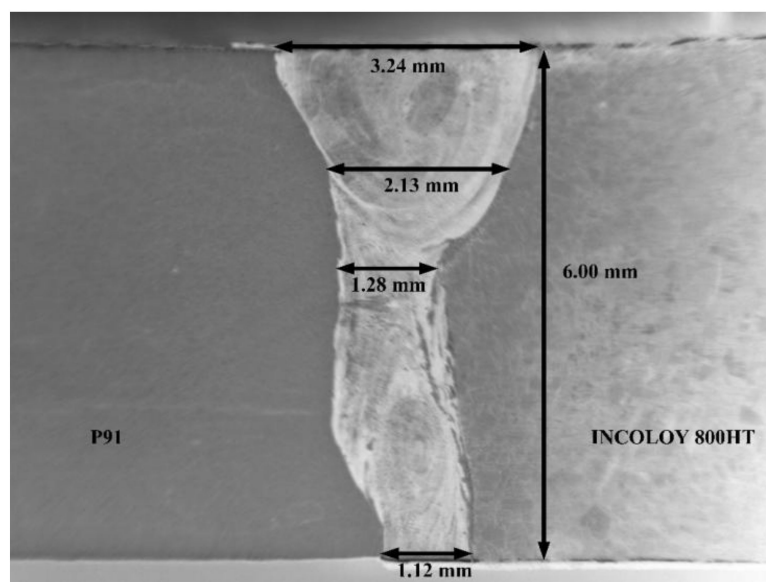
**Figure 3.** Macrograph of the laser weld bead.

The macrograph of the weld cross-section representing the weld bead geometry in Figure 3 hints at the keyhole mode of penetration caused by vapor pressure under high heat energy input in laser welding. Complete penetration with a narrow weld bead was obtained, as per the macrograph. Due to heat transfer and conduction, a grain size gradient was formed along the weldments. The weldment obtained and its different zones can be further characterized in detail.

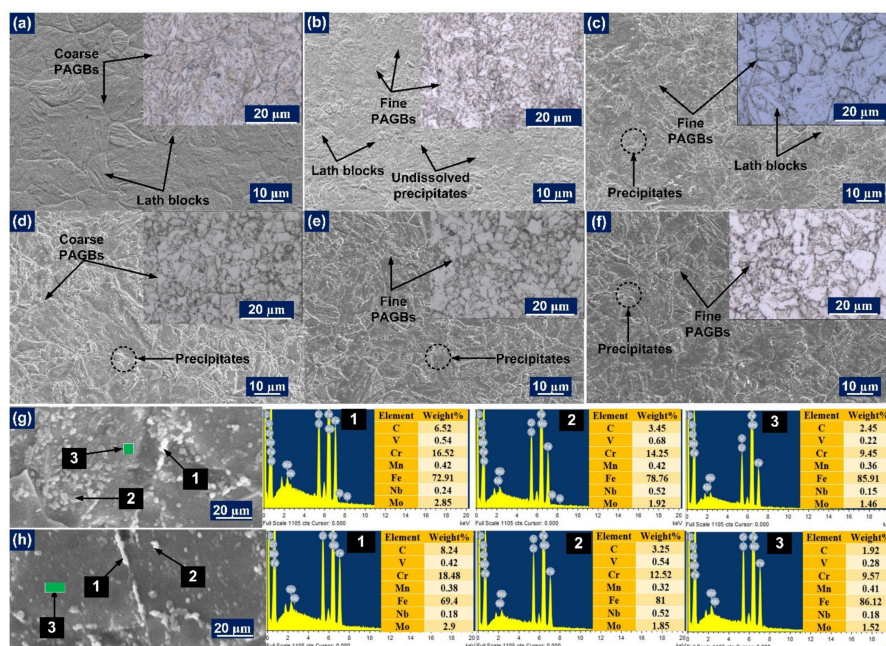
Figure 4. P91 HAZs in AW condition: (a) CGHAZ; (b) FGHAZ; (c) ICHAZ; after PWHT (d) CGHAZ; (e) FGHAZ; (f) ICHAZ; ICHAZ at higher magnification showing the location for EDS spectrum for (g) AW; (h) PWHT condition.

The micrograph of the P91 steel HAZ next to the WFZ consists of three different regions with an inhomogeneous microstructure. On the basis of the peak temperature experienced and phase transformations during the weld thermal cycle, the P91 HAZ typically consists of the coarse-grained HAZ (CGHAZ), fine-grained HAZ (FGHAZ), and inter-critical HAZ (ICHAZ) [41]. The microstructure of the CGHAZ adjacent to the WFZ experiences a much higher peak temperature than the A_{c3} , and, due to exposure at such a high temperature, precipitates are dissolved, which contributes to the reduction of the pinning force at the grain boundaries and results in grain coarsening, as shown in Figure 4a. The optical image Figure 4a shows the presence of the lath blocks and coarse grains in CGHAZ, which were also observed in the SE image. The SE image of CGHAZ also shows the complete dissolution of the particles. The region of FGHAZ and ICHAZ both have fine-grain structures and were difficult to distinguish by optical image, as shown in Figure 4b–d. However, the peak temperature experienced by the FGHAZ was higher or close to A_{c3} , and, for ICHAZ, it was in the range of A_{c1} to A_{c3} . That difference in peak temperature experienced by the FGHAZ/ICHAZ leads to the variation in the overall fraction area of the precipitates and final microstructure. FGHAZ exhibits the untempered

martensitic microstructure and partial dissolution of the carbide precipitates due to the lower peak temperature and results in the formation of the fine PAGs compared to CGHAZ Figure 4b. The undissolved carbide precipitates in FGHAZ show the coarsening nature and are marked in Figure 4b. In ICHAZ, the lower peak temperature results in the partial transformation of the austenite and the negligible dissolution of the carbide precipitates. This results in the final ICHAZ microstructure which exhibits the complex structure of the untempered martensite and austenite transform products (ATP), as given in Figure 4c. Although all of the regions of P91 HAZ of the weldments differ significantly in their PAGs, the fraction area of the precipitates, and the final microstructure, after PWHT the phase of each zone was basically the same and consisted of the ferritic-carbide mixture, i.e., tempered martensite and carbide precipitates with different tempering degree depending on the peak temperature experienced during the welding cycle. The region of the HAZs of P91 steel after the PWHT is mentioned in Figure 4d–f. After PWHT, however, more precipitates evolved at the grain boundaries and matrix. This caused softening across the HAZ due to a reduction in solid solution hardening [42]. The CGHAZ, after PWHT, exhibit the coarse PAGs in the tempered martensitic matrix (Figure 4d: optical image) along with newly evolved carbide and carbonitrides precipitates along the boundaries and inside the matrix (Figure 4d). The evolution of the new precipitates was also observed in FGHAZ and ICHAZ, as given in Figure 4e,f. The higher magnification image was captured in the ICHAZ for both AW (Figure 4g) and PWHT (Figure 4h) conditions to observe the decoration of the particles along the boundaries and inside the matrix. The image also shows the morphology and distribution of the precipitates inside the matrix and is also utilized for the EDS spectrum. The EDS spectrum of the white particles (Figure 4g: AW) decorated along the PAGBs shows the higher weight percentage of the Cr (16.52%) and Mo (2.85%) which ensure the presence of the secondary phase carbide particles that are enriched with Cr and Mo. The white particles inside the matrix show chromium (Cr) and molybdenum (Mo) as major elements, along with vanadium (V) and niobium (Nb). The EDS spectrum of the matrix is represented at point 3. A similar observation was also observed after the PWHT and is represented in Figure 4h. It is also well known from other studies that P91 steel contains mainly intragranular MX precipitates enriched with V and Nb, and intergranular $M_{23}C_6$ precipitates at PAGBs and sub-grain boundaries mainly enriched with Cr and Mo.

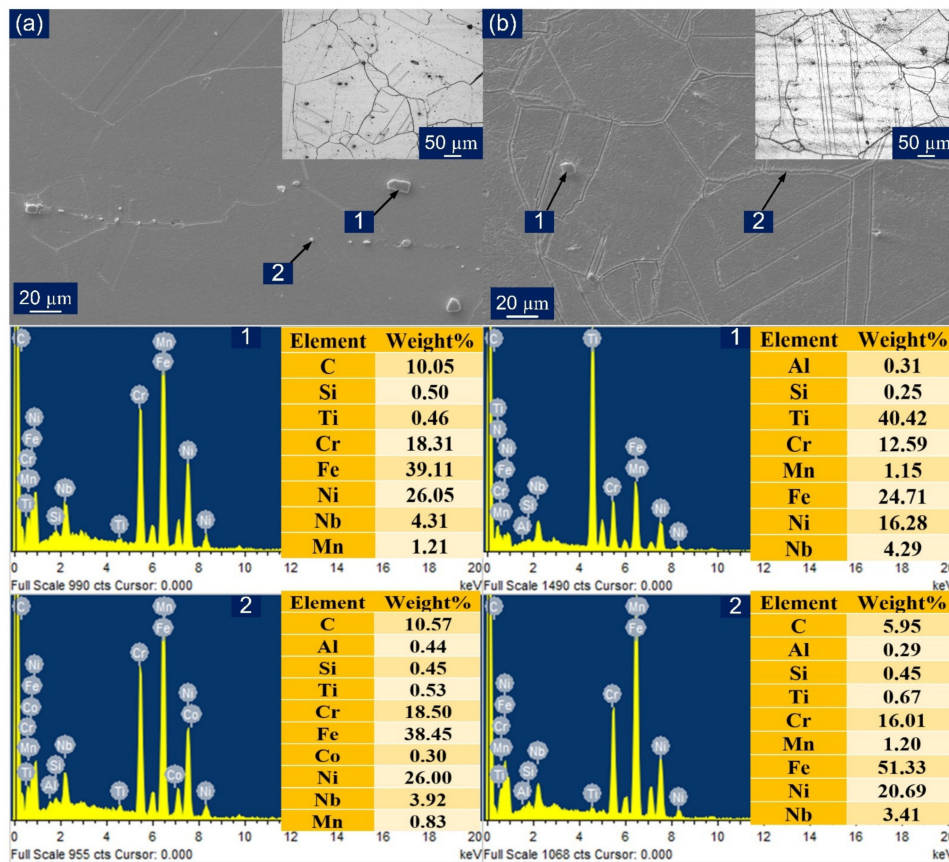
Figure 5. (a) Incoloy 800HT HAZ in AW condition with EDS spectrum for precipitate observed in AW condition; (b) Incoloy 800HT HAZ in PWHT condition with EDS spectrum for precipitate observed in PWHT condition.

While a coarse grain can be observed near the weld fusion boundary of Incoloy 800HT, a very narrow and indistinguishable HAZ was formed owing to its comparatively lower heat conductivity. The microstructure of Incoloy 800HT was found to be constant and homogenous in the welded state. The grains that are near to the weld fusion boundary of Incoloy 800HT are classified as CGHAZ (Figure 5a,b: optical). The presence of Ti(C,N) is visibly peaked in Figure 5a. The EDS spectra result for the thickened grain boundary with the possibility of grain boundary liquation is shown in Figure 5b via spectrum at point 2; a high Cr percentage can be inferred to the formation of $M_{23}C_6$ precipitate near grain boundaries. However, the PWHT performed for this study has not shown any effect on the Incoloy 800HT base metal and weld fusion boundary, as the recommended PWHT temperature for this is 820 °C, which is higher than the recommended and performed PWHT temperature for P91 weldments [43]. The presence of Cr, Fe, Al, Ti, and Nb in the alloying composition of Incoloy 800HT contributes to solid solution hardening. In addition, the controlled presence of the γ' phase along with the existence of different carbide phases contributes to precipitation hardening.

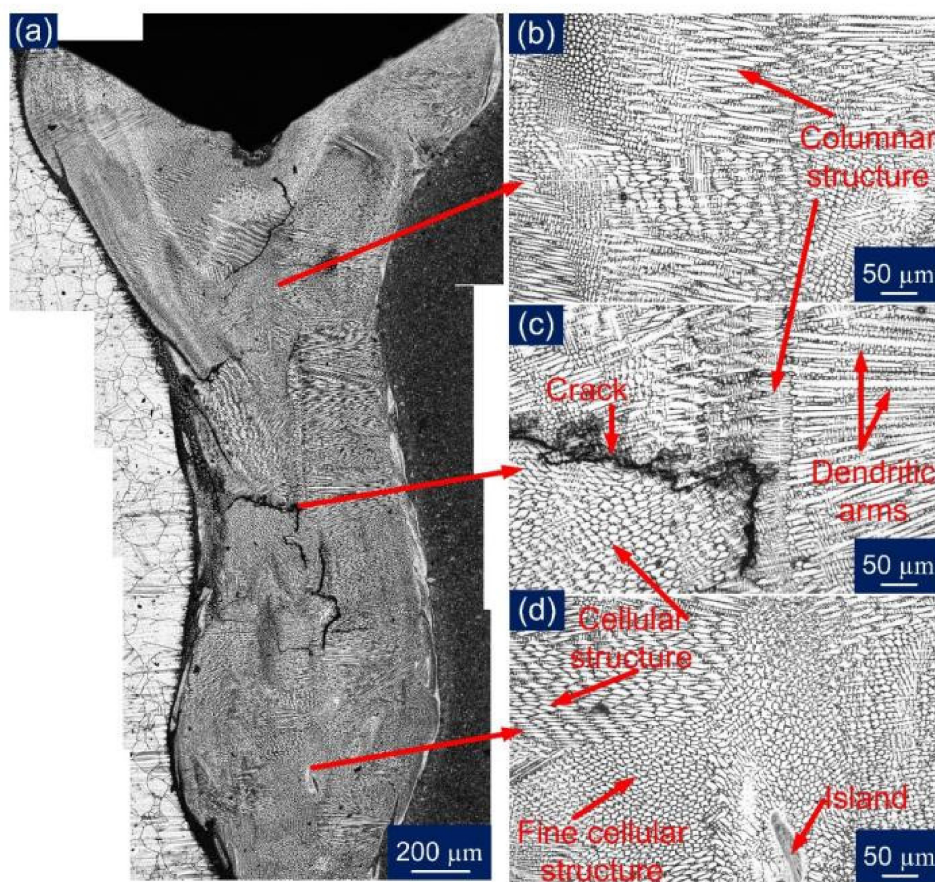
Figure 8. Optical images for: (a) WFZ in AW condition; (b) top WFZ; (c) WFZ mixed zone; (d) bottom WFZ.

The optical images were captured for the entire WFZ for detailed analysis, as shown in Figure 8. The different austenitic structures obtained in the austenitic matrix of the WFZ can be categorized on the basis of the solidification mode. The solidified microstructure in the WFZ is controlled by the growth rate (R), temperature gradient (G), degree of the constitutional supercooling, and alloy composition. The ratio G/R determines the solidification mode, and G^*R influences the size of the structure. The growth occurs from unmelted solid grains of the base metal; hence the G/R ratio is higher at the fusion boundary. The degree of constitutional supercooling affects the temperature gradient, transforming the solidification mode to form cellular, columnar, and equiaxed dendrites. The solidification tends to proceed from the interface to the WFZ. Similarly, different dendritic structures were obtained in the WFZ. It can be perceived, from Figure 8a, that in the formation of the different structures throughout the WFZ, the columnar growth predominated near the base metal interface, and the solidification mode then changed to the cellular and fine cellular structure in the WFZ. Figure 8b depicts a mixed zone in the WFZ where different dendritic morphologies exist. The dendritic arms and inter-dendritic cores

can also be observed where segregation of alloying elements occurs. Figure 8c illustrates the solidification cracking phenomenon observed along the solidified grain boundary (SGB). The dominant presence of different cellular structures and an unmixed zone ‘island’ (Figure 8d) were also spotted near the bottom of the WFZ. The different cells or dendrites were separated by a boundary that has a different composition from the bulk weld fusion zone, due to solute redistribution known as the solidification subgrain boundary (SSGB). The intersection boundary of such a similar group of subgrains or cells can be described as a solidification grain boundary. At the same time, a high-angle misorientation SGB whose crystallographic component migrates away from its compositional component can be described as a migrated grain boundary (MGB).

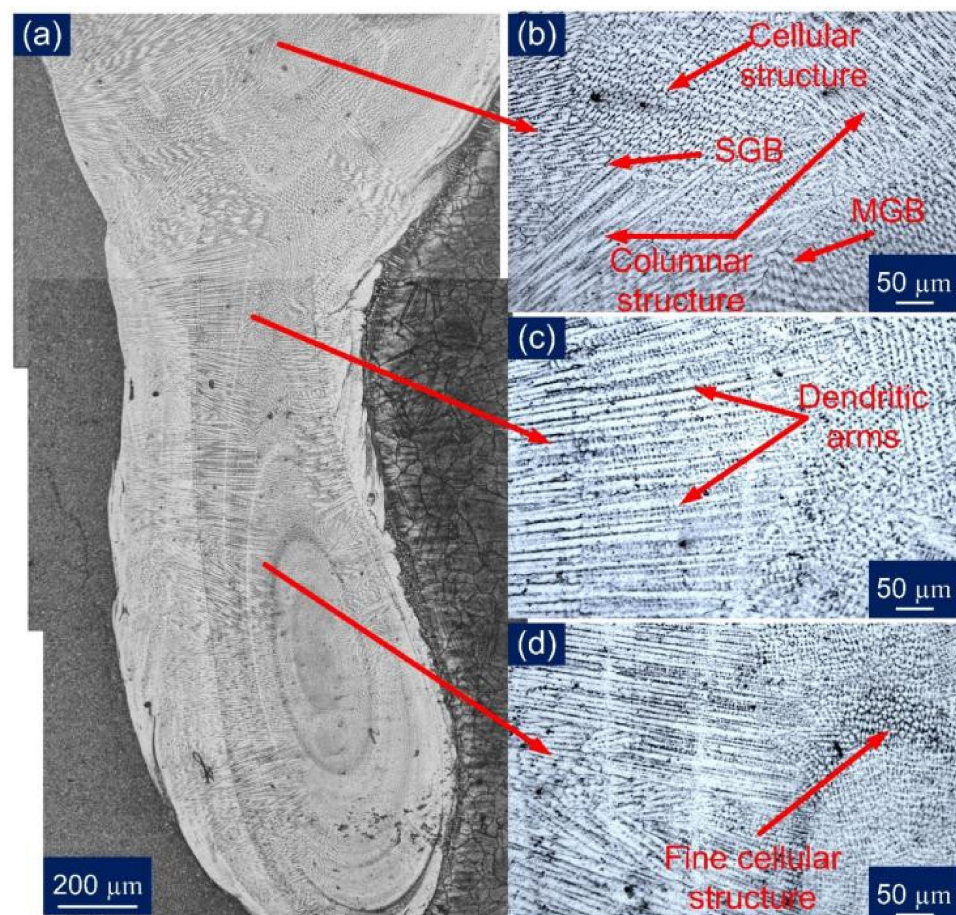
Figure 9. Optical images for: (a) WFZ in PWHT condition; (b) top of the WFZ; (c) WFZ mixed zone; (d) bottom WFZ.

Further, the comparative analysis was completed for a PWHT WFZ. However, being austenitic in nature, it did not respond to PWHT. From a stitched Figure 9a, though, it can be assumed that cracks were not present along the overall weld length, as no sign of cracks were there in the few specimens observed. Figure 9b–d also confirms the presence of discussed solidification modes as in the observed top WFZ groups of cellular and columnar structures are indicated with SGB and MGB. It was concluded, from the optical image study, that inhomogeneity was present in the WFZ to a significant extent; hence the inter-dendritic areas were further characterized using EDS analysis.

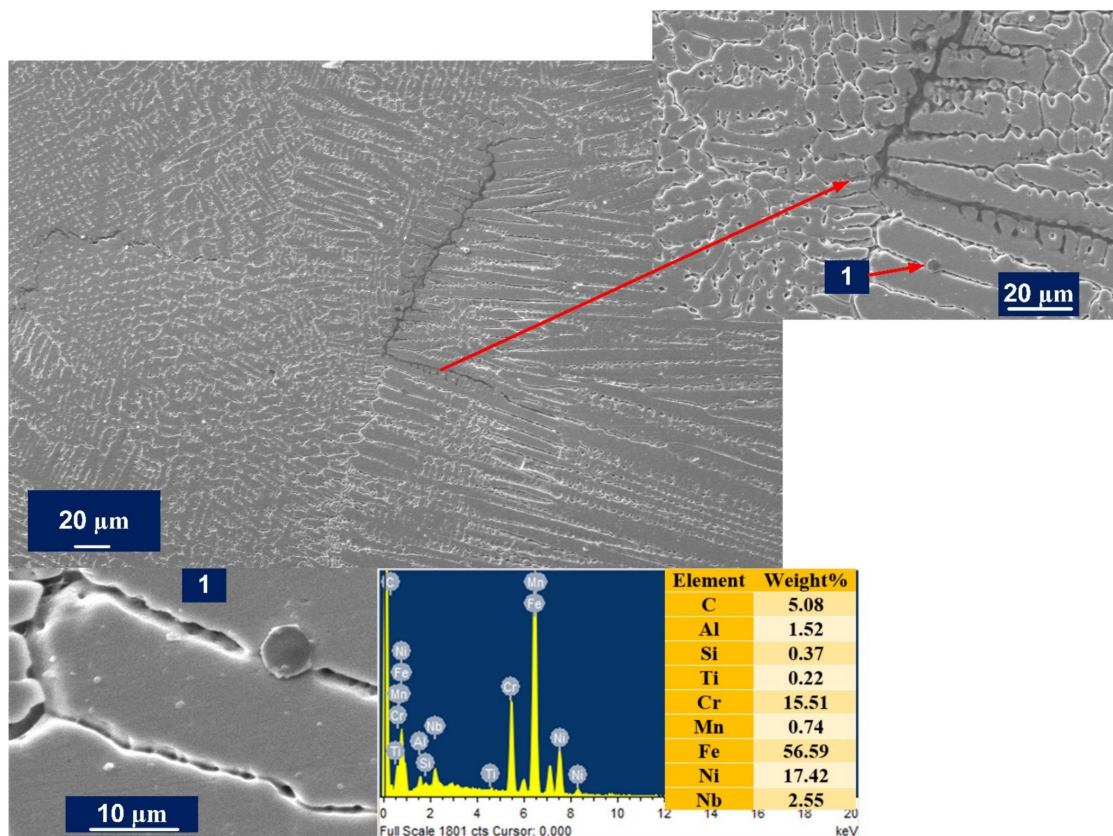
Figure 10. SEM micrograph cracks in AW specimen WFZ and EDS spectra of precipitate observed in the dendritic core region.

The solidification cracks were observed in the WFZ along the grain boundaries, as shown in Figure 10, and the EDS analysis suggests the particle might be a chromium carbide. However, Figure 9a indicates no cracks in the WFZ. This could suggest the cracks were not uniformly distributed along the welded joint. In Figure 8a, the crater at the very top indicates that, under the sudden shock of the high temperature at the start, the initial location under the focus of the laser beam—the area to be joined—might have

experienced cracking, possibly in a limited area only. The major cause for this could be the presence of low melting eutectic constituents forming elements, i.e., Nb, Ti, and Si. However, no liquation cracking was observed in the HAZ, due to the fine and coarse microstructural differences of the base metals. During solidification, the segregation of Nb occurred in the dendritic areas, as shown in Figure 11. As the eutectic reaction occurs, the formation of γ /NbC and γ /Laves constituents is reported to take place and this expands the solidification temperature range, leading to uneven cooling and cracking [47]. Nickel has a high affinity for sulfur to form nickel sulfide (NiS) along the grain boundaries and is considered to be the main cause of hot cracking in Incoloy 800HT during welding [17]. Type 1A cracks were observed in the weld region only, and no crack formation was witnessed in the HAZ regions of either parent metal. More cracks were observed in the weld region near to Incoloy 800HT side interface, which again reflects the susceptibility of Incoloy 800HT to hot cracking.

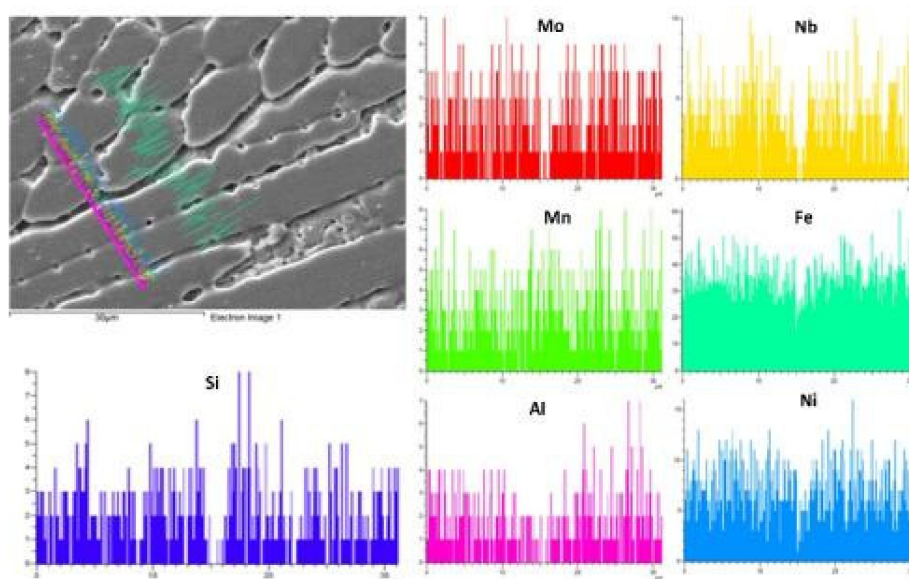
Figure 11. Line map EDS analysis across the interdendritic cores in the weld region.

In Figure 11, the microsegregation of Mo, Si, and Fe along dendritic core and subgrain boundaries in the interdendritic region can be observed. Meanwhile, the P91 side of WFZ majorly evolved elongated cellular and columnar dendrites. The fusion structures were formed as per the solidification rate, which is affected by the material's physical and chemical properties and, also, the keyhole mode. Rapid heating and cooling causes the cellular structure to change into a dendritic structure. The keyhole causes a low transfer of heat through the interface to the base metal, which also creates thermally generated stresses. In the weld region, grain boundaries were found to be rich in Ti, Si, and Nb concentrations. These elements tend to produce complex solidification temperature changes at the grain boundaries. Si concentration which was segregated, as shown in Figure 11, was found in

higher concentrations in fusion zone, and this plays a crucial role in hot cracking. As the columnar dendritic structure was observed in the WFZ in a large quantity, it is possible that the cracks were observed alongside them, as depicted in Figure 10. Carbon affects the formation of a higher columnar dendritic structure, which causes partial dissolution of precipitates. Fewer precipitates were observed in the WFZ as Ti consumed C present and its carbide transferred in the molten pool and accumulated near the Type II boundary.

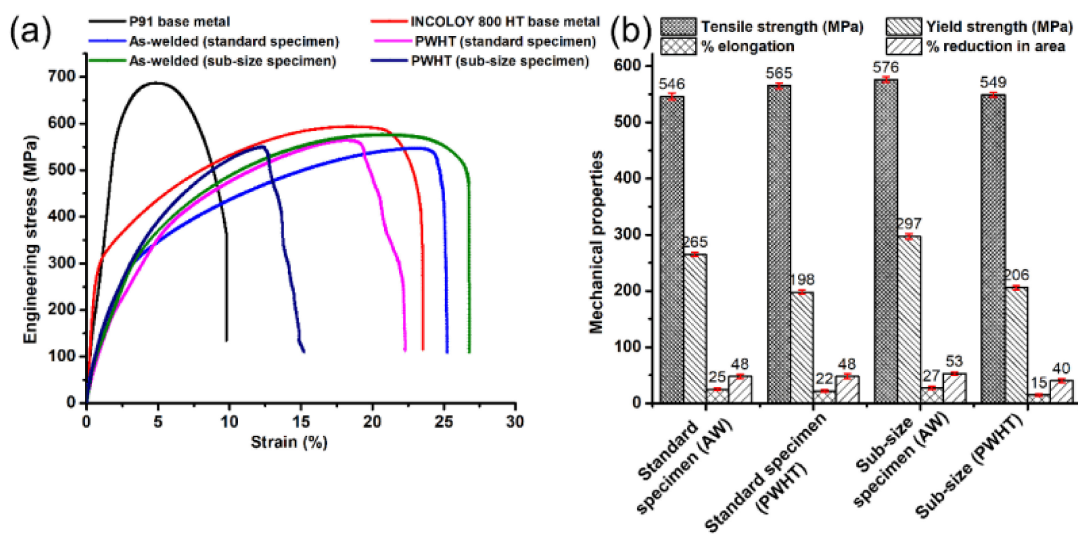
Figure 12. (a) Engineering stress-strain curves for performed tensile tests, (b) variation in mechanical properties for different conditions of the welded joint.

The tensile tests were conducted on the transverse tensile specimen, and the test results are mentioned in Table 4. The trend of stress and strain can be observed and compared through the engineering stress-strain obtained, as shown in Figure 12a. The variation in tensile properties is shown in Figure 12b. The tensile strength of the AW joint (standard specimen) was measured 546 ± 6 MPa, which was lower than the tensile strength of both the base metal P91 (687 ± 8 MPa) and Incoloy 800HT (593 ± 5 MPa). In the AW condition, the fracture was observed in the region of the Incoloy 800HT HAZ, as shown in Table 5. After the PWHT, the fracture occurred in the region of the Incoloy 800 HT base metal with a tensile strength of 576 ± 5 MPa, which was still lower than the P91 and Incoloy 800 HT base metal. However, a fracture from the region of the Incoloy 800 HT base metal ensures that the joint is safe for USC boiler service after the PWHT. The percentage (%) elongation of the welded joint was also measured and found to be higher than the Incoloy 800 HT base metal for both AW ($25 \pm 2\%$) and PWHT ($27 \pm 3\%$) conditions. The yield strength of the welded joint was measured as 265 ± 4 MPa and 297 ± 5 MPa for the AW and PWHT joint, which was close to the yield strength value of the Incoloy 800HT base metal (285 ± 4 MPa). Base metals exhibited the highest tensile and yield strength, while the welded specimens have shown resembling results, which are reported in another study [48]. For a sub-size specimen, the fracture was observed in the center region of the WFZ, and the strength was measured as 565 ± 5 MPa and 549 ± 4 MPa for AW and PWHT conditions, respectively. The failure from the center region of the WFZ might be due to the presence of the solidification cracks, which showed the sudden propagation just after the yielding. Still, with the lower yield strength observed in AW and PWHT conditions, tensile strength was obtained in the reported range. This might suggest that the cracks were only dominant near the starting region of the weld bead due to the instability caused by the initiation of the keyhole and high heat input, or the liquid metal may have filled the cracks to slightly heal them, as represented in Figure 13a. It can be visualized from Figure 13b that there was backfilling as the major compositional elements in the area mapping analysis were evenly distributed in the region. Figure 14a–c depicts the crack along with the columnar dendritic microstructure, and the magnified view of the region shows the re-solidification in the crack Figure 14b–d [44]. The percentage of elongation measured for sub-size specimens were 198 ± 3 MPa and 206 ± 4 MPa for AW and PWHT, respectively, which was lower than the corresponding values of a standard tensile specimen. The percentage of elongation was also measured as lower than the standard tensile specimen, and was $22 \pm 2\%$ and $15 \pm 2\%$ for the AW and PWHT joint (Figure 12b).

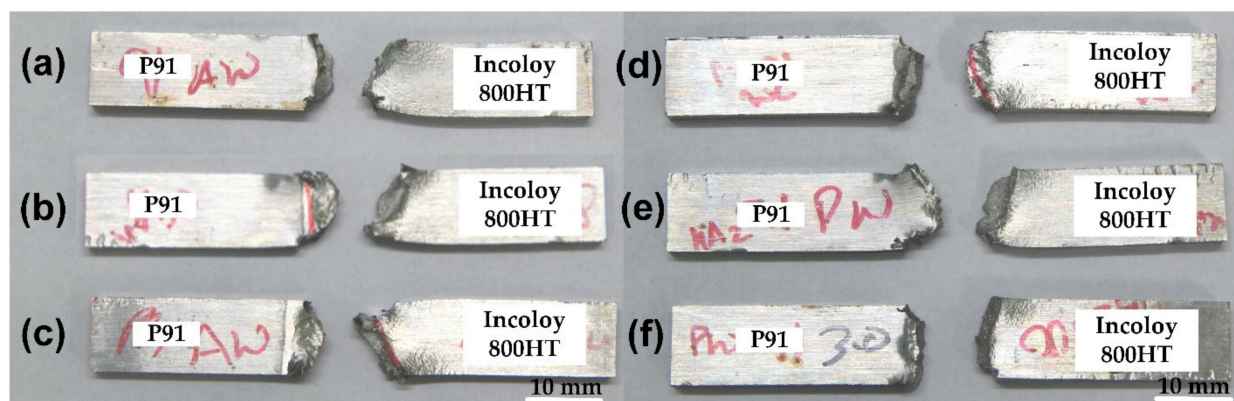
Figure 17. Samples fractured under Charpy impact testing from (a) WFZ (b) HAZ P91; (c) HAZ Incoloy 800HT; (d) PWHT WFZ; (e) PWHT HAZ P91; (f) PWHT Incoloy HAZ.

The energy absorbing capacity of the welded joint was evaluated by performing the Charpy impact toughness test at room temperature, and the results are shown in Table 6. The fractured impact tested specimen is shown in Figure 17. The impact toughness of the WFZ was measured as 65 ± 4 J in the AW condition, which was very low compared with the impact toughness of the P91 base metal (105 ± 4 J) and Incoloy 800 HT base metal (102 ± 5 J). The poor impact toughness value for the WFZ was attributed to the presence of solidification cracks along the SGBs and MGBs in the weld and segregation of the alloying elements, along with the inter-dendritic areas. However, the impact toughness of the WFZ obtained for the AW joint met the standard recommended value of 41 J (ASME standard) and >47 J (EN 1599:1997 standard) [53], which ensured that the impact toughness of the dissimilar laser welded joint of P91 and Incoloy 800 HT was qualified

for boiler requirements. The fractured impact specimen showed the complete fracture of the specimen into two parts for both AW and PWHT joints (Figure 17). In dissimilar weldments, the results showed the maximum impact toughness for the P91 base metal compared to the WFZ and Incoloy 800 HT base metal. Meanwhile, the impact toughness of the P91 HAZ and Incoloy 800HT HAZ were measured as 102 ± 5 J and 75 ± 3 J, respectively (Table 6). The lower Incoloy 800HT HAZ impact toughness, in contrast with the P91 HAZ, was highly unexpected and suggested the formation of secondary carbide particles in the intergranular region due to the segregation of the alloying elements near the HAZ region [54]. The presence of precipitation in Incoloy 800HT HAZ hindered the dislocation movement, hence lowering the ductility and toughness [45]. In P91 HAZ, the impact toughness was measured as close to the P91 base metal. However, a dissimilar weld of P91 with austenitic grade steel with fusion-welded A-TIG and M-TIG process produced poor impact toughness, and it did not qualify the USC boiler requirements [50,55,56]. The PWHT showed an increase in the impact toughness of the P91 HAZ, and was measured at 108 ± 6 , while a drastic reduction was observed in the WFZ and Incoloy 800 HT HAZ. The impact toughness in the WFZ and Incoloy 800 HT HAZ were measured at 55 ± 2 J and 45 ± 3 J, respectively. The increase in impact toughness might be due to the tempering of the martensite. The increase in impact toughness of the WM after the PWHT was also reported in the previous study [56]. The impact toughness of the P91 HAZ was measured as higher than the P91 base metal. The much-reduced toughness value in Incoloy 800HT HAZ could be due to slight ageing, as the intergranular fracture mode was observed and is frequently due to the formation of secondary carbides in the matrix, dissolution of primary carbides, and phase transformation of TiC to $Cr_{23}C_6$ [23,54]. As illustrated in Figure 18a,b, the fractography analysis shows the formation of narrow and deep dimples, which confirms the ductile mode of failure mixed with the intragranular fracture. It seems complicated to comment on the loss of ductility. It could be due to either the presence of solidification cracks or due to the formation of secondary carbides.
