Article

Study on Microstructure and Mechanical Properties of Laser Welded Dissimilar Joint of P91 Steel and INCOLOY 800HT Nickel Alloy

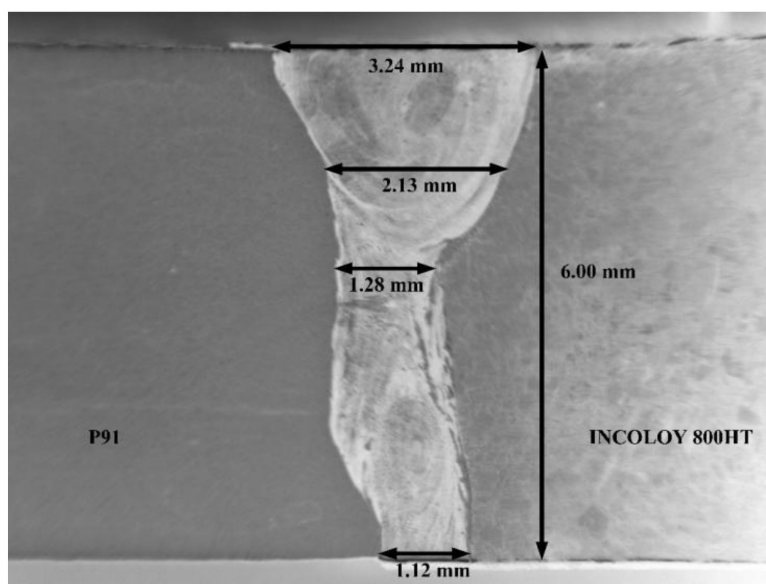
**Figure 3.** Macrograph of the laser weld bead.

The macrograph of the weld cross-section representing the weld bead geometry in Figure 3 hints at the keyhole mode of penetration caused by vapor pressure under high heat energy input in laser welding. Complete penetration with a narrow weld bead was obtained, as per the macrograph. Due to heat transfer and conduction, a grain size gradient was formed along the weldments. The weldment obtained and its different zones can be further characterized in detail.

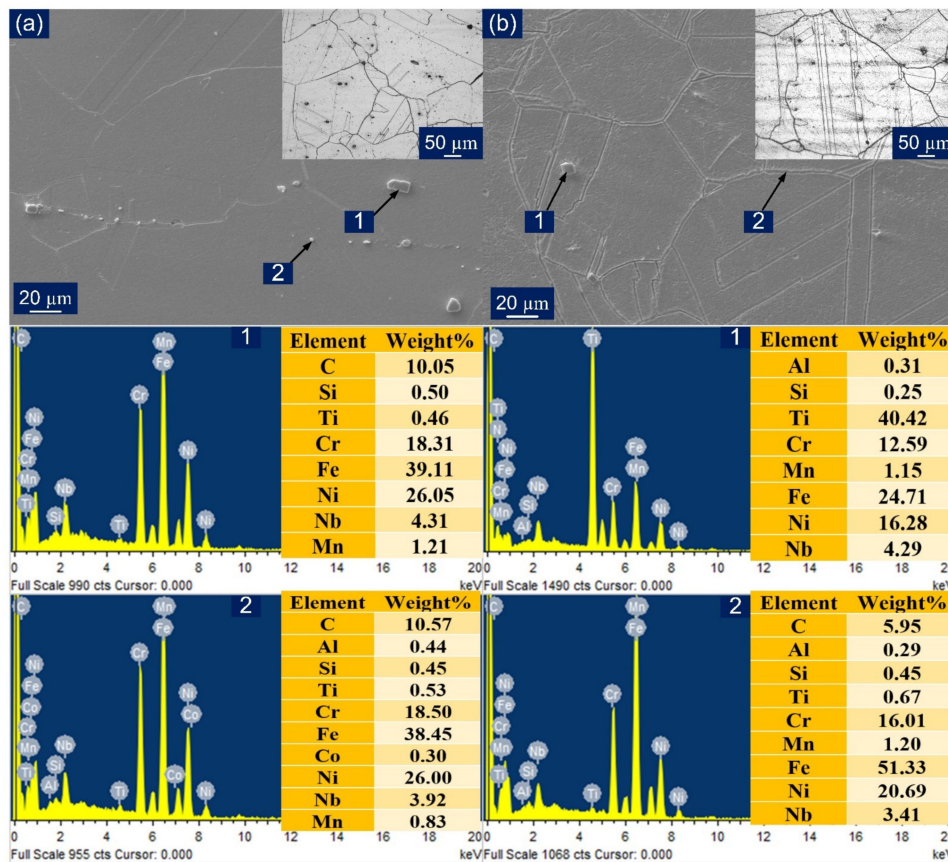
Figure 5. (a) Incoloy 800HT HAZ in AW condition with EDS spectrum for precipitate observed in AW condition; (b) Incoloy 800HT HAZ in PWHT condition with EDS spectrum for precipitate observed in PWHT condition.

While a coarse grain can be observed near the weld fusion boundary of Incoloy 800HT, a very narrow and indistinguishable HAZ was formed owing to its comparatively lower heat conductivity. The microstructure of Incoloy 800HT was found to be constant and homogenous in the welded state. The grains that are near to the weld fusion boundary of Incoloy 800HT are classified as CGHAZ (Figure 5a,b: optical). The presence of Ti(C,N) is visibly peaked in Figure 5a. The EDS spectra result for the thickened grain boundary with the possibility of grain boundary liquation is shown in Figure 5b via spectrum at point 2; a high Cr percentage can be inferred to the formation of $M_{23}C_6$ precipitate near grain boundaries. However, the PWHT performed for this study has not shown any effect on the Incoloy 800HT base metal and weld fusion boundary, as the recommended PWHT temperature for this is 820 °C, which is higher than the recommended and performed PWHT temperature for P91 weldments [43]. The presence of Cr, Fe, Al, Ti, and Nb in the alloying composition of Incoloy 800HT contributes to solid solution hardening. In addition, the controlled presence of the γ' phase along with the existence of different carbide phases contributes to precipitation hardening.
