Aleksander Piwek*, Tomasz Jażdżewski**

The room above the porte cochère of the Kwidzyn castle in the times of the Pomesanian chapter

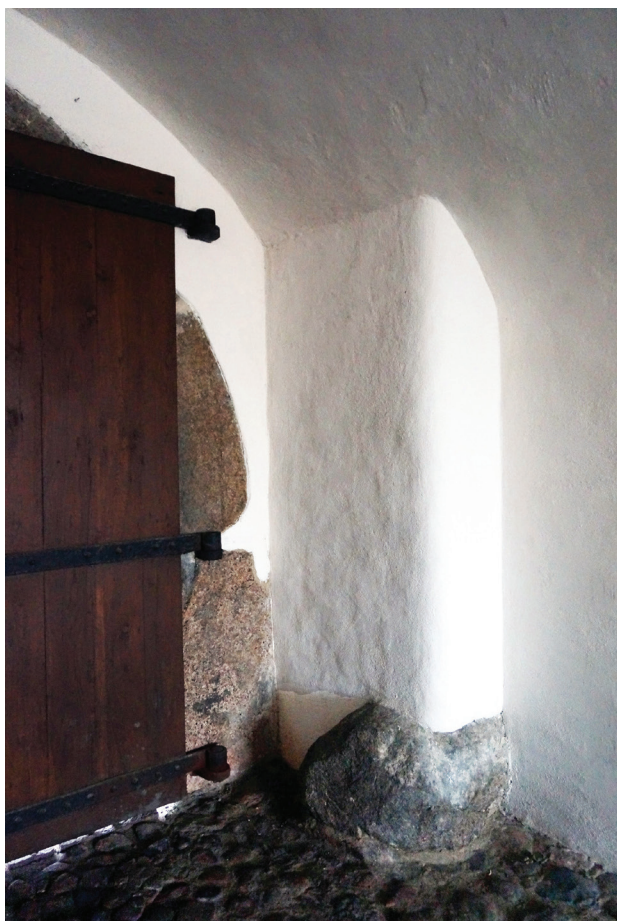
Fig. 7. The eastern fragment of the medieval entrance to the Kwidzyn castle with a late-Gothic extension (pilaster) and a modern segmental vault (photo by A. Piwek)

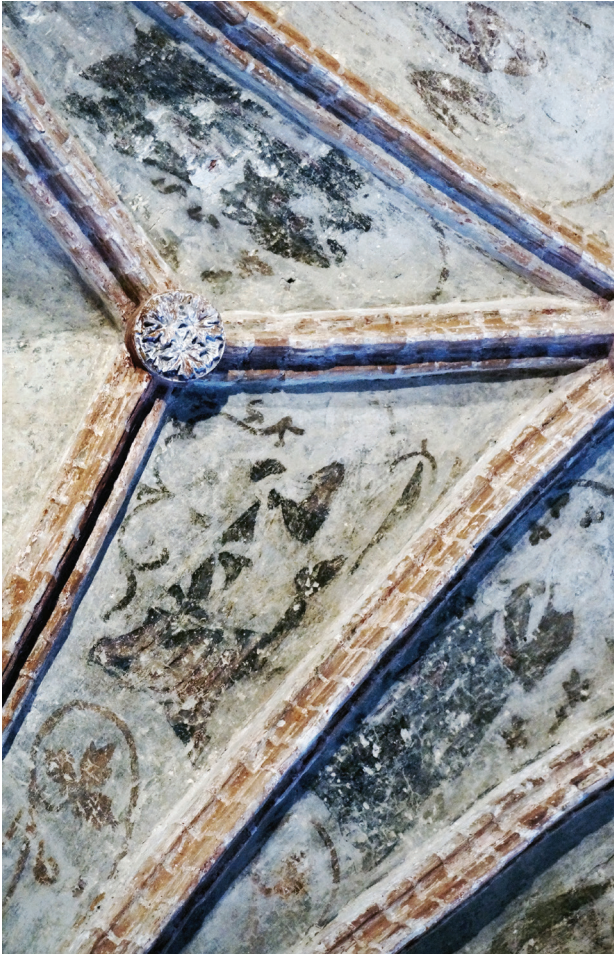
Fig. 9. Part of the northern bay vault with traces of exposed polychrome (2nd quarter of the 15th century?) (photo by A. Piwek)

The completely uncovered polychromes (Fig. 9) indicate the sacral function of the room and the time of its creation. It is assumed that they were made between 1400 and 1450 [10, pp. 8, 9], although this is not the only possibility¹³. Their sacral content (figures of saints) corresponds with the new use of the hall. Their appearance only on the vaulting of the northern bay has not been explained yet. The suggested reason is the start of the war in 1409 [9, p. 8] and its consequences. There is also another explanation. When a wooden partition is placed in the middle of the interior, it separates parts intended for users of different status – the clergy and the castle servants.
