EXPERIMENTAL RESEARCH ON INSUFFICIENT WATER LUBRICATION OF MARINE STERN TUBE JOURNAL BEARING WITH ELASTIC POLYMER BUSH

Agnieszka Barszczewska
Gdańsk University of Technology, Poland

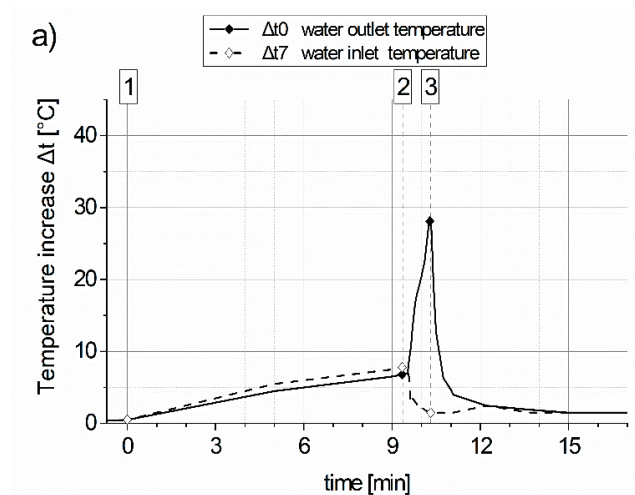
Fig. 8. Temperature and friction torque increase diagrams for bearing with elastic polymer bush. Test conditions: pressure=0.3 MPa, shaft revolution speed =10 rev/s, water flow=0 L/min. a) Water temperature increase diagram, b) Bush temperature increase diagram, c) Friction torque increase diagram, 1 - closing the water flow, 2 - sudden increase in the resistance of motion, 3 - stopping motor's operation.

The results of the test conducted at 0.3 MPa in the conditions of no-water flow are presented in Fig. 8.

Following the closing of the water flow (1), the temperatures of the water and the bush rise at a similar rate. After approx. 9 minutes into the test, a sudden rise in the resistance of motion occurs (2), thus the valves are being opened and the water pump turned on. This resulted in bringing down the temperatures on the inlet side of the bearing (Δt_5 , Δt_6 , Δt_7), but also in a sudden increase of the temperatures at the outlet (Δt_0 , Δt_2 , Δt_3). These temperature changes concerns the water and the upper part of the bearing, where lubricating grooves are placed. The outlet temperatures increase is a result of pushing out the hot water from the bearing and it might be additionally affected by water backflow phenomenon [49]. The opening of the fresh water flow did not affect the temperatures at the bottom of the bush (Δt_1 , Δt_4), since water mainly flowed through the lubrication grooves.
