EXPERIMENTAL RESEARCH ON INSUFFICIENT WATER LUBRICATION OF MARINE STERN TUBE JOURNAL BEARING WITH ELASTIC POLYMER BUSH

Agnieszka Barszczewska
Gdańsk University of Technology, Poland

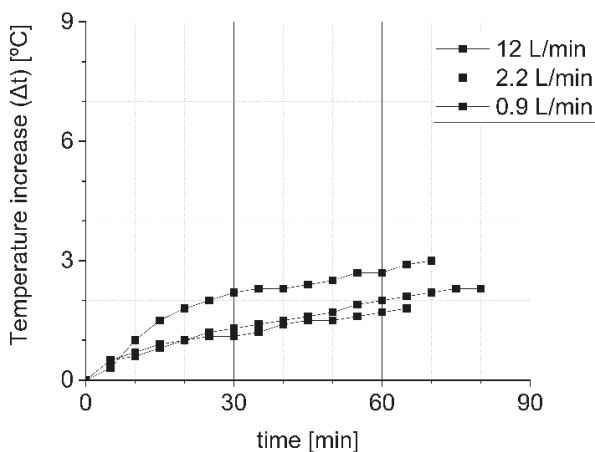
Fig. 9. Temperature increase diagram for bearing with elastic polymer bush. Test conditions: pressure=0.4 MPa, shaft revolution speed =10 rev/s, water flow=0.9-12 L/min.

Taking into account that the radial clearance of the bearing might have been altered in the previous tests, it was decided to verify whether the bearing would be able to work at the load of 0.4 MPa and a flow of 12 L/min (Fig. 9). As it turned out, the bearing was able to operate for the set period of time (60 min) without an excessive temperature increase (2°C). Moreover, the bearing underwent further tests at 2.2 and 0.9 L/min, during which neither sudden changes in the resistance of motion nor large temperature increases were observed for the period of 60 minutes.

The fact is that the temperatures were no longer increasing in a degressive way, which may be symptomatic of temperature instability in the system and the occurrence of mixed friction in the bearing.
