INFLUENCE OF SOLID PARTICLE CONTAMINATION ON THE WEAR PROCESS IN WATER LUBRICATED MARINE STRUT BEARINGS WITH NBR AND PTFE BUSHES

Gdańsk University of Technology, Poland

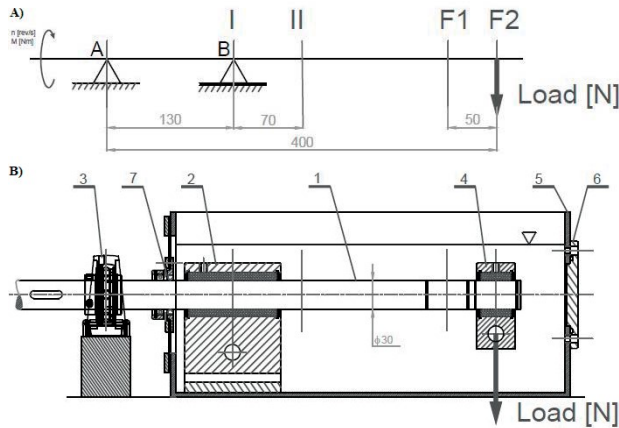
Fig. 2. Test stand description A) diagram of the stand and B) cross-section of the stand: 1 - shaft, 2 - tested bearing in a self-adjusting support, 3 - rolling bearing, 4 - slide bearing through which the load is exerted, 5 - tank filled with water, 6 - cover, and 7 - sealing

A three-phase electric motor was connected to a 30 mm diameter shaft by a torsionally flexible coupling. The shaft (1) was supported on two bearings: a self-aligning roller bearing (3) and a slide bearing located in the self-adjusting support (2), which allows the shaft to freely position in the slide bearing bush during bending. The shaft was partially located in the tank (5) filled with fresh water, which was the medium that lubricated the tested bearing. At its end, the slide bearing was mounted in the housing (4) through which the load was exerted. At the end of the shaft at the bearing mounting point F, a frame was attached and loaded with a concentrated force that simulated a load with a ship propeller. In front of the tank, a rolling bearing was installed, whose task was to ensure

that the seal (7) and a sealed cover (6) are coaxial at the end of the tank. An assembly hole was made that also protected against undesirable leakage of water from the tank. Such an experimental test stand allowed for a controlled application of a bending load on the journal of the tested water-lubricated plain bearing.
