Contemporary Architectural Design in the Context of Historic Remains: The Case of the Old City of Gdańsk

A. Taraszkievicz, K. Grębowski, K. Taraszkievicz & J. Przewłócki

To cite this article: A. Taraszkievicz, K. Grębowski, K. Taraszkievicz & J. Przewłócki (2021) Contemporary Architectural Design in the Context of Historic Remains: The Case of the Old City of Gdańsk, *Heritage & Society*, 14:1, 1-19, DOI: [10.1080/2159032X.2021.2016051](https://doi.org/10.1080/2159032X.2021.2016051)

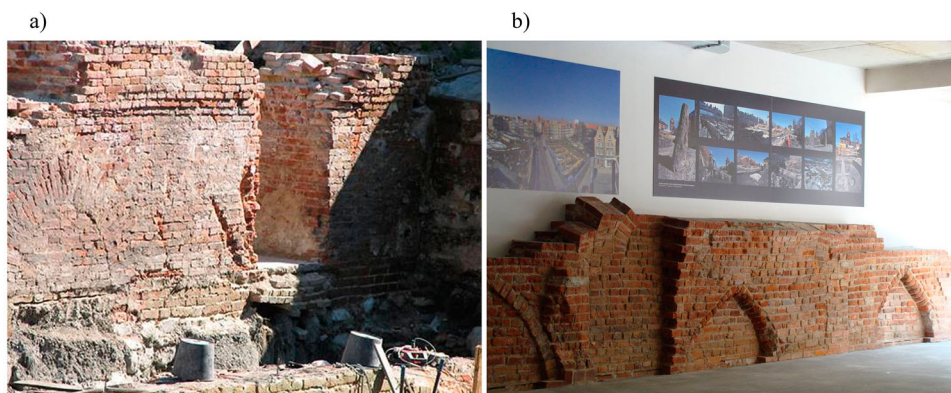
Figure 5. a) Fragment of Gothic brick cellar walls, b) Remnant of the Gothic wall displayed on the ground floor of the block on Szeroka Street, Gdańsk. Source: photo by A. Taraszkievicz, 2011, 2012

The block has a deep, two-storey underground car park due to city parking requirements. The excavation work for the car park uncovered valuable remains of Gothic brick cellar walls of the tenement houses that used to stand there (Figure 5a). These historic remains, with their beautiful ogival vaulting, conflicted with the functional and technical solutions proposed in the design, thus preventing the whole project from progressing.

historic walls where they had been found, i.e., underground. However, this would have made it impossible to build the underground car park necessary for the proper functioning of the modern building, so the designers believed that the historic walls should be removed from their underground location and displayed in public view on the ground floor level.

Finally the decision was made, in consultation with the conservation authorities, to cut the walls into large four-metre pieces, enclose them within steel clamps specially designed for this purpose, take them out and move them to a military training ground for drying, mould removal and conservation. Once the reinforced concrete ceiling was built over the underground car park, the walls were returned to the site where they were reassembled and placed according to their historical orientation and position, but one and a half storeys higher, i.e., at the ground floor level. Thanks to this solution (not entirely complying with the Venice Charter), a previously unknown, valuable fragment of Gdańsk's brick architecture was excavated and saved. Displayed to the general public on the ground floor of the new block, it makes for an attractive historical element in the modern interior design, accessible to all (Figure 5b). Thus, the architecture of the block creatively combined looking into the future without forgetting about the legacy of the past.

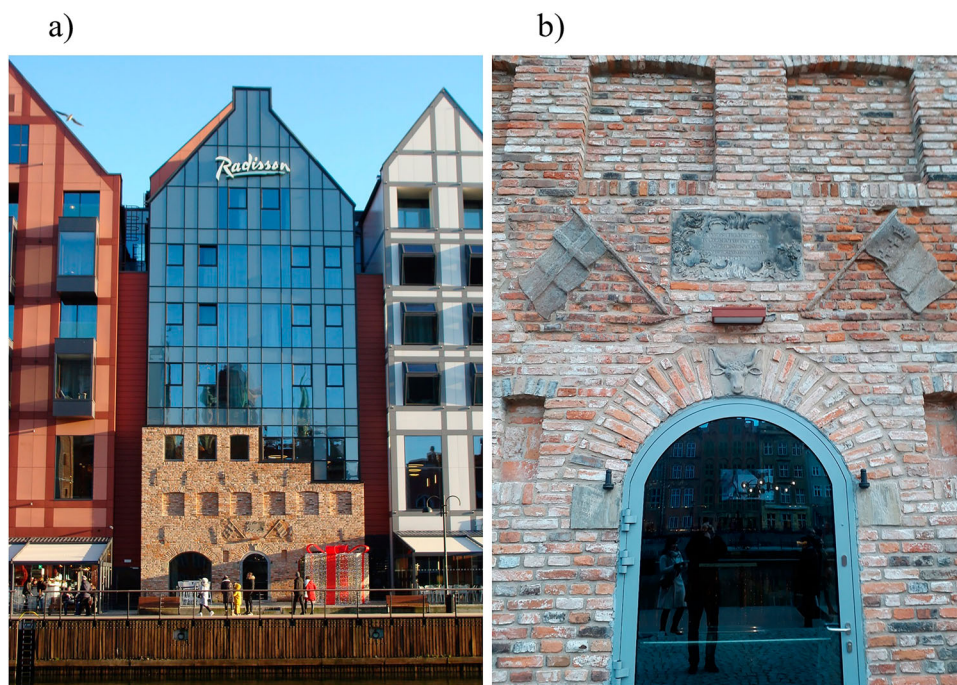
Figure 7. a) Front façade of the Woli Łab granary on Wyspa Spichrzów, Gdańsk, b) Close-up of the relief of the flags and the cartouche. Source: A. Taraszkiewicz, own materials, 2020

Due to its poor technical condition and weak foundations which could not bear the weight of the superstructure planned in the modern design, comparable to the original dimensions of the granary, a rather controversial decision was made to completely dismantle the historical building, a decision to a large extent contrary to the Venice Charter guidelines. Dismantled and inventoried, brick and stone elements and architectural details underwent conservation and were then rebuilt in their original location on a solid, reinforced concrete foundation. Rebuilt in this way, the façade wall could now take the weight of the contemporary five-storey glazed superstructure designed in the aluminium post and beam façade technology. The preserved coat of arms, relief with the flags and the cartouche with the inscription (Figure 7a, b) were set in the axis of the façade, above the entrance on the ground floor.
