# Properties of Old Concrete Built in the Former Leipziger Palace

**Abstract:** This research aims to determine the mechanical, chemical, and physical properties of old concrete used in the former Leipziger Palace in Wrocław, Poland. The cylindrical specimens were taken from the basement concrete walls using a concrete core borehole diamond drill machine. The determination of the durability and strength of old concrete was based on specified chosen properties of the old concrete obtained through the following set of tests: measurements of dry density, tests of water absorption, specification of concrete compressive strength and frost resistance, determination of the modulus of elasticity, measurement of the pH value, determination of water-soluble chloride salts and sulphate ions, and X-ray diffraction analyses. Large dispersions of the compressive strength (10.4 MPa to 34.2 MPa), density (2049 kg/m<sup>3</sup> to 2205 kg/m<sup>3</sup>), water absorption (4.72% to 6.55%), and stabilized secant modulus of elasticity (15.25 GPa to 19.96 GPa) were observed. The paper is intended to provide scientists, civil engineers, and designers with guidelines for examining and assessing the long

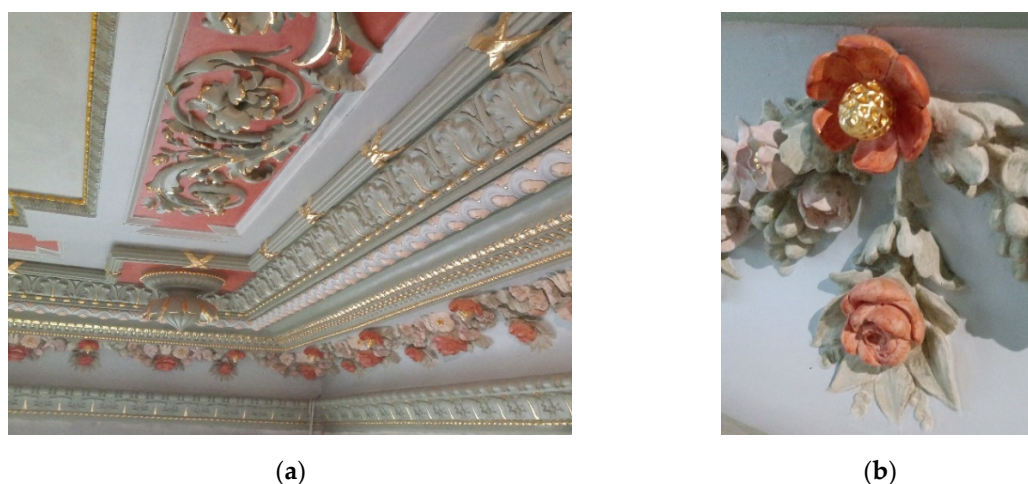
**Figure 2.** Stucco renovation on the ceiling: (a) partial view on the ceiling; (b) view of the gilded floral detail.

The Leipziger had the palace for only four years, then sold the building in 1878 to the County Office (Kreisausschuss). The Palace was expanded and rebuilt in the following years. Then, the Palace served administrative functions until 1945. Next, it belonged to the Geological Company Proxima for many years. At present, the former Leipziger Palace in Wrocław is in the process of being rebuilt (by the TORUS Company from Gdańsk, Poland) into a five-star hotel, which will be named Altus Palace (see Figure 1). Currently, besides finish and building work, extensive conservation and restoration work has been carried out to restore the splendour of the old building. The architectural form of the Palace in the interior is enriched by decorations, with an antique renaissance repertoire of ornaments and decorations that have been subjected to restoration and refilling (see Figure 2).

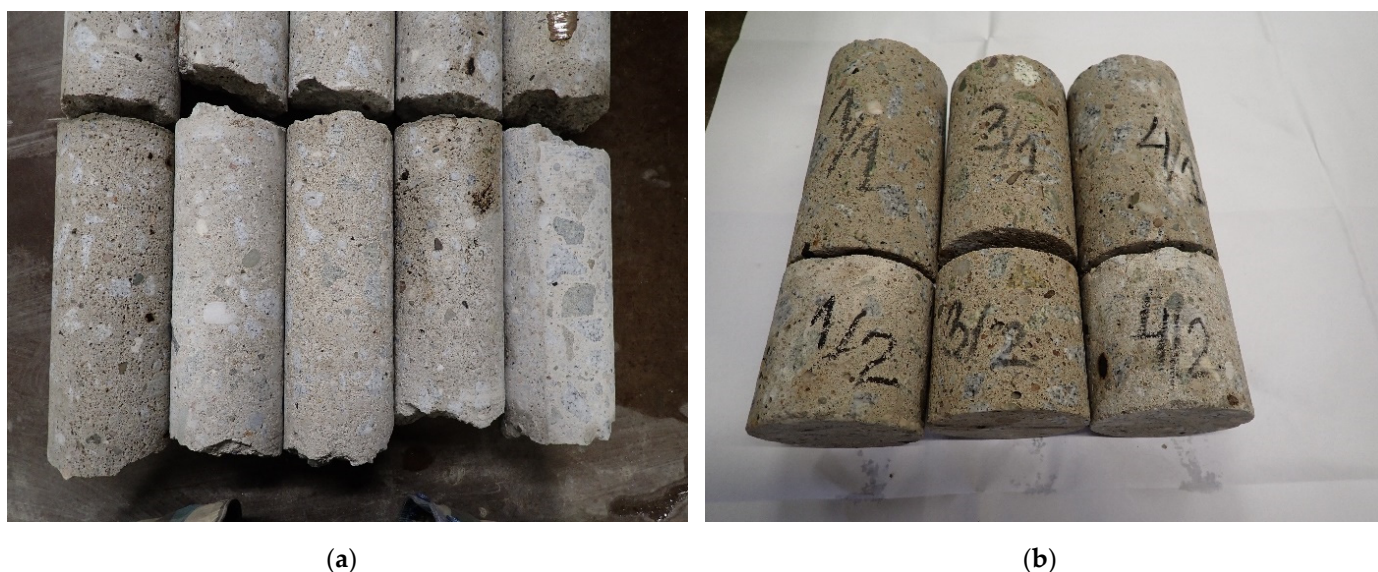
**Figure 3.** Old cylindrical concrete specimens: (a) taken from basement wall using a borehole diamond drill machine; (b) example view on some prepared concrete cores.

The old concrete specimens for the determination of the mechanical, chemical, and physical properties were taken from the structural elements of basement walls by a concrete core borehole diamond drill machine (see Figure 3a). It can be seen that some old concrete cores included visible pores (probably connected with an improper compact procedure of the concrete mix during placement) with a predominance of fine aggregate below 4mm grain-size with a low amount of additional coarse aggregates (granite and boulder) with grains with a diameter of 8 to 16 mm. Two types of concrete cores were prepared for mechanical tests (see Figure 3b). Firstly, 15 concrete cores with a diameter of approximately 100 mm ( $f_{c,cycl 100}$ ) and a length to core diameter ratio of 1 were used for compressive tests. The dimensions of the concrete cores were specified according to the standard EN 12504-1 [53]. The strength results determined for the chosen diameter of concrete cores of  $f_{c,cycl 100}$  can be directly comparable to the cube strength  $f_{c,cube}$  of 15 cm × 15 cm × 15 cm concrete specimens. Secondly, six concrete cores with a length to core diameter ratio equal to 1.5 and 2.0 with a diameter of approximately 100 mm were prepared to determine the modulus of elasticity indicated by two chosen standards. The EN 12390-13 [54] standard guidelines state that for the determination of the modulus of elasticity in compression, the ratio between the specimen length and the dimension will be in the range from 2 to 4, while the ASTM C469M standard [55] requires cores having a length-to-diameter ratio greater than 1.5. It should be noted that in old concrete structures, often it is not possible to drill cores with high length to core diameter ratios (due to, e.g., low old concrete strength, voids, or low-quality interlayers in concrete). In these cases, it is necessary to limit planned mechanical tests or to use non-standards specimen dimensions. The results obtained for cores with low dimensions can be recalculated to standard dimensions of concrete specimens according to proper guidelines with the application of the strength correction factor [56].

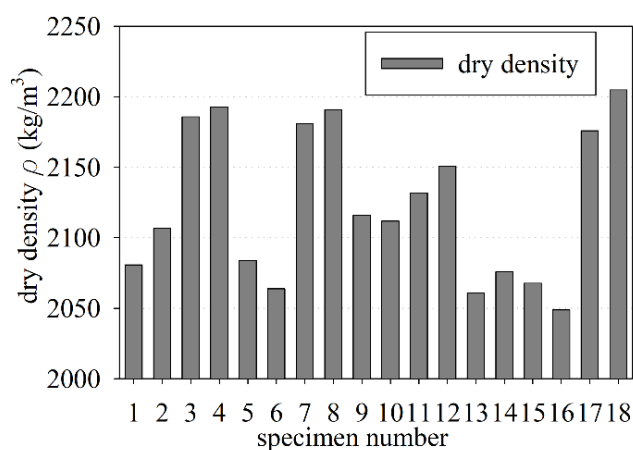
**Figure 4.** Measurement of the old concrete dry density.

The laboratory tests showed that the dry density of the old concrete varied from  $2049 \text{ kg/m}^3$  to  $2205 \text{ kg/m}^3$  (see Figure 4). The mean dry density value of the old concrete was equal to  $2124 \pm 13 \text{ kg/m}^3$ , while the median was  $2114 \text{ kg/m}^3$ . The mean dry density value fulfilled the conditions for normal-weight concrete, according to EN 206 [65] (the dry density over  $2000 \text{ kg/m}^3$  and below to  $2600 \text{ kg/m}^3$ ). However, the mean dry density of the old concrete specimens are below the  $2160 \text{ kg/m}^3$  limit specified in the ACI 318-19 standard [66] for normal-weight concrete; thus, the investigated old concrete could not be categorized as normal concrete, according to the ACI 318-19 standard [66].

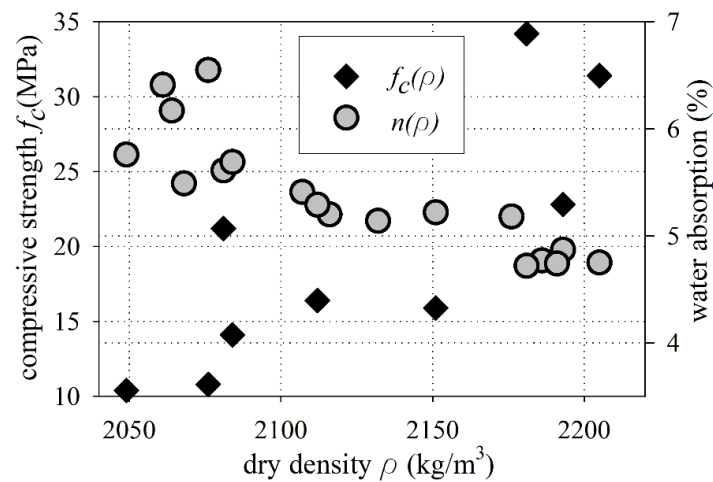
**Figure 5.** Compressive strength and water absorption vs. dry density.

The specified water uptake capacity of the old concrete samples ranged from 4.72 to 6.55% (see Figure 5). The mean value of the water absorption was  $5.39 \pm 0.13\%$ , while the median was equal to 5.26%. The water absorption for structural concrete should not be greater than 9% for concrete protected from atmospheric conditions, and not greater than 5% for concrete exposed to atmospheric conditions [60]. On the other hand, the structural concrete is qualified as poor quality when the water absorption value is greater than 5%, according to the report of the International Federation for Structural Concrete [67].

The uniaxial test results of the compressive strength for old concrete cores vs. the dry density are shown in Figure 5. Figure 5 exhibits the general characteristic, that an increase in the density of old concrete caused a higher compressive strength and lower water absorption of old concrete. The compressive strength of concrete cores varied from 10.4 MPa to 34.2 MPa. The difference in compressive strength results may result from the production technology, which was probably based on hand mixing with handmade proportions of the concrete components. Additionally, a lack of uniform compaction during the placement of old concrete causes differences in dry density and compressive strengths. The mean in-situ compressive strength value was  $19.7 \pm 2.8$  MPa, while the median was equal to 16.4 MPa. The strength results of the concrete cores were comparable to the cube strength (see EN 12504-1 standard [53]), so  $f_{c,cube} = f_{c,cycl 100} = 19.7 \pm 2.8$  MPa. Figure 6 shows that parts of some concrete specimens after uniaxial compressive tests—views of the form of failure with visible organic inclusions and predominance of fine aggregates.

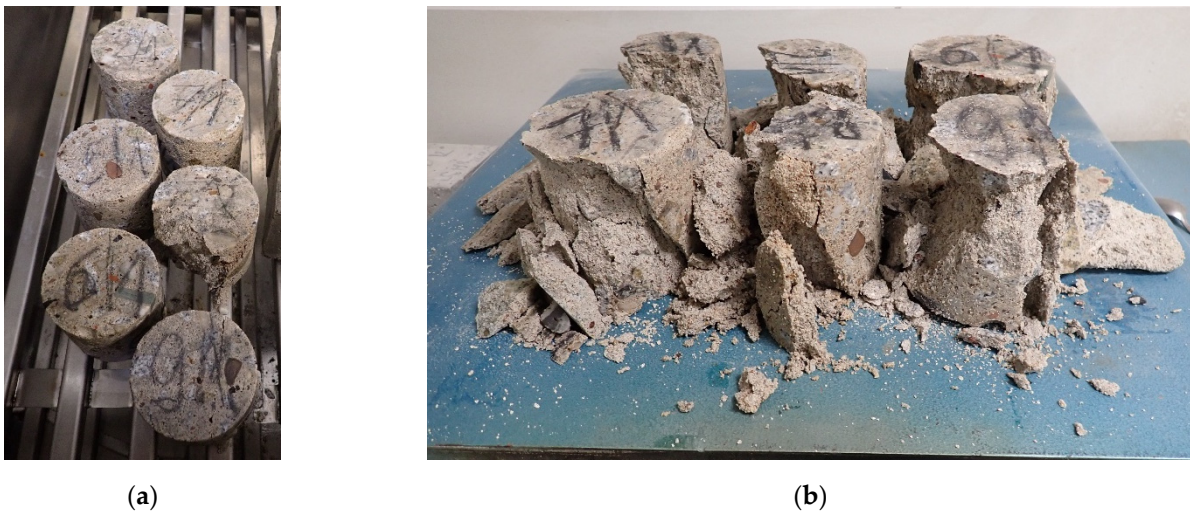
**Figure 7.** Frost resistance tests: (a) view of concrete specimens inside the freezing chamber after tests; (b) view of a form of failure concrete specimens.

Cylindrical samples were subjected to 50 freezer cycles consisting of freezing at  $-18 \pm 2$  °C for 4 h and thawing by total immersion in water at  $18 \pm 2$  °C for 4 h. After 50 freezer cycles (see Figure 7a), the compressive strength tests were performed (see Figure 7b). The compressive strength of the old concrete after 50 freezer cycles varied from 1.7 MPa to 16.1 MPa. The mean value of the compressive strength after 50 freezer cycles was  $10.4 \pm 2.2$  MPa, while the median was 12.1 MPa (see Figure 8). The value of the mean compressive strength after 50 freezer cycles was about 47% lower than the compressive strength of the base samples ( $f_{m, is} = 19.7$  MPa). Additionally, two cores showed cracks and visible loosening parts in the concrete from samples (see Figure 7a). The difference between compressive strength, before and after 50 freezer cycles, was considerably higher than 20%, and cracks appeared on the old concrete cores. Therefore, according to PN-B-06250 [60], the old concrete did not have freezing resistance properties.

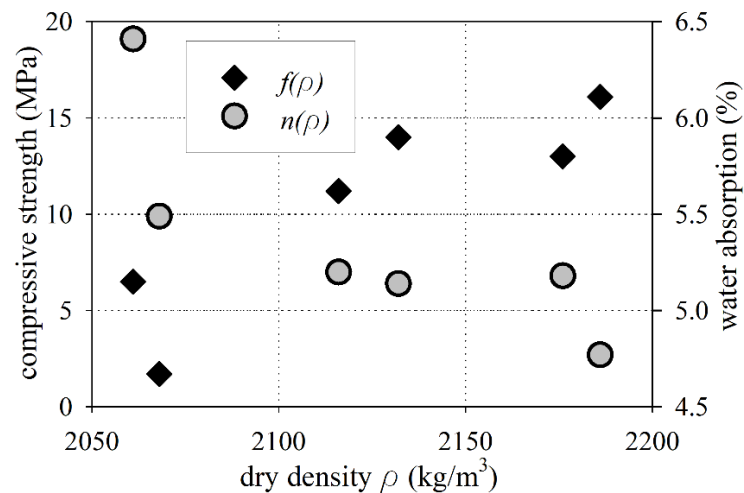
**Figure 8.** Compressive strength after 50 freezer cycles and water absorption vs. dry density.

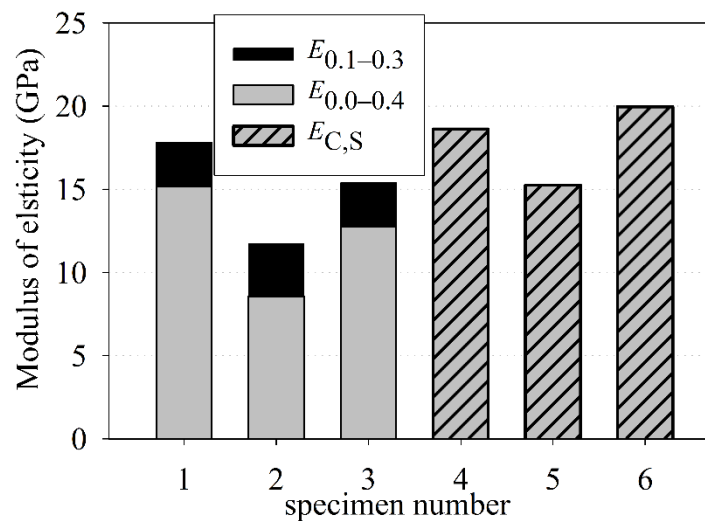
Figure 9. Modulus of elasticity in compression vs. dry density.

The stabilized secant modulus of elasticity,  $E_{CS}$ , specified according to EN 12390-13 [54], ranged from 15.25 to 19.96 GPa (see Figure 9), with a mean value equal to 17.95 GPa. For concrete cores tested according to ASTM C469M [55], the moduli of elasticity was specified as the applicable customary working stress, ranging from 0 to 40% and from 10 to 30%. A difference of about 18% between the mean values of the modulus of elasticity for  $E_{0.0-0.4}$  and  $E_{0.1-0.3}$  was observed. The mean modulus of elasticity for  $E_{0.0-0.4}$  was 12.17 GPa and for  $E_{0.1-0.3}$  was 14.97 GPa.

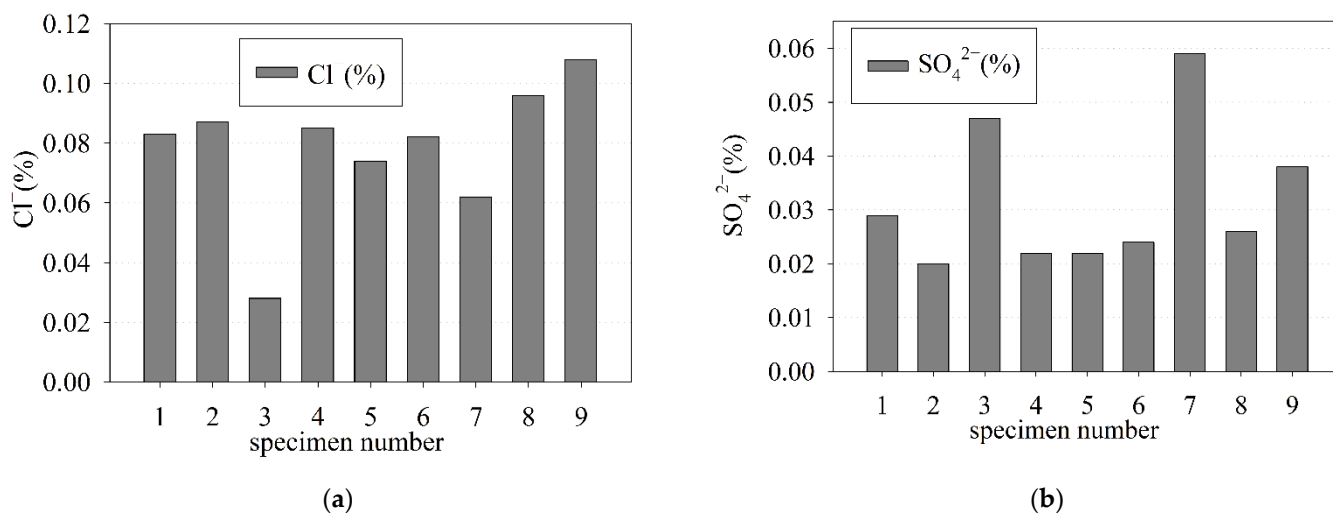
**Figure 11.** Content as the dry weight percentage of water-soluble (a) chloride ions ( $\text{Cl}^-$ ); (b) sulfate ions ( $\text{SO}_4^{2-}$ ).

The content of water-soluble chloride ions ( $\text{Cl}^-$ ) and sulfate ions ( $\text{SO}_4^{2-}$ ) was determined as the percentage of dry weight using the chemical tests. The water-soluble chloride ion values ranged from 0.028 % to 0.108 % (see Figure 11a), with the mean value equal to  $0.078 \pm 0.008\%$  and the median equal to 0.083 %. The sulfate ion values ranged from 0.020 to 0.059% dry weight (see Figure 11b), while the mean value was  $0.032 \pm 0.004\%$  and the median was 0.026% dry weight.

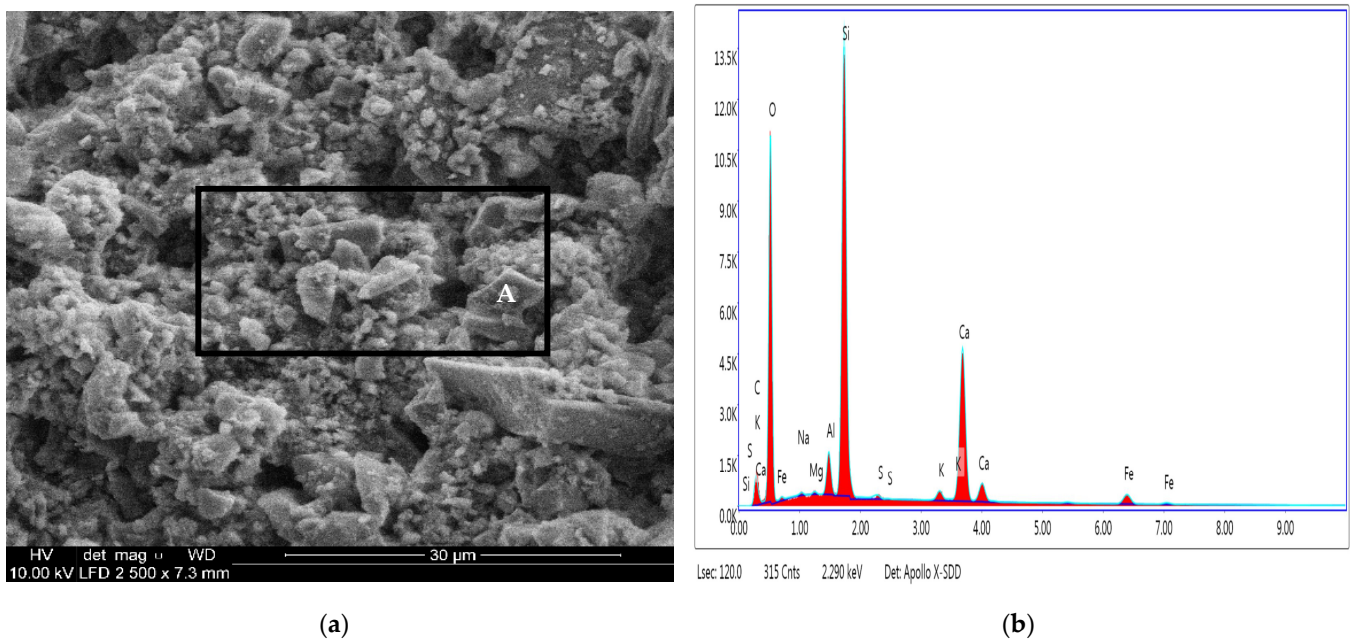
**Figure 12.** SEM/EDS analysis: (a) SEM microscopic images; (b) EDS of the sample on the selected area (A).

The scanning electron microscopy (SEM) image of the chosen sample taken from the old concrete structure is shown in Figure 12a. The results of the analysis of the chemical composition of the sample (in the selected area marked in Figure 12a) based on the presented spectrum (see Figure 12b) determined by the EDAX method are collected in Table 2.

The presented image SEM (see Figure 12a) of the chosen test sample shows that the old concrete element was a layer structure formed from the products of the cement hydration process. The shape and size of the crystalline phases are the result of the formation of chemical compounds in the structure of the tested concrete. According to the data presented in Table 2, the content of elements in the tested sample, taken from the structural old concrete element, is as follows: silica (43.9%), calcium (41.2%), iron (8.3%), aluminium (3.9%), and potassium (1.9%) by weight, respectively. The remaining amount of the identified elements in the structure of the tested sample was below 1% of the mass of the concrete sample.

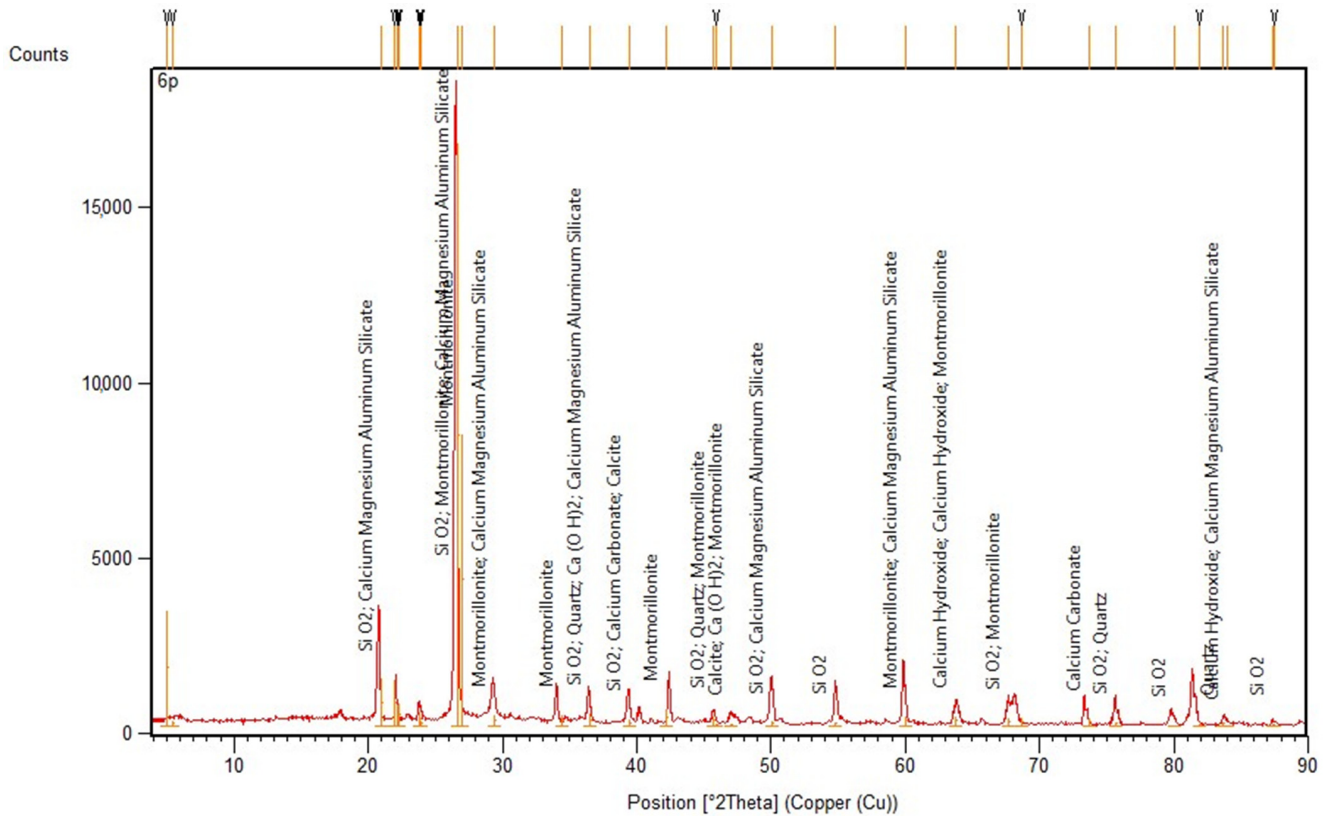
Figure 13. XRD pattern of the old concrete sample.

The XRD method was applied for the identification of the phase composition of the old concrete. The results of the mineralogical composition (in the form of a diffraction pattern) based on a chosen old concrete sample are presented in Figure 13.

The analysis of the evolution of concrete over the years, its phase composition, and its microstructure is critical to determine its durability. The obtained test results (see Figure 13) indicate that the following compounds were mainly dominant in the concrete structure after 120 to 140 years:  $(\text{Na,Ca})_{0,3}(\text{Al,Mg})_2(\text{Si}_4\text{O}_{10})(\text{OH})_2\text{xnH}_2\text{O}$ —montmorillonite, calcium–magnesium–aluminium–silicate hydrate (C–M–A–S–H),  $\text{CaCO}_3$  (calcite) as the carbonate phase,  $\text{Ca}(\text{OH})_2$ —portlandite, and  $\text{SiO}_2$ —quartz. The registered chemical compounds are products of the reacted clinker phases included in the cement used for concrete, including many years of exposure to atmospheric conditions and water.
