Properties of Old Concrete Built in the Former Leipziger Palace

Abstract: This research aims to determine the mechanical, chemical, and physical properties of old concrete used in the former Leipziger Palace in Wrocław, Poland. The cylindrical specimens were taken from the basement concrete walls using a concrete core borehole diamond drill machine. The determination of the durability and strength of old concrete was based on specified chosen properties of the old concrete obtained through the following set of tests: measurements of dry density, tests of water absorption, specification of concrete compressive strength and frost resistance, determination of the modulus of elasticity, measurement of the pH value, determination of water-soluble chloride salts and sulphate ions, and X-ray diffraction analyses. Large dispersions of the compressive strength (10.4 MPa to 34.2 MPa), density (2049 kg/m³ to 2205 kg/m³), water absorption (4.72% to 6.55%), and stabilized secant modulus of elasticity (15.25 GPa to 19.96 GPa) were observed. The paper is intended to provide scientists, civil engineers, and designers with guidelines for examining and assessing the long-term durability of old conc

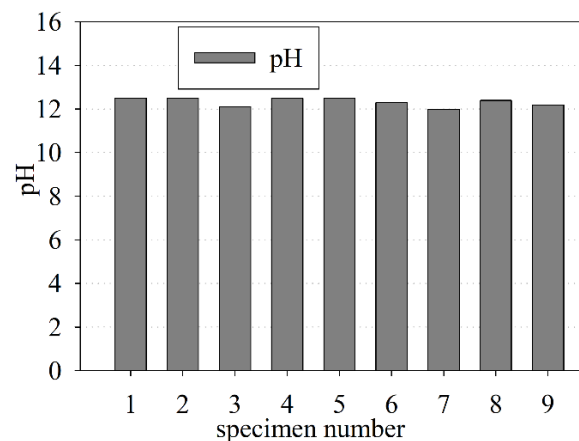
Figure 10. The pH value of the old concrete.

The pH value is an important factor that influences the corrosion rate of reinforcement [75,76]. Freshly made concrete has a pH value that varies from 12.5 to 13.5 [77], while the corrosion of reinforcement generally occurs when the pH value is less than 9 [78]. Under the laboratory tests for the old concrete samples, it was determined that the mean value of the pH was 12.33 ± 0.06 , while the median was 12.40. The pH values for the old concrete ranged from 12.00 to 12.50 (see Figure 10). The pH of the old concrete was in the safety range. One of the concrete cores (which was not subjected to strength tests) included a flat bar-shaped reinforcement, which was in a very good condition, which confirms the results obtained for the safe pH value.
