# 3D X-ray Micro-CT Analysis of Rebar Corrosion in Reinforced Concrete Subjected to a Chloride-Induced Environment

**Abstract:** The paper presents experimental investigations of the concrete covers' protective ability to counteract rebar corrosion in reinforced concrete cubes. The concrete sample was subjected to a chloride-induced environment to get corroded and combined with an un-corroded sample. The chloride-accelerated technique can induce a high degree of corrosion within a controlled time. Moreover, detailed and thorough experimental measurements and analyses of reinforcement loss due to corrosion and its influence on concrete microstructure, were studied through 3D X-ray micro-computed tomography. The rebar outside the concrete was heavily corroded due to the chloride-accelerated test, whereas, only local surface corrosion products appeared inside the concrete. It turned out that the concrete cover showed protective ability to counteract the reinforcing-steel corrosion mechanism despite the accelerated corrosion environment. Moreover, the bond strength between the reinforcement rebar and concrete was not visibly affected since the failure force in the pull-out test and fa

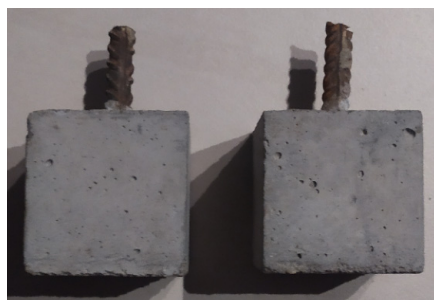
Finally, two cubic concrete samples with dimensions of  $70 \times 70 \times 70$  mm reinforced with a centrally located steel bar with a diameter of 12 mm were prepared; thus, the concrete cover was equal to 29 mm (Figure 1). The reinforcement ratio value was  $\rho = 2.1\%$ . The tensile strength of the steel was  $f_{ys} = 650$  MPa, and the modulus of elasticity of steel was  $E_s = 200$  GPa. For the first seven days, blocks were stored in a climatic chamber at a temperature of about 20°C and humidity 95% to avoid surface evaporation and autogenous shrinkage. Relatively small dimensions for the reinforced concrete specimens were used to enable the entire sample to be scanned in the micro-CT system.

**Figure 1.** Reinforced concrete cubes for experimental procedure.
