Stress-strain model of lower corroded steel plates of normal strength for fitness-for-purpose analyses

Abstract

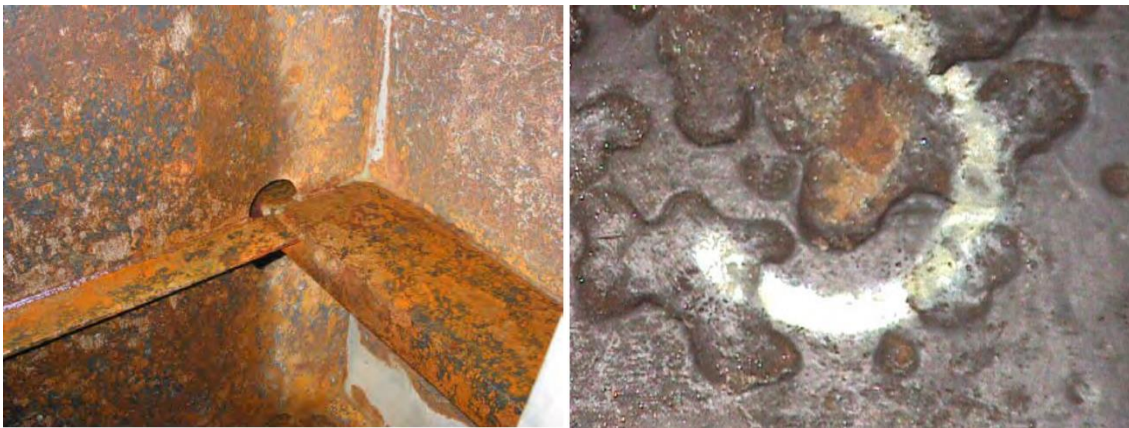
41 Figure 1. The comparison between general (left) and pitting corrosion (right) [6].

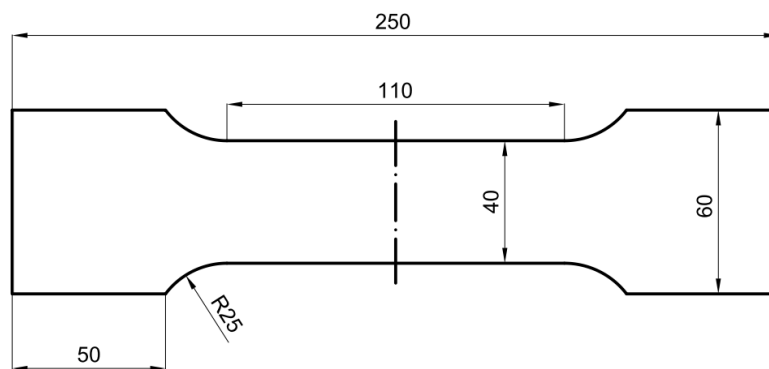
131 Figure 2. Dimensions of standard coupon specimens [mm].

121 [35]) from each thickness of standard size (see Figure 2) were taken from different places of steel
 122 sheets (1.25 m x 2.5 m) and analysed. In each thickness, six or seven specimens were used to obtain
 123 the mechanical properties in an intact state, whereas ten samples were subjected to the accelerated
 124 marine immersed corrosion degradation. In case of intact plates, a such number of specimens provided
 125 a minimum reliable database regarding the mean values of mechanical properties and their scatter. In
 126 case of corroded specimens, such number leads to an examination of changes in mechanical properties
 127 with the corrosion development with the low difference between subsequent degradation levels.

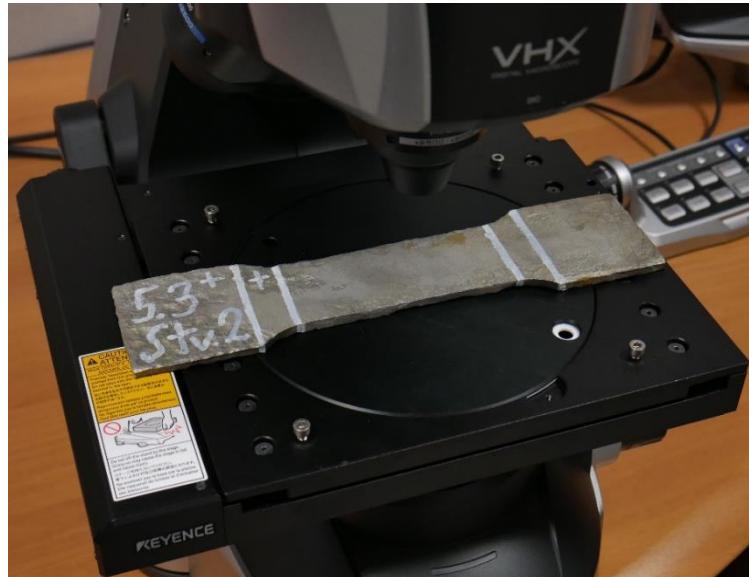
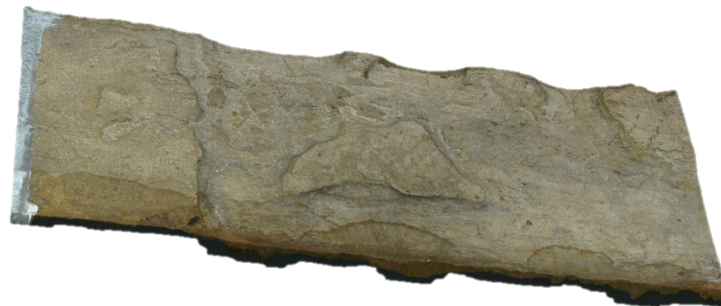
171 Figure 4. Example of the specimen during scanning (top) and example of reproduced surface
172 (bottom).

162 observed (see Figure 4, bottom).

165 measurements, the specimens were cleaned. The scanning provided information about the surface
166 non-uniformities (only one surface could be scanned at a time), whereas degradation level was
167 obtained based on mass measurements. The example of the corroded specimen after cleaning, during
168 scanning, is presented in Figure 4.

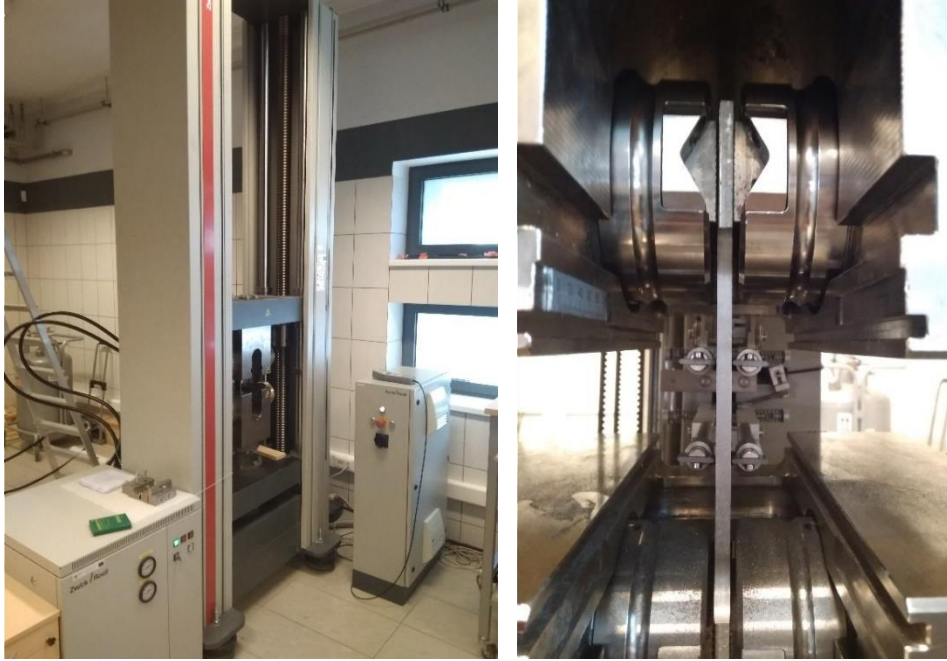
200 Figure 5. Testing machine (left) and mounted specimen with installed extensometer (right).

193 The standard Zwick-Roell Z400 machine with a step electric engine was used to conduct the tensile
 194 test and estimate the elasticity modulus, where a mechanical extensometer was adopted (see Figure
 195 5). The tests were performed following the ISO standard for tensile testing [35] of flat coupons, and
 196 the loading was displacement-driven. The strain rate was 0.00025 mm/mm/s up to the moment, where
 197 the yield point has been reached. Above the yield point, the strain rate was 0.002 mm/mm/s. The
 198 distance between heads was 170 mm.

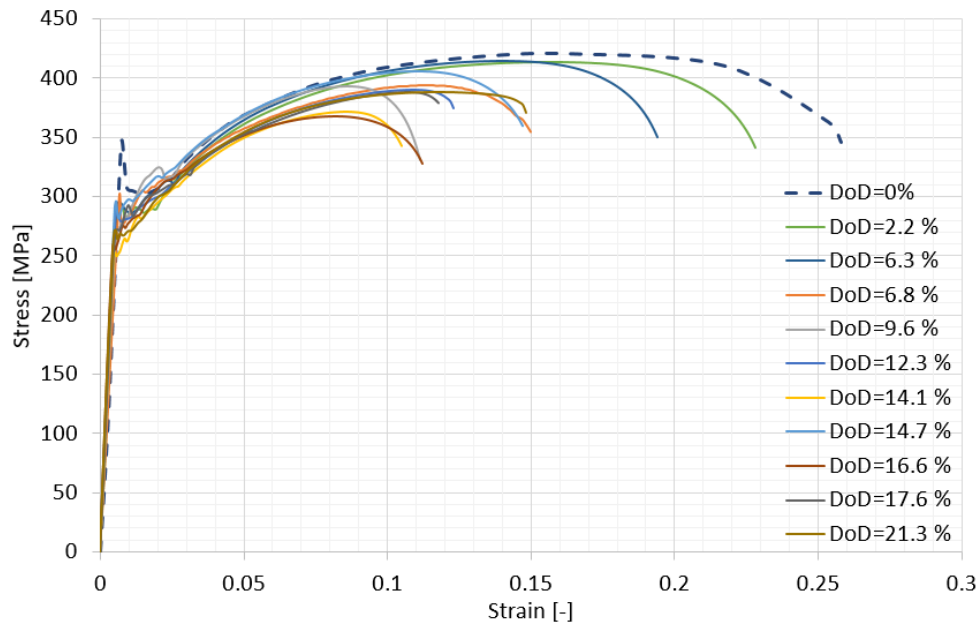
Figure 8. Stress-strain relationships for 6 mm specimens subjected to corrosion degradation

237 Similar observations could be captured for other groups of thicknesses. The stress-strain relationships
238 for 6 mm specimens are presented in Figure 8, whereas for the 8 mm specimens are shown in Figure
239 9. The most evident differences in changes in the yield stress could be noticed in Figure 9 for the 8 mm
240 specimens. In the 6 mm specimens, those changes are smaller (see also Table 4). Nevertheless, a lack
241 of the yield plateau for severely corroded specimens and a significant drop of total elongation is purely
242 visible in both cases.

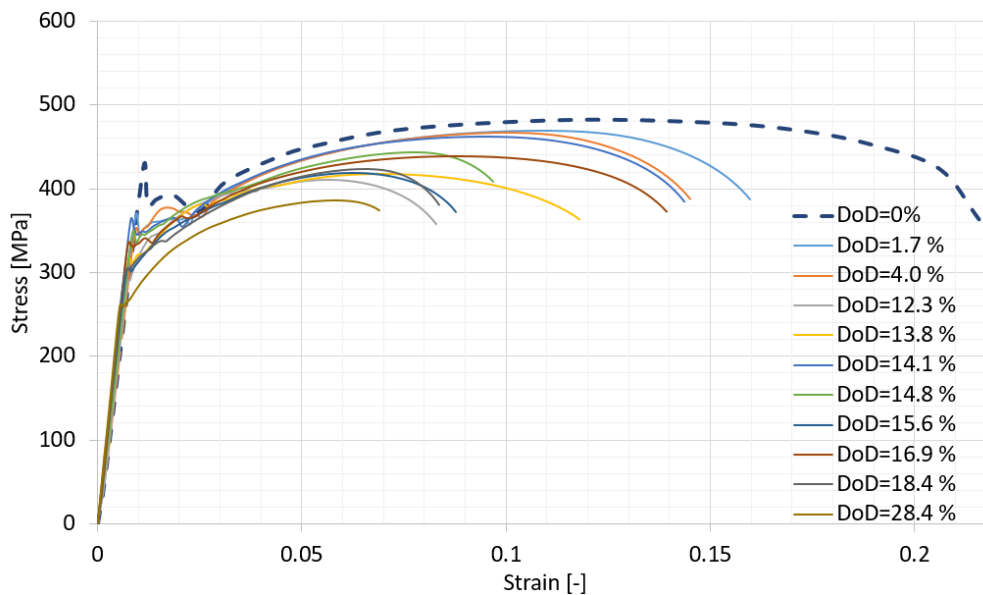
Figure 9. Stress-strain relationships for 8 mm specimens subjected to corrosion degradation

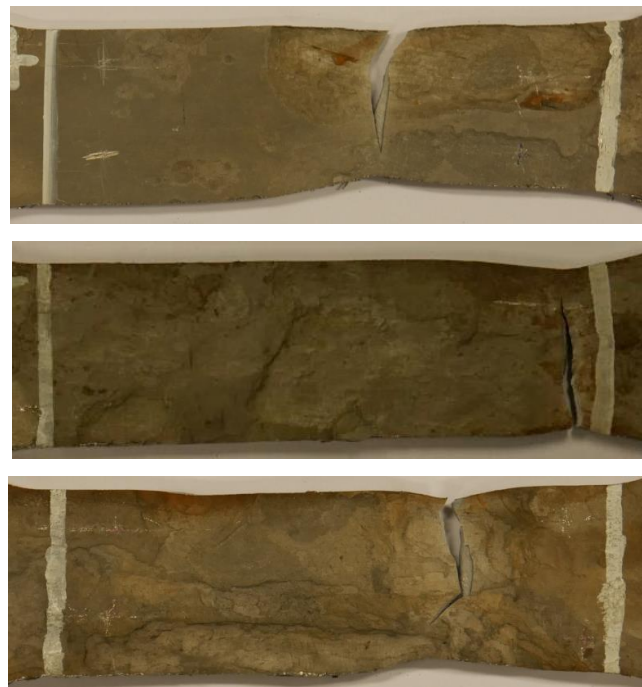
328 Figure 13 shows examples of failure modes of tested specimens. It could be noticed that the failure
329 mode is different in comparison to typically observed for intact specimens. In most cases, the cross-
330 section, where the breaking line is followed, is related to the position, where the minimum cross-
331 sectional area along the gauging part is located [29]. Further, the breaking line is non-straight and
332 inclined in most cases, which is not the case of intact specimens, where a straight line is usually noted
333 perpendicular to the loading direction.
