Article

Influence of a Lighting Column in the Working Width of a W-Beam Barrier on TB51 Crash Test

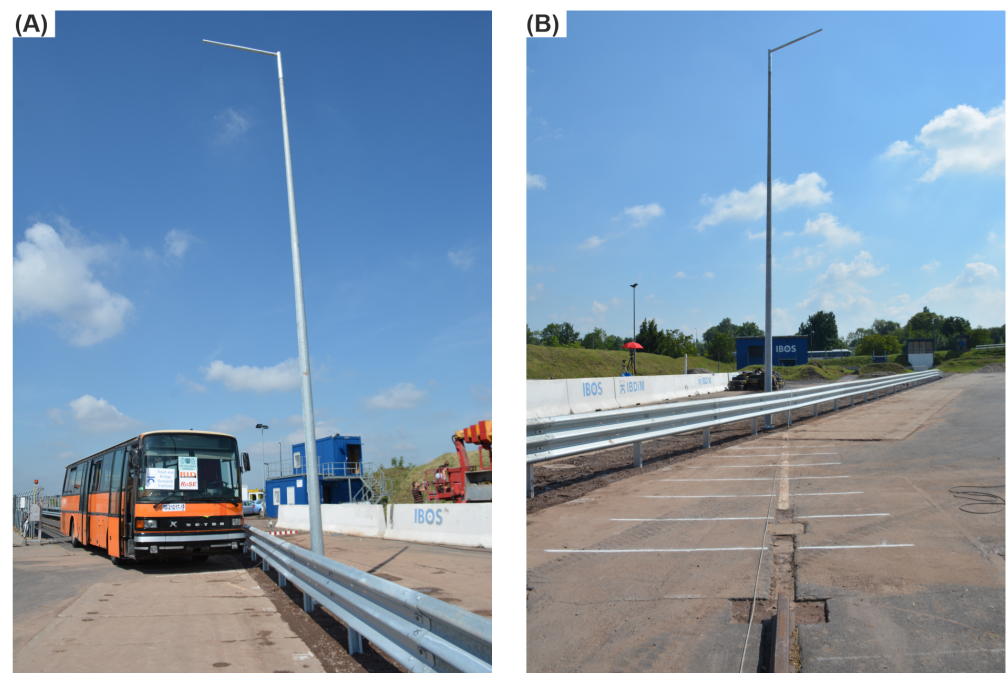
Figure 4. Test site before the collision, with (A) a view of the run-up track with the bus and the impact point and (B) a view of the impact point from the point of view of the run-up track.

The analyzed crash test also considered the lighting column in the working width of the barrier. This column was the 100HE3 class according to the EN 12767 standard [32]. Without a foundation, the column was 10 m long and weighted 87 kg. It was mounted 1.75 m behind the 12th post of the barrier (see Figure 4), and its axis was distanced at 0.60 m from the face of the system. The foundation was made of a 150 × 30 × 30 cm reinforced concrete cube, weighing approximately 225 kg.

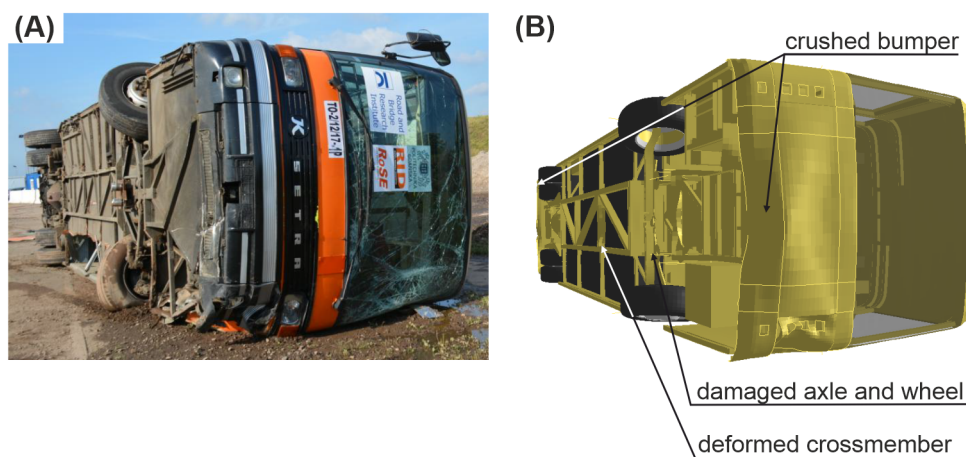
Figure 15. View of the damaged vehicle. (A) Experiment; (B) simulation.

In the experiment, the rear window of the vehicle was broken, the front windshield was severely cracked, and the front bumper was crushed. Moreover, the left-front wheel of the vehicle was broken. The left side of the vehicle was damaged due to the contact with the guardrail. In the simulation, the left side of the vehicle was also damaged. Additionally, the front and rear bumpers were crushed due to the impact. Moreover, the cross-member of the chassis frame was damaged and the front axle was bent near the left-front wheel.

A comparison of vehicle's damage between the full-scale crash test and simulation is presented in Figure 15.
