# Combination of terrestrial laser scanning and UAV photogrammetry for 3D modelling and degradation assessment of heritage building based on a lighting analysis: case study—St. Adalbert Church in Gdansk, Poland

The construction of the St. Adalbert Church in Gdansk dates to 1310. It is a church of rich history and great historical value, and its care is challenging. In this study, the combination of unmanned aerial vehicle (UAV) photogrammetry and terrestrial laser scanning (TLS) was used to accurately build a 3D model of the church. Together with the collected historical inventory documentation, the historic building information model (HBIM) was generated. The Autodesk-Revit<sup>®</sup> tool was used for this purpose. On the basis of the generated model, the reflection properties of the laser scanner beam and red–green–blue (RGB) images, a methodology was proposed for analysing the degradation of the church's components. The main hypothesis of this study is based on the analysis of sunlight outside the church. In addition to the importance of the method for determining the risks of church degradation, a high-quality method for model visualization combining two photogrammetric tech

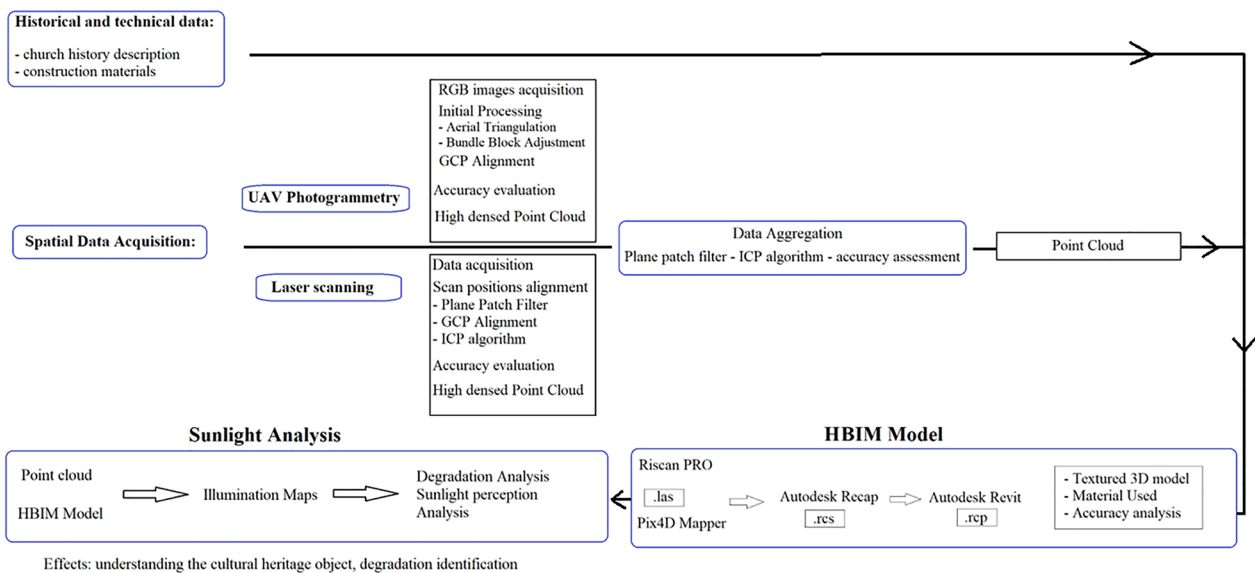
**Fig. 2** The research workflow

- (1) Acquiring all details of the historical information of the church.
- (2) Acquiring spectral and geometric information from a laser scanner and UAV photogrammetry.
- (3) Building an individual HBIM of the church based on the obtained data.
- (4) Proposing a sunlight analysis in terms of possible degradation and light perception by humans.

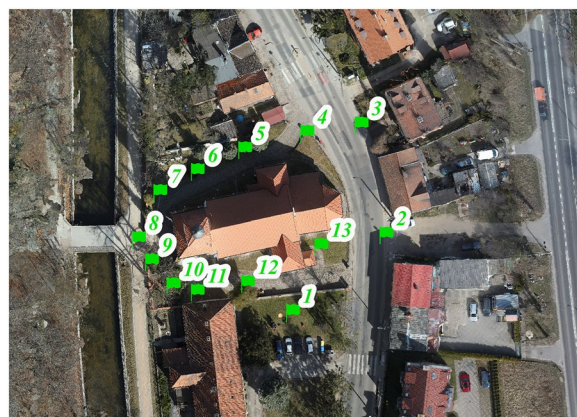
**Fig. 4** Scan positions location

In order to present the possibilities of using the laser scanner more broadly, we have presented the location of the scanner positions during the measurements in Fig. 4. According to the Fig. 4, scan positions around the church are numbered from 1 to 13. Additional scan positions from 14 to 20 were located inside the church. Denser distribution of scanner positions around the tower was

because the scanner was located in close proximity to the church. This was for two reasons: first, to combine the scans recorded outside and inside the church, we needed to have as many common elements as possible to minimize an alignment error. Second, we used the beam reflection intensity for our analyses. Due to the fact that its value also depends on the angle, the type of material, its colour and humidity, we didn't want the angle of a laser beam to be perpendicular to the church (which has the effect of too high intensity value saturation) or too large (where the laser beam won't be able to return to the scanner).
