Interdisciplinary research as a form of monument protection and preparation for the investment process on the example of the former Gdańsk Shipyard complex

Architectural and conservation research of the U-Boat Hall (89 A)

Conservatory material and colour template for the former Gdańsk Shipyard area

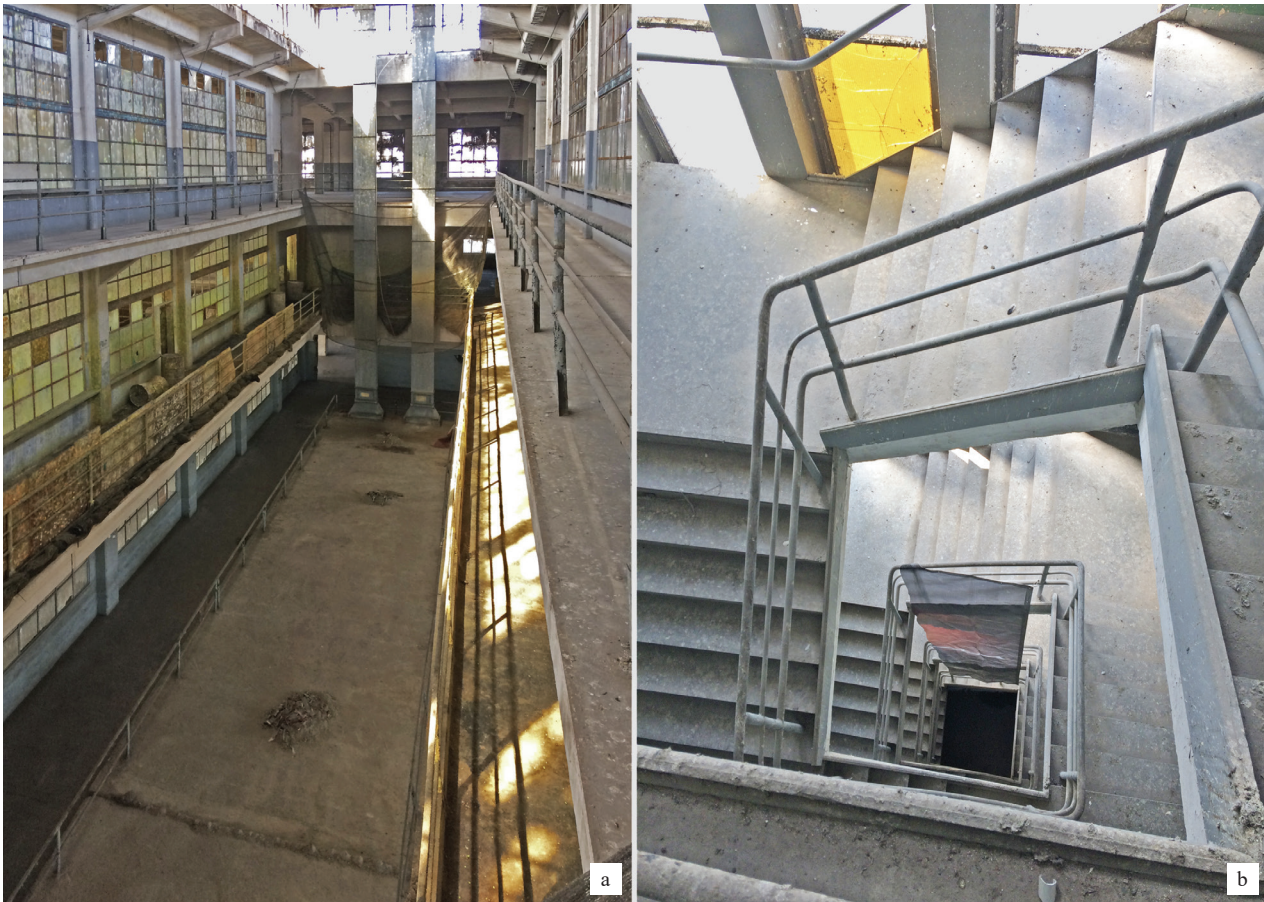
Fig. 6. Interiors of the Main Warehouse (89A), so-called the U-Boat Hall, 2019 (before the start of conservation works):
 a) repetitive floor of the building (6th floor) – top view of one of the atriums,
 b) the staircase – stairs in all three staircases – double L-shaped stairs, monolithic, reinforced concrete structure
 (photo by A. Orchowska-Smolińska)

Il. 6. Wnętrza Magazynu Głównego (89A), tzw. Hali U-Bootów, stan na 2019 r. (przed rozpoczęciem prac konserwatorskich):
 a) piętro powtarzalne (magazynowe) budynku 89A (VI piętro) – widok od góry na jedno z atriumów,

b) klatka – schody we wszystkich trzech klatkach schodowych – łamane, czterobiegowe, żelbetowe, monolityczne (fot. A. Orchowska-Smolińska)

buildings, these analyzes are performed using methods that would apply to historically more complex buildings (Fig. 6). The reason is the assumption made for the entire complex that the primary phase is not overriding, and the adaptations, repairs, and maintenance are to be carried out with respect to all layers by 1989 or even 1996¹¹. As a result of this assumption, not only a detailed analysis of bricks, joints, plasters, and artificial stone used for the façade decoration was carried out, but also such elements as metal gates, glazing of industrial window joinery, primary and subsequent colours of individual elements.
