Experimental ultimate strength assessment of stiffened plates subjected to marine immersed corrosion

Krzysztof Woloszyk^a, Yordan Garbatov^{b,*}, Jakub Kowalski^a

<https://doi.org/10.1016/j.apor.2023.103679>

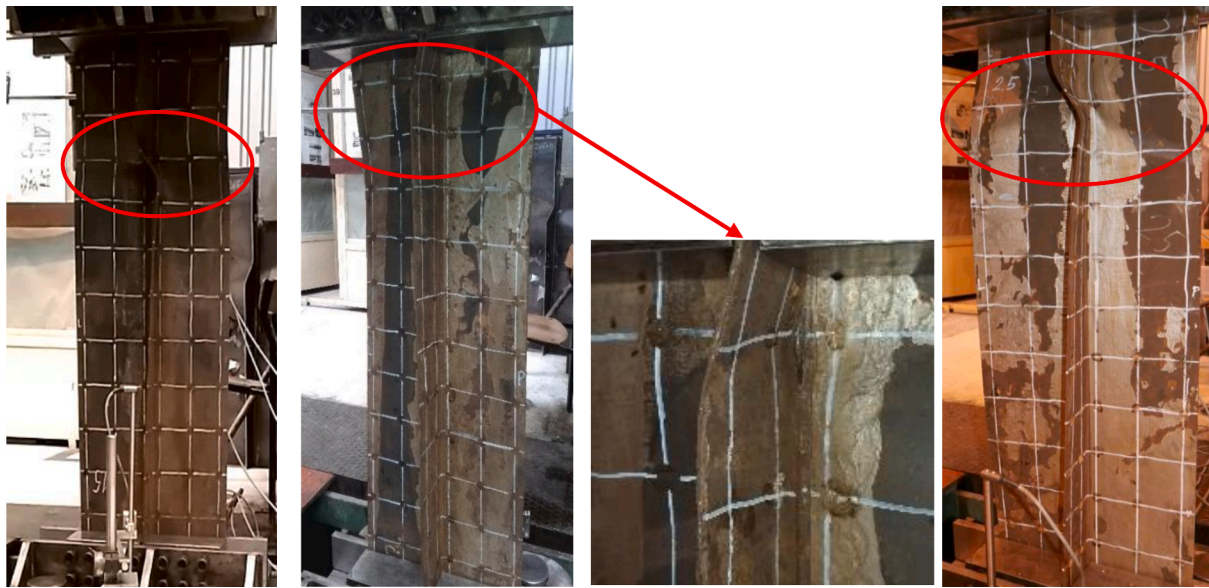
Fig. 9. Post-collapse shapes for 5 mm specimens with degradation level of 7% (left), 14% (mid) and 21% (right).

The post-collapse shapes for 5 mm specimens are presented in Fig. 9. In specimens with *DoD* of 7 and 21%, the collapse has been caused by the local plate buckling followed by stiffener tripping, like the intact specimens. Primarily, the plate buckled locally, which initiated the collapse of the stiffened plate. However, due to the loss of in-plane stiffness, the stiffener also started to buckle in a very localized mode. The cross-section of the highest plastic deformations was away from the mid-length of the specimen due to the uneven distribution of the corroded thickness of the plate and the stiffener for each degradation level. In the

case of 5 mm specimens, the regions of high corrosion diminutions were closer to the upper support, which caused a similar position of a critical cross-section. Further, in the specimen with a *DoD* of 14%, the region of high plastic deformations was not that localised and has been more extended along with the specimen, which indicates that the local plate buckling occurred together with the lateral-torsional buckling of the stiffener.

The stiffened plate region, where the highest plastic deformations occurred, was somewhat away from the middle due to uneven thickness distribution (the regions are marked in red envelopes in Figs. 9–11). In many cases, it was very close to the support. In the case of electrochemically corroded plates (Garbatov et al., 2017), these regions were much closer to the middle cross-section in most cases, even for much higher degradation levels. This was caused by a more uniform thickness distribution (although non-uniform) compared to the present research.

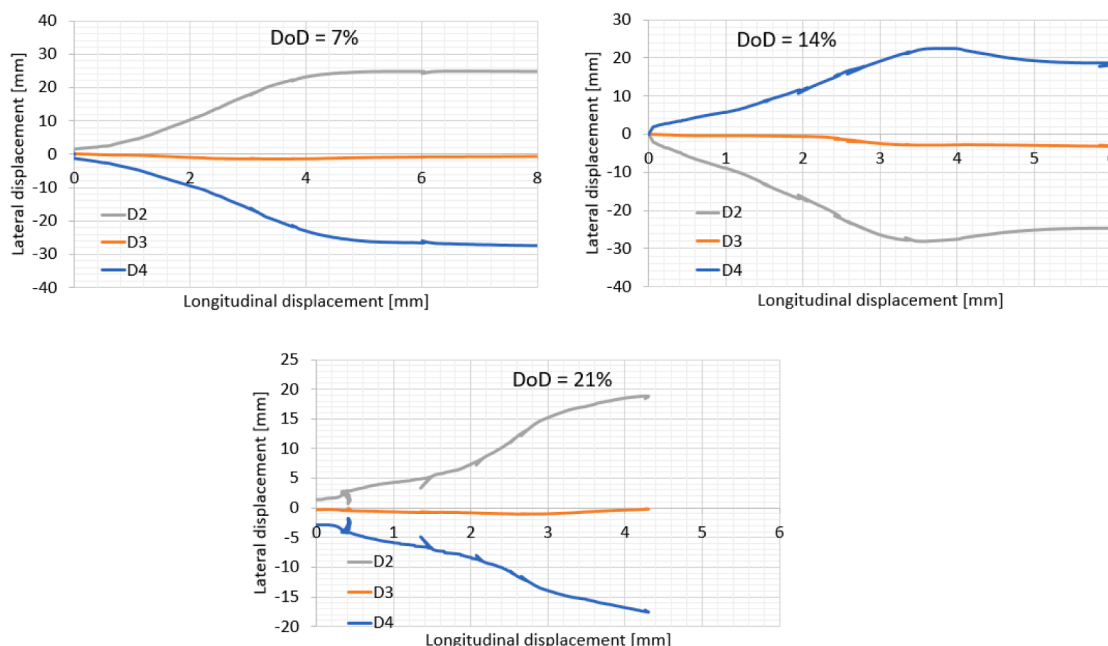
Fig. 13. Lateral displacements in corroded specimens of 5 mm: 7% of DoD (left, top), 14% of DoD (right, top) and 21% of DoD (bottom).

Fig. 13 shows the displacements measured for the 5 mm specimen. It is noted that the plate on both sides of the stiffener buckled locally from

the beginning of the loading (the displacements in D2 and D4 are increasing in opposite directions) due to existing initial imperfections (see Table 2). Simultaneously, the stiffener was almost plane until the ultimate strength was reached (displacement D3 was minimal). After getting to the point of maximum compressive force, the displacements on both sides of the plate were relatively constant or even decreased. In the case of the stiffener, for specimens with a 7% and 21% of degradation level, the lateral displacement decreases. However, for a specimen with a 14% level of degradation, due to the existence of lateral-torsional buckling of the stiffener, the mid-lateral displacement increases slightly. The displacements for the most severely corroded plate were not captured in a full range of longitudinal displacement due to the failure of the measuring device.
