Effectiveness of various types of coating materials applied in reinforced concrete exposed to freeze–thaw cycles and chlorides

This study assesses the durability of coated and uncoated concrete surfaces protected with four different coating materials: water-soluble (BW), solvent-based (BR), mineral (MI), and epoxy (EP). The durability assessment includes evaluating the absorption rate of water, pull-off adhesion strength, and coating material thickness. Concrete samples were subjected to immersion in regular water and a 7% urea solution, followed by cyclic freezing and thawing. Furthermore, the diffusion of chloride ions in concrete was evaluated using the impressed voltage method, with the samples exposed to the aging process immersed in a 3.5% NaCl solution. The results indicate that EP and BW coatings were significantly affected by the presence of urea and freeze–thaw cycles, resulting in a 43% and 47% reduction in pull-off adhesion strength, respectively. Notably, the MI-coated concrete samples exposed to urea solution and the freeze–thaw cycles exhibited a significant reduction in the absorption rate due to the accumulation of crystals on the coating surface, resulting in red

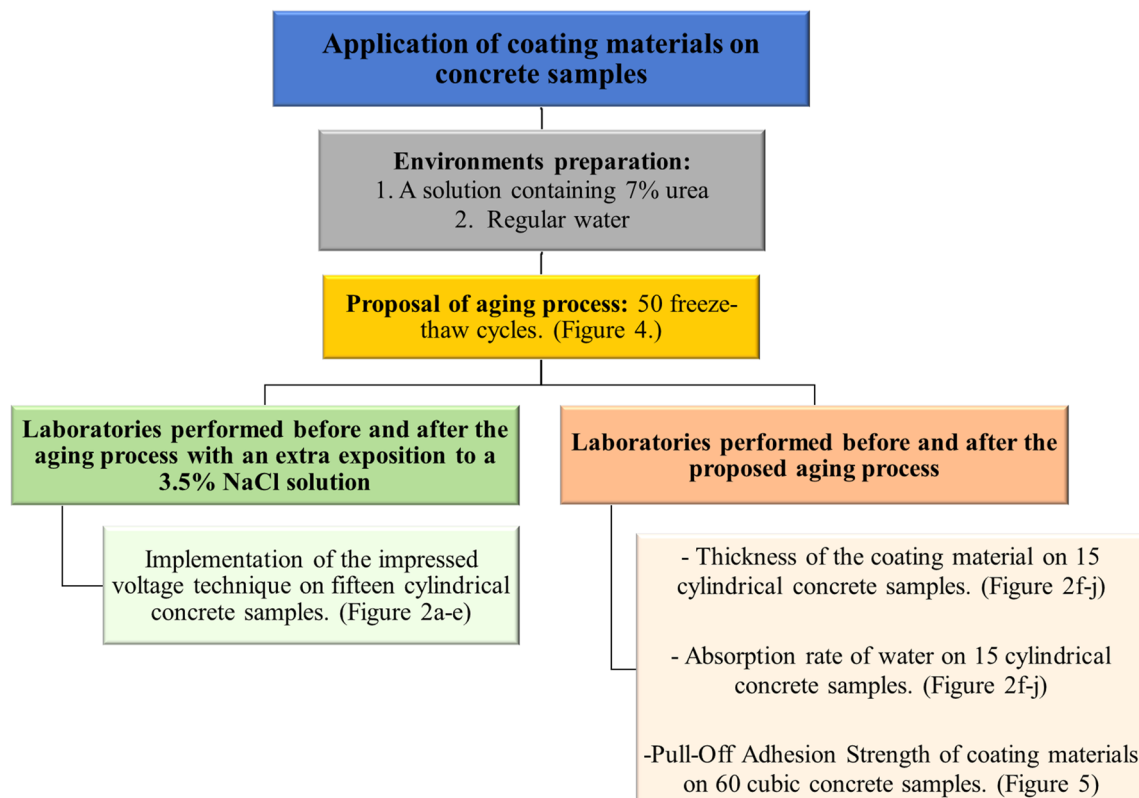
Figure 1. Research methodology.

Experimental procedure. This research study aims to evaluate the effectiveness of different coating materials applied to concrete surfaces exposed to various contaminants. The study will combine quantitative evidence of changes in adhesion strength, absorption, and coating thickness. The findings will contribute to the growing research area on concrete protection in contaminated environments. Figure 1 shows the research methodology used during this study.

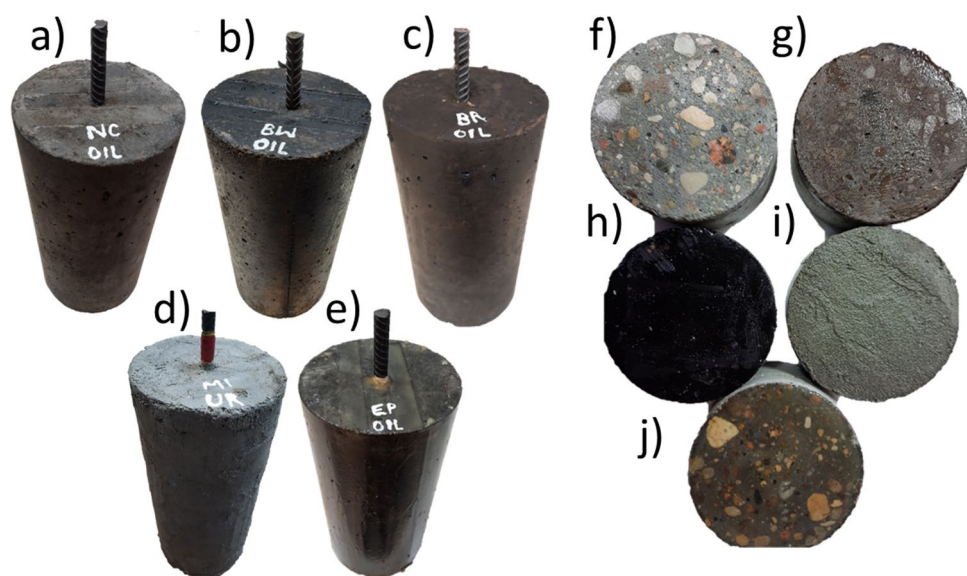
Figure 2. Reinforced concrete samples for the impressed voltage technique: (a) EP, (b) MI, (c) BW, (d) NC, (e) BR. Concrete samples for water absorption rate: (f) NC, (g) BR, (h) BW, (i) MI, (j) EP.

In this study three types of concrete samples were utilized. Pull-off adhesion strength tests were performed on cube-shaped specimens measuring 100×100 mm. Cylinders with reinforced concrete measuring 150×300 mm were used for the impressed voltage technique. Additionally, cylinders measuring 100×50 mm were employed to assess water absorption rates. Detailed illustrations of these concrete specimens can be found in Figs. 2 and 5.

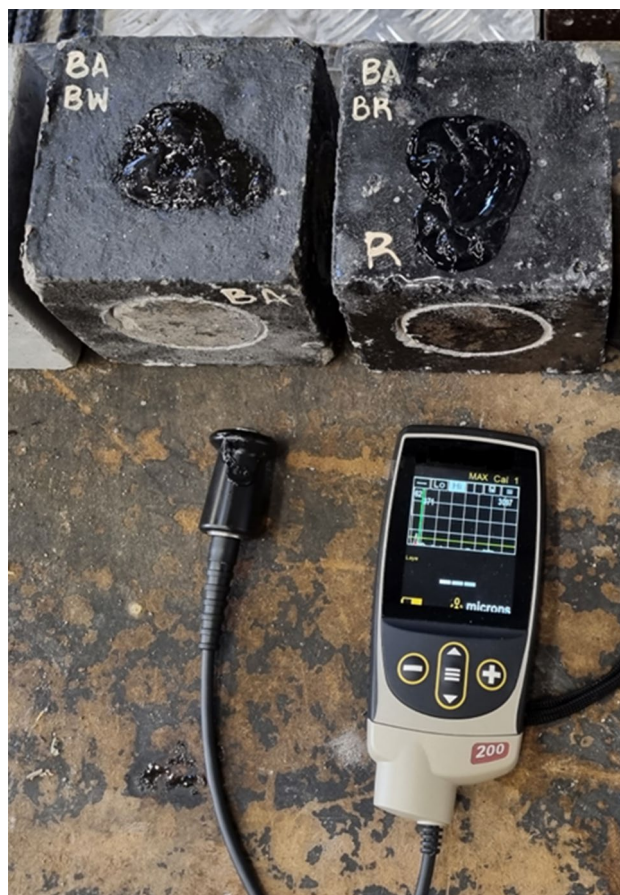
Figure 3. Measurement of coating material thickness.

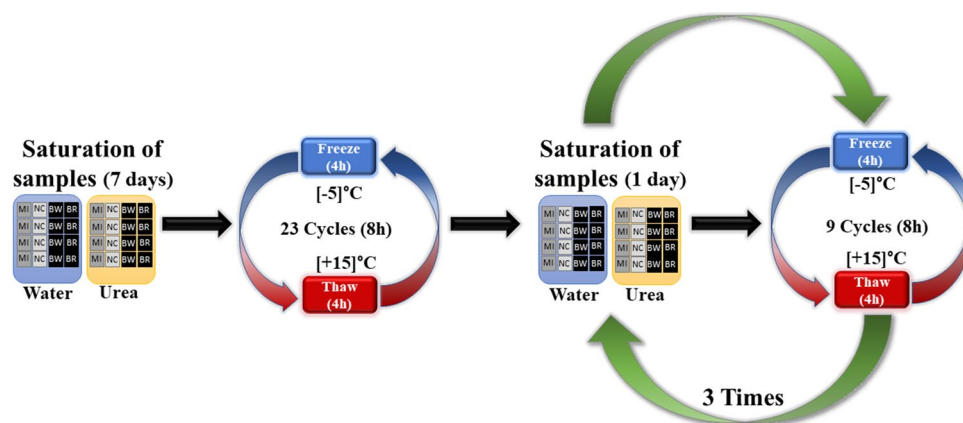
Figure 4. Aging process description. Freeze–thaw cycles and saturation of concrete samples.

Aging process. An accelerated aging test was conducted using a Tropol K-012 frost resistance test chamber, which is commonly employed for assessing the frost resistance of building materials. The specimens were subjected to cyclical freezing in air and thawing in water, while an electronic programmer monitored the cycles.

To simulate freeze–thaw conditions in the laboratory, the test was performed at temperatures ranging between $[-5]$ and $[+15]$ °C. Two solutions were employed to simulate contaminated environments: regular water and urea solution with a concentration of 7%. The aging process, as depicted in Fig. 4, was applied to the samples. Furthermore, each specimen was coated with one of the four materials assessed in this research: BW, BR, MI, and EP. Additionally, a control sample without protection (NC) was included for comparison with the protected samples. After 50 freeze–thaw cycles and a 10-day saturation period, the absorption rate, pull-off adhesion strength, and chloride permeability of each sample were measured.

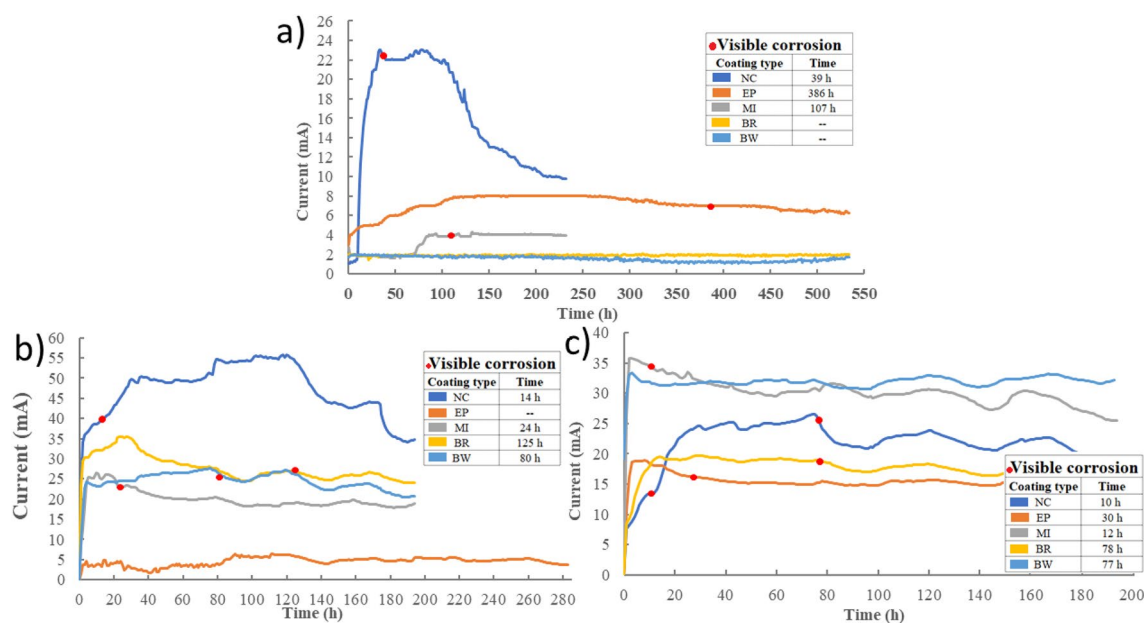
Figure 11. Current intensity curve, (a) before the aging process, (b) after the aging process and saturation in water, (c) after the aging process and saturation in urea, 7%.

Impressed voltage technique. The current intensity curves for samples before and after freeze–thaw cycles, saturated with regular water and urea, are presented in Fig. 11. Prior to the aging process, the maximum current for samples without coating protection was 23 mA, which was 58.18% lower than the samples saturated with regular water (55 mA). This increase indicates that the resistivity of the concrete surface has been compromised after the aging process, allowing for increased penetration of chloride ions into the concrete matrix. On the other hand, samples without coating protection and saturated with urea exhibited a current intensity 52.36% lower than samples saturated with water. This can be attributed to the presence of urea residues on the surface, which partially permeabilize the material and reduce the passage of chloride ions. Ramakrishnan1 et al.⁴².

MI, BR, and BW were the most affected materials by the freeze–thaw cycles. Before the aging process, these samples registered current values of 4.28, 2.08, and 1.98 mA, respectively. These values increased to 26.41, 35.54, and 27.73 mA for samples saturated in regular water and 35.78, 19.72, and 33.37 mA for samples saturated in urea

solution. In the case of samples protected with EP coatings, the highest current value of 18.93 mA was obtained in the samples exposed to urea, showing an increase of 235.10% before freeze–thaw cycles and 297.57% for samples saturated in water. These results align with previous findings by Aguirre et al.⁴⁶, where the highest current value for samples with epoxy coating was reported as 8 mA. Furthermore, it can be observed that, for all samples, the use of coating materials extended the appearance of corrosion products, thus protecting the concrete matrix in a chloride ion environment.

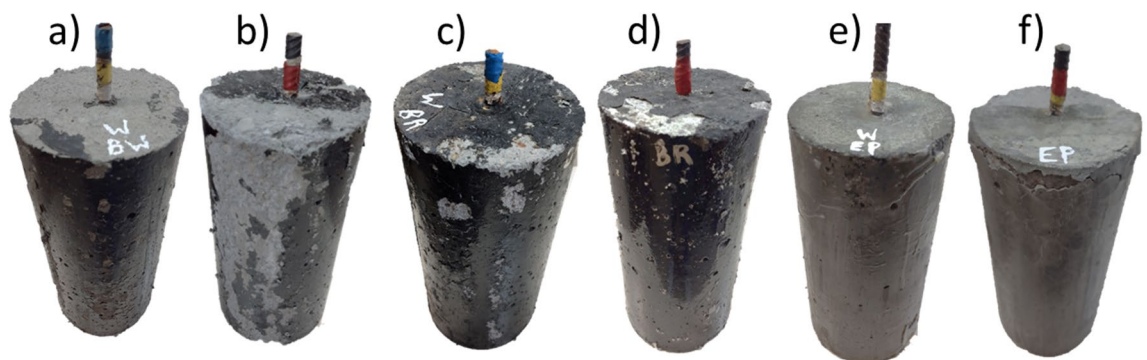
Figure 12. Concrete samples after the aging process. (a) BW water saturation, (b) BW urea saturation, (c) BR water saturation, (d) BR urea saturation, (e) EP urea saturation, (f) EP water saturation.

Figure 12 presents EP, BR, and BW concrete samples after the aging process, revealing visible physical damage in the coating materials. It is important to note that MI coating remained intact and undamaged throughout the aging process, regardless of exposure to water and urea. Similarly, EP samples exposed to water did not present any physical damage, effectively hindering the diffusion of chlorides into the concrete. However, EP samples exposed to urea, as well as BR, and BW samples exposed to water and urea, showed signs of physical damage. Among them, BW samples saturated with urea were the most adversely affected after the aging process.

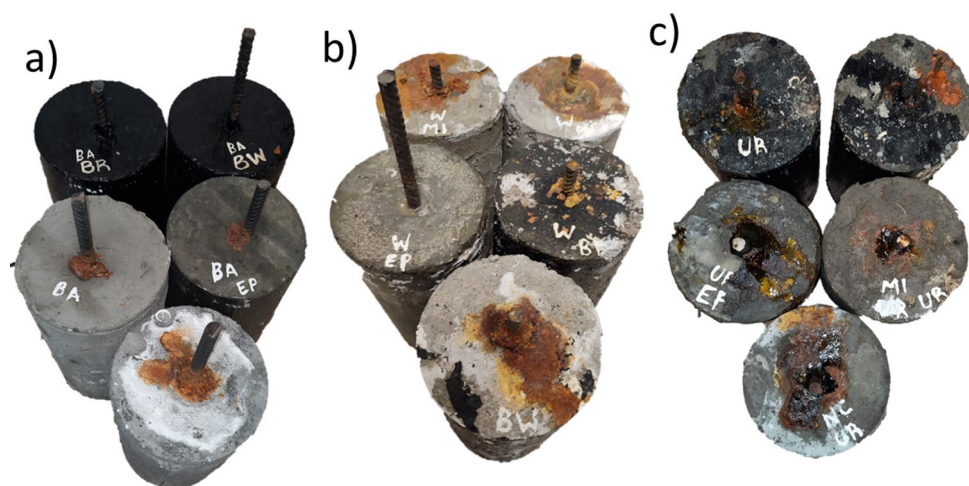
Figure 13. Concrete samples after the impressed voltage technique (a) before the aging process, (b) after the aging process and saturation in water, (c) after the aging process and saturation in urea, 7%.

Figure 13 presents the coated and uncoated reinforced concrete samples after the aging process and corrosion test. None of the specimens presented cracks on the concrete surface during the corrosion test, indicating that all laboratories were concluded once corrosion products became visible. After 22 days of testing, BW and BR samples did not present any corrosion on the concrete surface. In this case, the test was finalized, analyzing the materials' resistance to chloride ions. It is important to highlight that EP samples exposed to regular water did not present any physical damage before the impressed voltage technique. However, the presence of chlorides and the current that passes through the concrete deteriorated the coating material, leading to its fracture and physical damage.
