Effectiveness of various types of coating materials applied in reinforced concrete exposed to freeze–thaw cycles and chlorides

Ginneth Patricia Millán Ramírez

, Hubert Byliński & Maciej Niedostatkiewicz

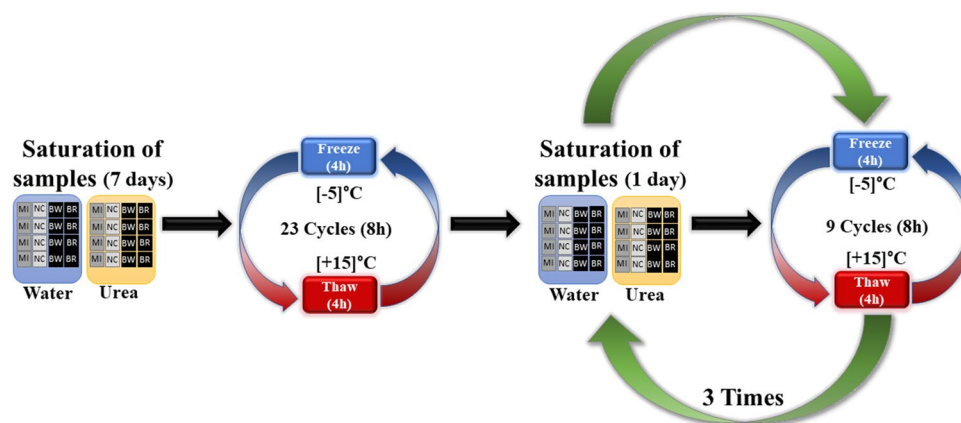
Figure 4. Aging process description. Freeze–thaw cycles and saturation of concrete samples.

Aging process. An accelerated aging test was conducted using a Toropol K-012 frost resistance test chamber, which is commonly employed for assessing the frost resistance of building materials. The specimens were subjected to cyclical freezing in air and thawing in water, while an electronic programmer monitored the cycles.

To simulate freeze–thaw conditions in the laboratory, the test was performed at temperatures ranging between $[-5]$ and $[+15]$ °C. Two solutions were employed to simulate contaminated environments: regular water and urea solution with a concentration of 7%. The aging process, as depicted in Fig. 4, was applied to the samples. Furthermore, each specimen was coated with one of the four materials assessed in this research: BW, BR, MI, and EP. Additionally, a control sample without protection (NC) was included for comparison with the protected samples. After 50 freeze–thaw cycles and a 10-day saturation period, the absorption rate, pull-off adhesion strength, and chloride permeability of each sample were measured.

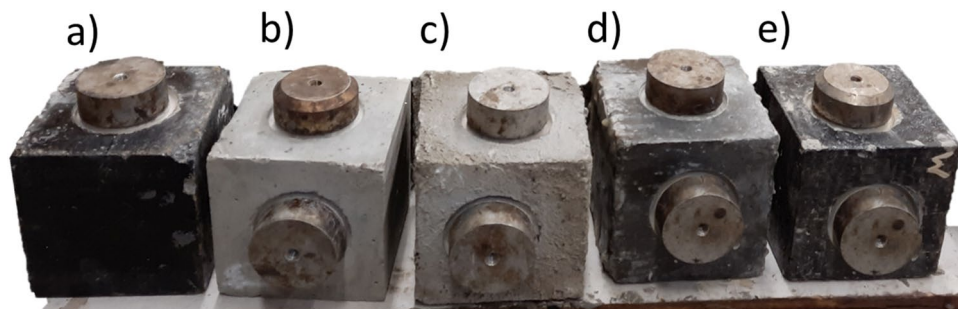
Figure 5. Concrete samples for the pull-off adhesion strength assessment (a) BR, (b) without coating, (c) MI, (d) EP, (e) BW.

In this study three types of concrete samples were utilized. Pull-off adhesion strength tests were performed on cube-shaped specimens measuring 100×100 mm. Cylinders with reinforced concrete measuring 150×300 mm were used for the impressed voltage technique. Additionally, cylinders measuring 100×50 mm were employed to assess water absorption rates. Detailed illustrations of these concrete specimens can be found in Figs. 2 and 5.

Adhesion strength test. The pull-off adhesion strength of coating applied to concrete surfaces was assessed in accordance with the ASTM D 7234-21 standard⁴. Cubic samples, as illustrated in Fig. 5, were used for the test.

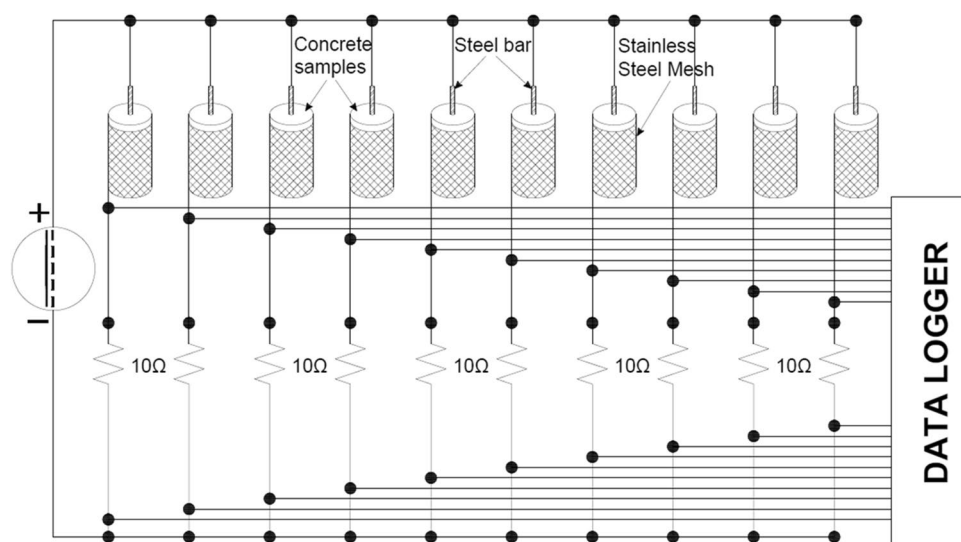
Figure 6. Electrical schematic design for the impressed voltage technique test.

Impressed voltage technique. To assess resistance to chloride ion permeability, the impressed voltage technique specified in the NT BUILD 356 standard²⁸ was employed. A constant direct current of 5 V was applied between a steel bar embedded in the concrete sample and the concrete surface. Furthermore, reinforced concrete specimens were partially immersed in a 3.0% NaCl solution during the test duration.

This test was conducted both before initiating the aging process and after seven days of completing the aging process in both coated and uncoated reinforced concrete samples. The test concluded upon the appearance of cracks or corrosion on the surface of the steel bar. The circuit assembly utilized an external DC power supply, YIHUA 3005D [0–30 V] 5 A, and a measurement data acquisition system capable of connecting ten samples simultaneously. The schematic design is illustrated in Fig. 6.

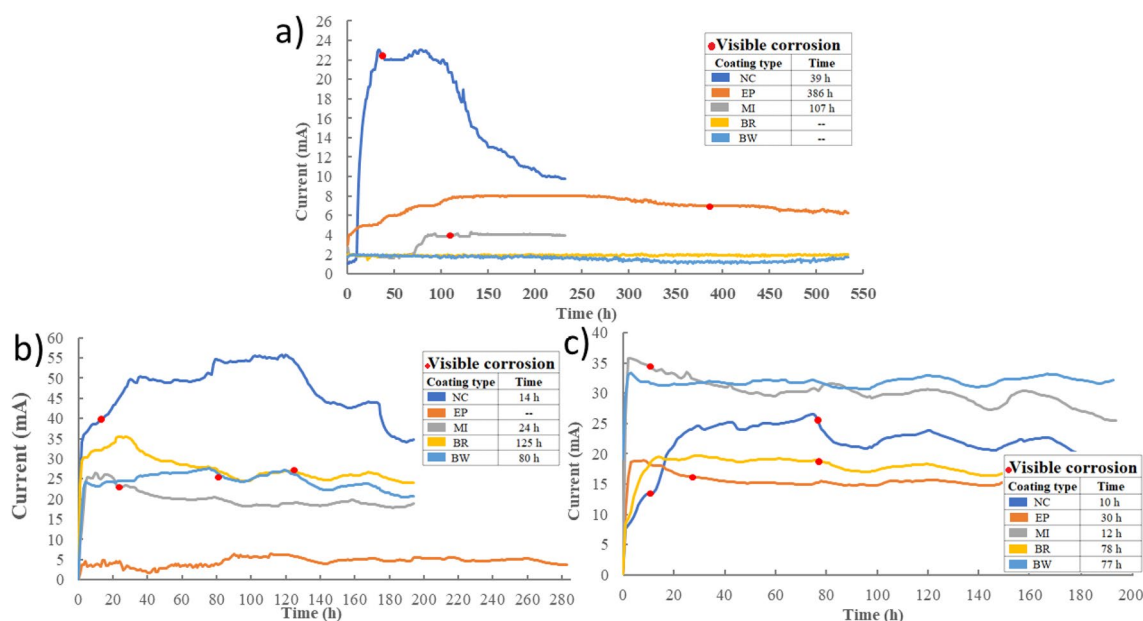
Figure 11. Current intensity curve, (a) before the aging process, (b) after the aging process and saturation in water, (c) after the aging process and saturation in urea, 7%.

Impressed voltage technique. The current intensity curves for samples before and after freeze–thaw cycles, saturated with regular water and urea, are presented in Fig. 11. Prior to the aging process, the maximum current for samples without coating protection was 23 mA, which was 58.18% lower than the samples saturated with regular water (55 mA). This increase indicates that the resistivity of the concrete surface has been compromised after the aging process, allowing for increased penetration of chloride ions into the concrete matrix. On the other hand, samples without coating protection and saturated with urea exhibited a current intensity 52.36% lower than samples saturated with water. This can be attributed to the presence of urea residues on the surface, which partially permeabilize the material and reduce the passage of chloride ions. Ramakrishnan1 et al.⁴².

MI, BR, and BW were the most affected materials by the freeze–thaw cycles. Before the aging process, these samples registered current values of 4.28, 2.08, and 1.98 mA, respectively. These values increased to 26.41, 35.54, and 27.73 mA for samples saturated in regular water and 35.78, 19.72, and 33.37 mA for samples saturated in urea

solution. In the case of samples protected with EP coatings, the highest current value of 18.93 mA was obtained in the samples exposed to urea, showing an increase of 235.10% before freeze–thaw cycles and 297.57% for samples saturated in water. These results align with previous findings by Aguirre et al.⁴⁶, where the highest current value for samples with epoxy coating was reported as 8 mA. Furthermore, it can be observed that, for all samples, the use of coating materials extended the appearance of corrosion products, thus protecting the concrete matrix in a chloride ion environment.

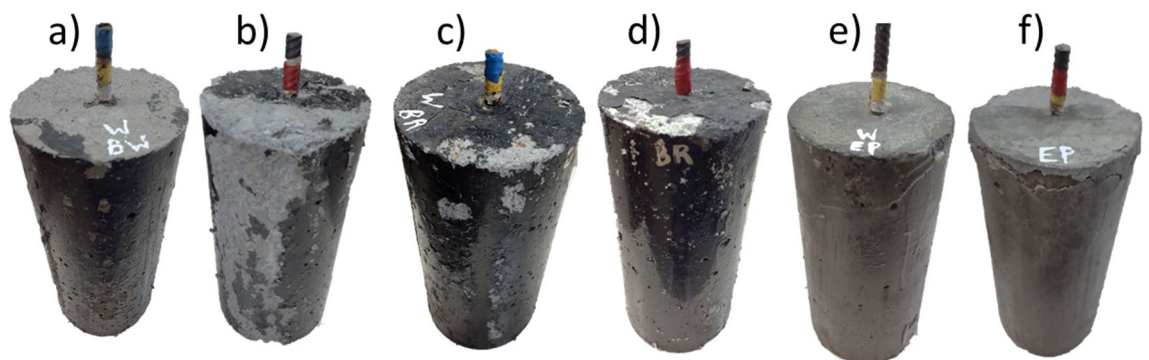
Figure 12. Concrete samples after the aging process. (a) BW water saturation, (b) BW urea saturation, (c) BR water saturation, (d) BR urea saturation, (e) EP urea saturation, (f) EP water saturation.

Figure 12 presents EP, BR, and BW concrete samples after the aging process, revealing visible physical damage in the coating materials. It is important to note that MI coating remained intact and undamaged throughout the aging process, regardless of exposure to water and urea. Similarly, EP samples exposed to water did not present any physical damage, effectively hindering the diffusion of chlorides into the concrete. However, EP samples exposed to urea, as well as BR, and BW samples exposed to water and urea, showed signs of physical damage. Among them, BW samples saturated with urea were the most adversely affected after the aging process.
