# High-Temperature Tensile Behaviour of GTAW Joints of P92 Steel and Alloy 617 for Two Different Fillers

**Abstract:** This study explores the high-temperature (HT) tensile rupture characteristics of a dissimilar gas-tungsten-arc-welded (GTAW) joint between P92 steel and Alloy 617, fabricated using ER62S-B9 and ERNiCrCoMo-1 fillers. The high-temperature tensile tests were performed at elevated temperatures of 550 °C and 650 °C. An optical microscope (OM) and a field emission scanning electron microscope (FESEM) were utilized to characterize the joint. The high-temperature test results indicated that the specimen failed at the P92 base metal/intercritical heat-affected zone (ICHAZ) rather than the weld metal for the ERNiCrCoMo-1(IN617) filler. This finding confirmed the suitability of the joint for use in the Indian advanced ultra-supercritical (A-USC) program. The fracture surface morphology and presence of precipitates were analysed using an SEM equipped with energy dispersive spectroscopy (EDS). The appearance of the dimples and voids confirmed that both welded fillers underwent ductile–dominant fracture. EDS analysis revealed the presence of Cr-rich  $M_{23}C_6$  phases, which

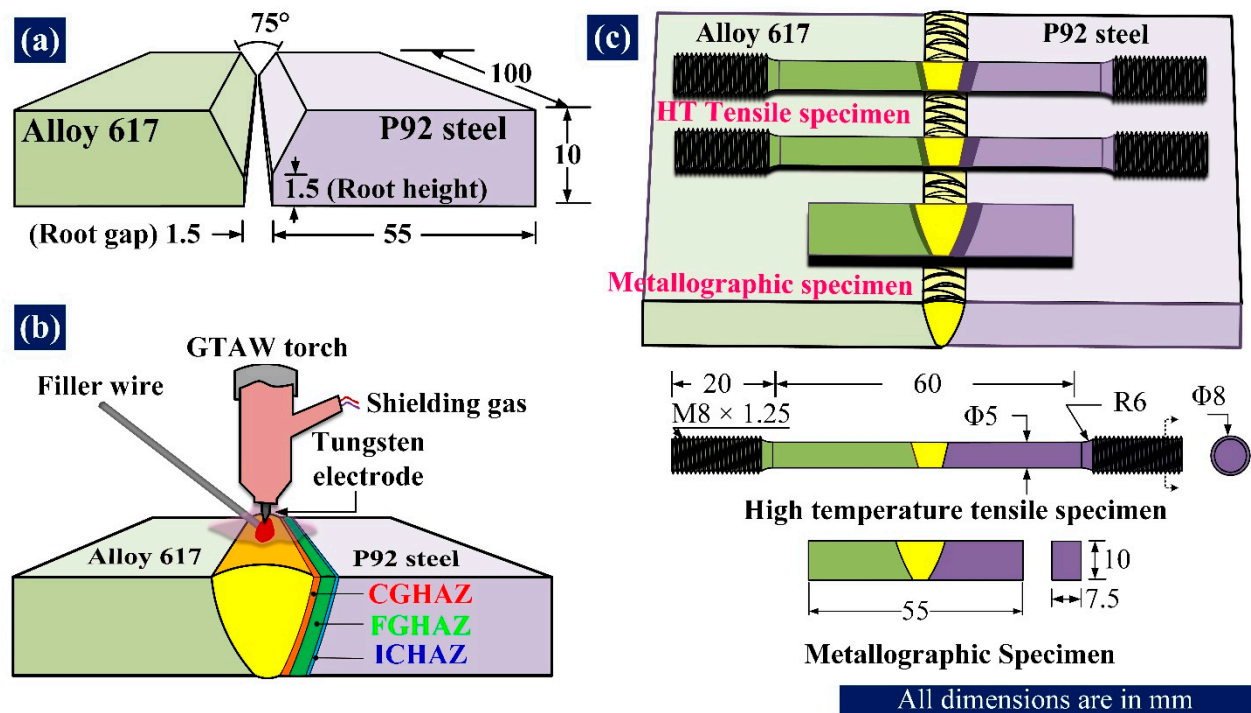
Figure 1. Schematic of (a) V-groove, (b) GTAW joint, (c) Welded plate and extracted samples with dimensions.

For this study, two 10 mm thick plates of P92 steel and Alloy 617 were welded together using the multi-pass gas tungsten arc welding (GTAW) process. The plates were cut and machined into dimensions of 100 mm  $\times$  55 mm  $\times$  10 mm. One side of the plates was machined as per the conventional V-groove of bevel angle 37.5° with a root face of 1.5 mm. All required dimensions related to the groove are illustrated in Figure 1a. Two joints were made: one joint with the P92 filler (ER62S-B9), and the other joint with the

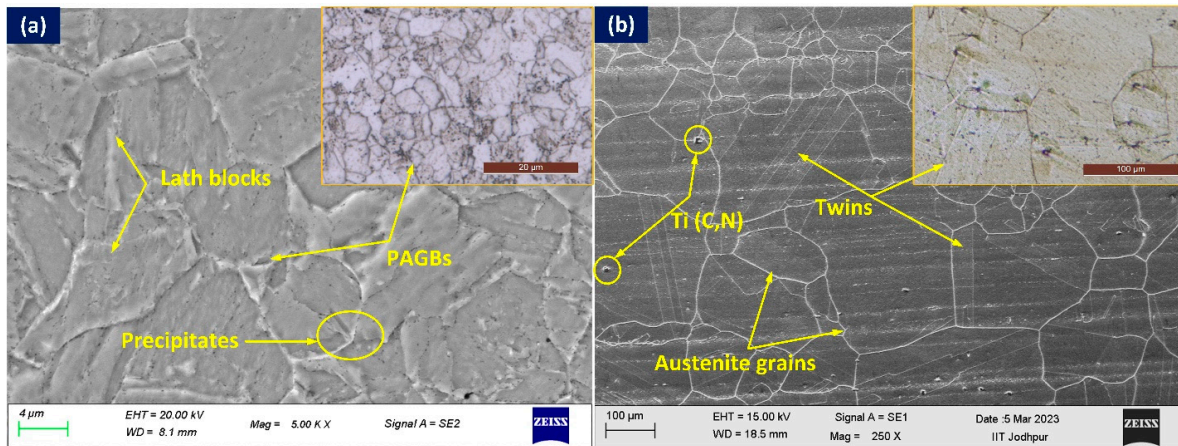
**Figure 2.** SEM and optical microstructure of (a) P92 steel BM and (b) Alloy 617 BM.

The microstructure of P92 steel BM is depicted in Figure 2a. The tempered martensitic microstructure consists of lath blocks, lath packets, packet boundaries, and prior austenite grain boundaries (PAGBs). The microstructure is strengthened through the presence of Cr, Mo, and W-rich coarse  $M_{23}C_6$  precipitates, as well as V and Nb-rich fine MX (X: C, N) precipitates [24,25]. The microstructure of Alloy 617 BM consists of a solid solution that strengthens the matrix of austenite grain (Figure 2b) along with twins and carbides of Cr and Mo ( $M_{23}C_6$ ), Mo-rich ( $M_6C$ ), and Ti-rich (MX (X: C, N)) [24,25].

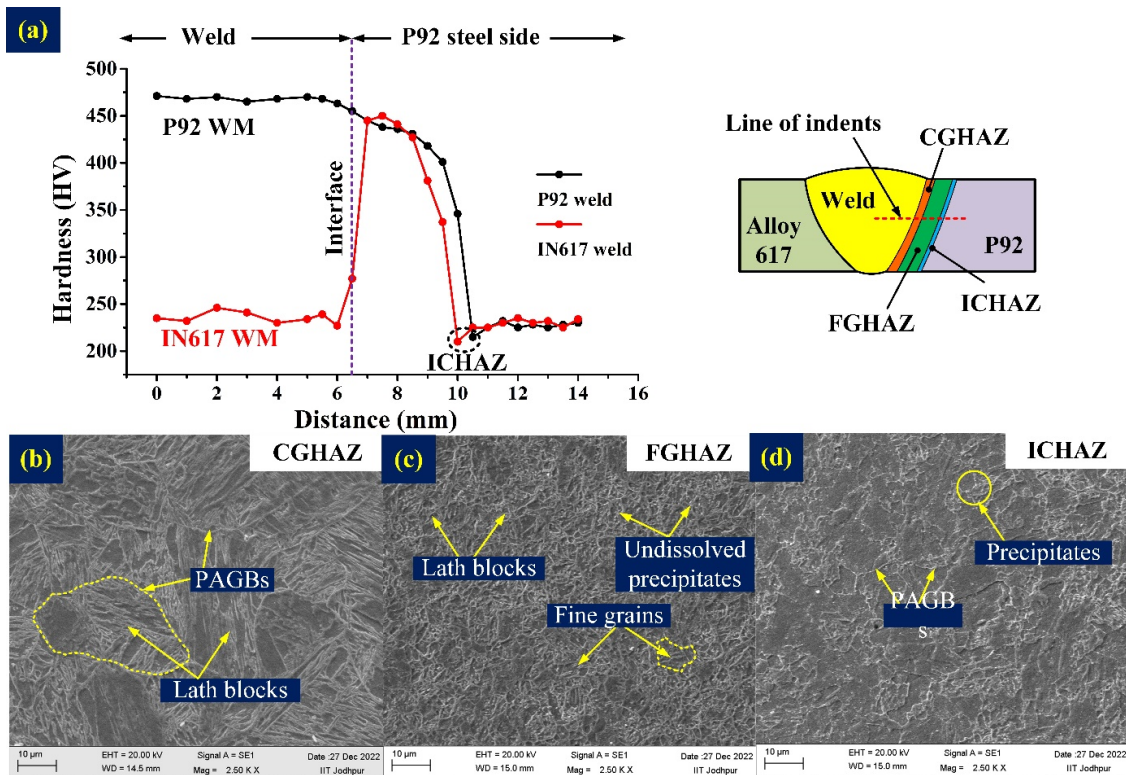
**Figure 3.** (a) Vickers-microhardness profile across the welded joint and SEM image of (b) CGHAZ, (c) FGHAZ, and (d) ICHAZ.

The region of P92 HAZ near the interface, i.e., CGHAZ, experiences a temperature far above the upper critical temperature ( $A_{c3}$ ), characterized by coarse PAGs, as depicted in Figure 3b. The high temperature causes carbide precipitates to dissolve, resulting in the formation of coarse PAGs and an untempered martensitic matrix with higher levels of carbon and nitrogen. This is also reflected in the hardness plot mentioned in Figure 3a. In contrast, the FGHAZ adjacent to the CGHAZ experiences peak temperatures close to or higher than  $A_{c3}$ , causing incomplete dissolution of carbide precipitates and resulting in fine PAGs, also shown in Figure 3c. The hardness of the FGHAZ measured lower than that of the CGHAZ, as shown in the hardness plot in Figure 3a. ICHAZ is formed near the base metal and experiences a temperature between the lower critical temperature ( $A_{c1}$ ) and  $A_{c3}$  that results in a negligible dissolution of the precipitates. The over-tempering of ICHAZ results in coarsening of the precipitates that reduces the strength and hardness of the region, and it is marked as the region of lowest hardness, as mentioned in Figure 3a; the microstructure of ICHAZ is shown in Figure 3d. The area located beyond the ICHAZ from the fusion line does not undergo a transformation from austenite to martensite during welding. The microhardness profiles for the P92-weld and IN617-weld samples are shown in Figure 3a. In the P92-weld sample, the average hardness of WM was  $468 \pm 3$  HV, while in the IN617-weld sample, the average hardness of WM was  $236 \pm 6$  HV, which is approximately half of the hardness of the P92-weld. In the P92-weld sample, the hardness of CGHAZ, FGHAZ, and ICHAZ was  $442 \pm 5$  HV,  $406 \pm 36$  HV, and 218 HV, respectively [22]. In the IN617-weld sample, the hardness of CGHAZ, FGHAZ, and ICHAZ was  $448 \pm 4$  HV,  $397 \pm 47$  HV, and 214 HV, respectively [23].

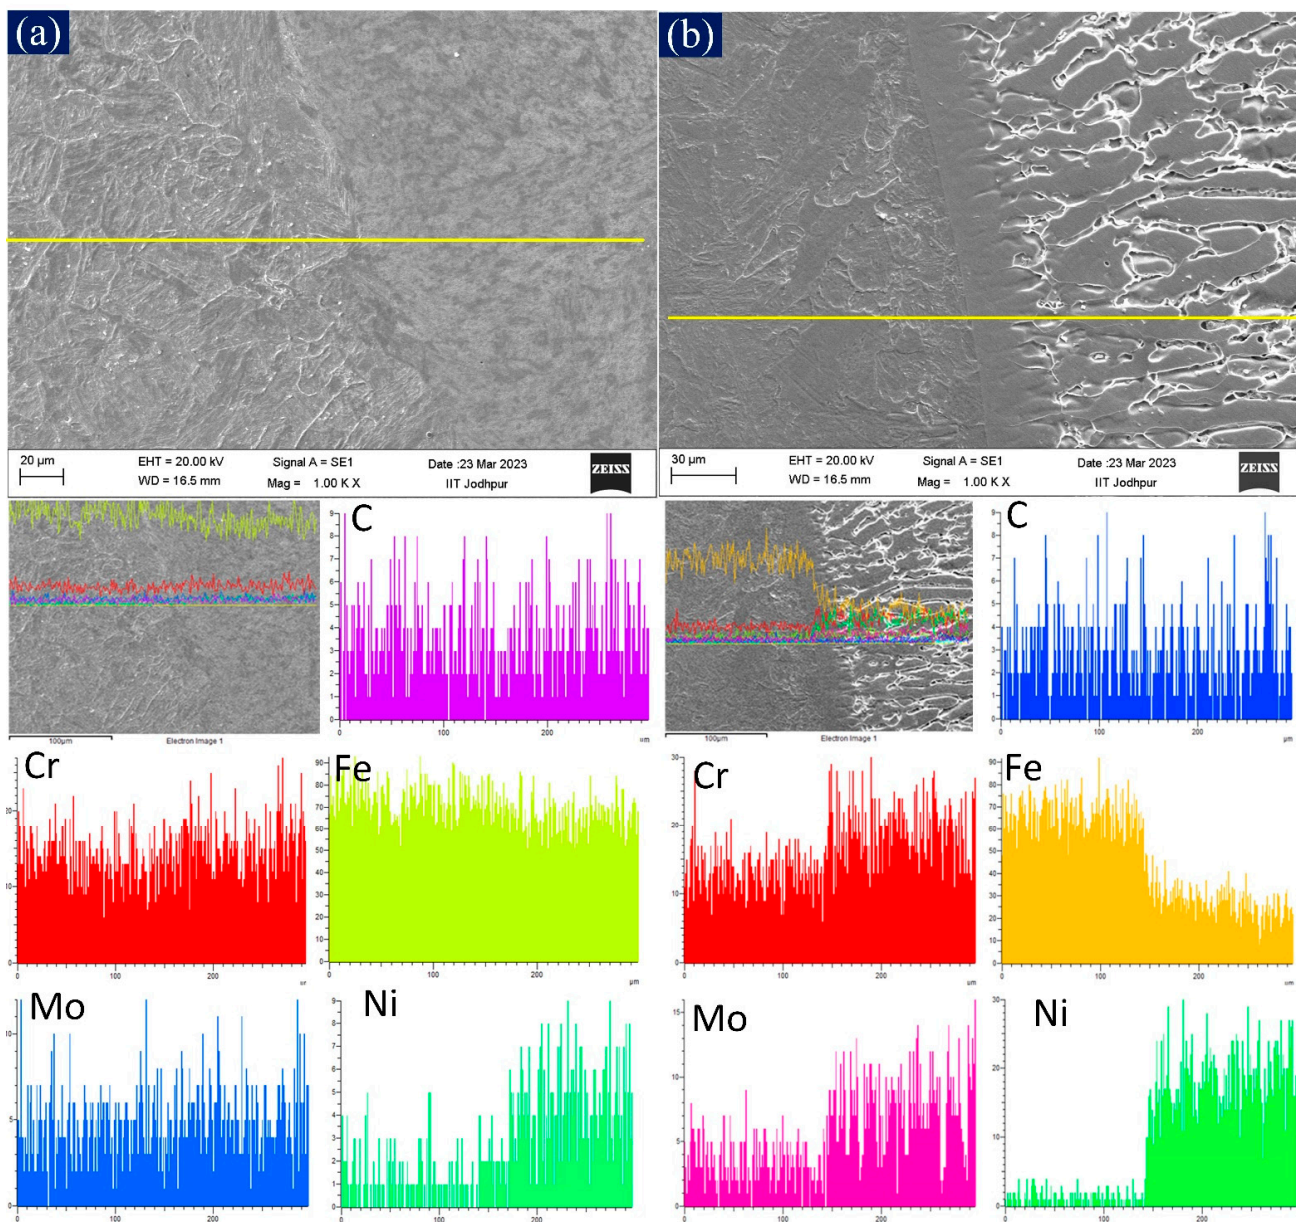
**Figure 4.** EDS line map across the interface of (a) P92-weld and P92 BM (b) IN617-weld and P92 BM.

The EDS line map was carried out on as-welded samples across the interface of WM and P92 to determine the diffusion of elements from the WM to P92-steel (Figure 4a,b). No significant diffusion was observed for the P92 filler because it has a similar composition to that of the P92 base material (Figure 4a). This confirms that the hardness variation was due to the change in the microstructure of the HAZ of P92, not from the elemental alteration due to diffusion of the elements from the WM to P92-HAZ. However, a significant element

variation is seen at the interface of the weld and P92 BM for the ERNiCrCoMo-1 filler (Figure 4b). The major variation is seen for Cr, Mo, Fe, and Ni. The line map confirms the diffusion of Fe from the P92 base matrix to the weld, as well as the diffusion of Cr, Ni, and Mo from the weld to the P92 base matrix. A similar observation has also been made in our previous study from the P92 filler [22] and the IN617 filler [23] welded joint.

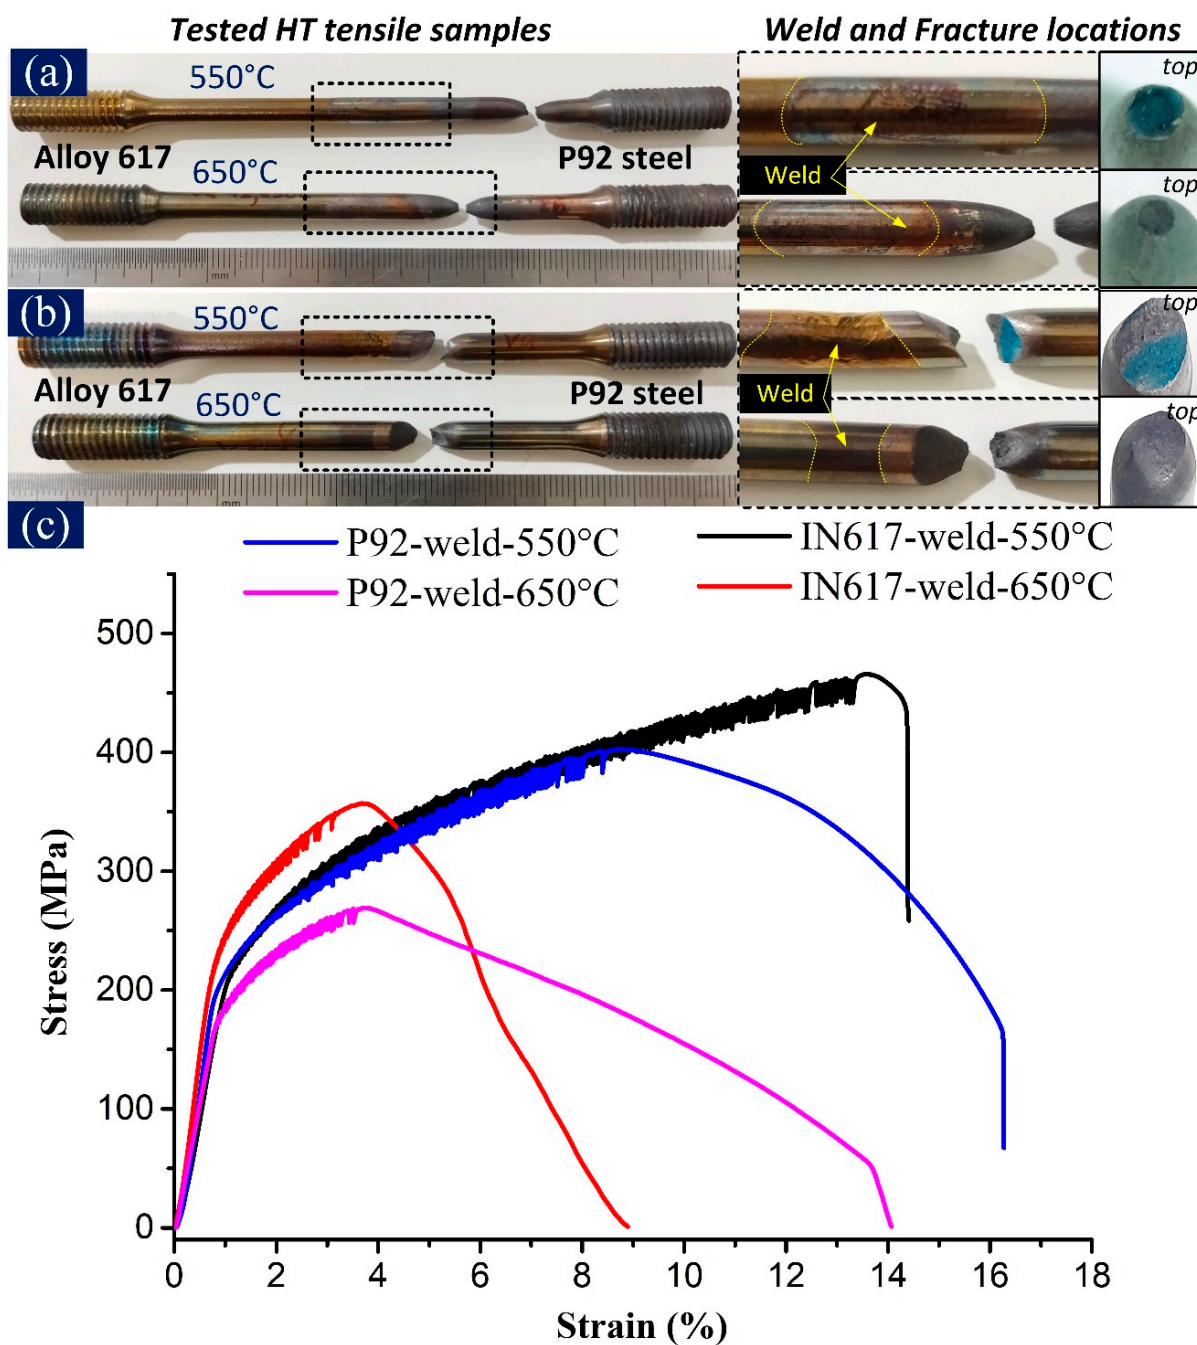
Figure 5. Tested HT tensile samples of (a) P92-weld (b) IN617-weld, and (c) HT tensile stress-strain curves.

which results in an increase in dislocation mobility. This, in turn, causes the dislocations to move more easily and interact with the solute atoms, creating strain localization. The strain localization results in a sudden increase in stress, followed by a decrease in stress as the material undergoes plastic deformation. This leads to the characteristic serrated appearance of the stress–strain curve during HT tensile testing. The serrated flow was observed in all welded samples with stress–strain curves tested at temperatures of 550 °C and 650 °C. Rodriguez [28] named this type of serration ‘type C’ serration. Sudden and repeated irregular stress drops below the overall level of the flow curve are regarded as type C serration. In the case of HT tensile testing of the P92-weld, the serrated flow (Figure 5c) was governed by the Alloy 617 side metal. On the other hand, for IN617-weld samples, the Alloy 617 side metal and nickel-based (ERNiCrCoMo-1) weld metal were responsible for the serrated flow behaviour (Figure 5c). The tested tensile samples of both welded samples, IN617-weld and P92-weld, are shown in Figure 5a,b along with the marked fracture location, weld location, and a top view of the fracture location.

Both P92-weld samples failed at the base metal of P92 steel. Thus, emphasis was also given to the stress–strain characteristic of P92 BM at high temperatures, as shown in Figure 6. During HT tensile testing of P92 BM at temperatures of 550 °C and 650 °C, P92 BM underwent work hardening up to point U (UTS point), followed by prolonged and steady softening from point U to N. During the softening stage, the stress decreased, with this reduction being more pronounced for lower strain rates ( $10^{-4}$ /s). Once the stress reached point N, a more substantial softening effect occurred, resulting in a change in slope that eventually led to fracture at point F. The material experiences softening at high temperatures, which leads to a decrease in its strength and hardness. This can make the material more susceptible to deformation and failure under stress [22]. The P92-weld sample displayed the same softening behaviour (Figure 5c) as P92 BM (Figure 6), with a softening curve changing the nature at point N, and a slope change up to the fracture point. The shape of the fracture appeared as a cup and cone type of fracture (Figure 7a). The softening stage of IN617-weld-550 °C was the smallest compared to IN617-weld-650 °C. As shown on the graph of IN617-weld-550 °C in Figure 5c, the softening curve (after the UTS point) first displayed ductile behaviour, and then sudden fracture occurred. On the other hand, the IN617-weld-650 °C sample showed smooth and elongated softening behaviour, indicated in Figure 5c. The blue colour in the partial fracture surface is also evidence of the partial brittle fracture in the partial area; an image of the sample is shown in Figure 5b.

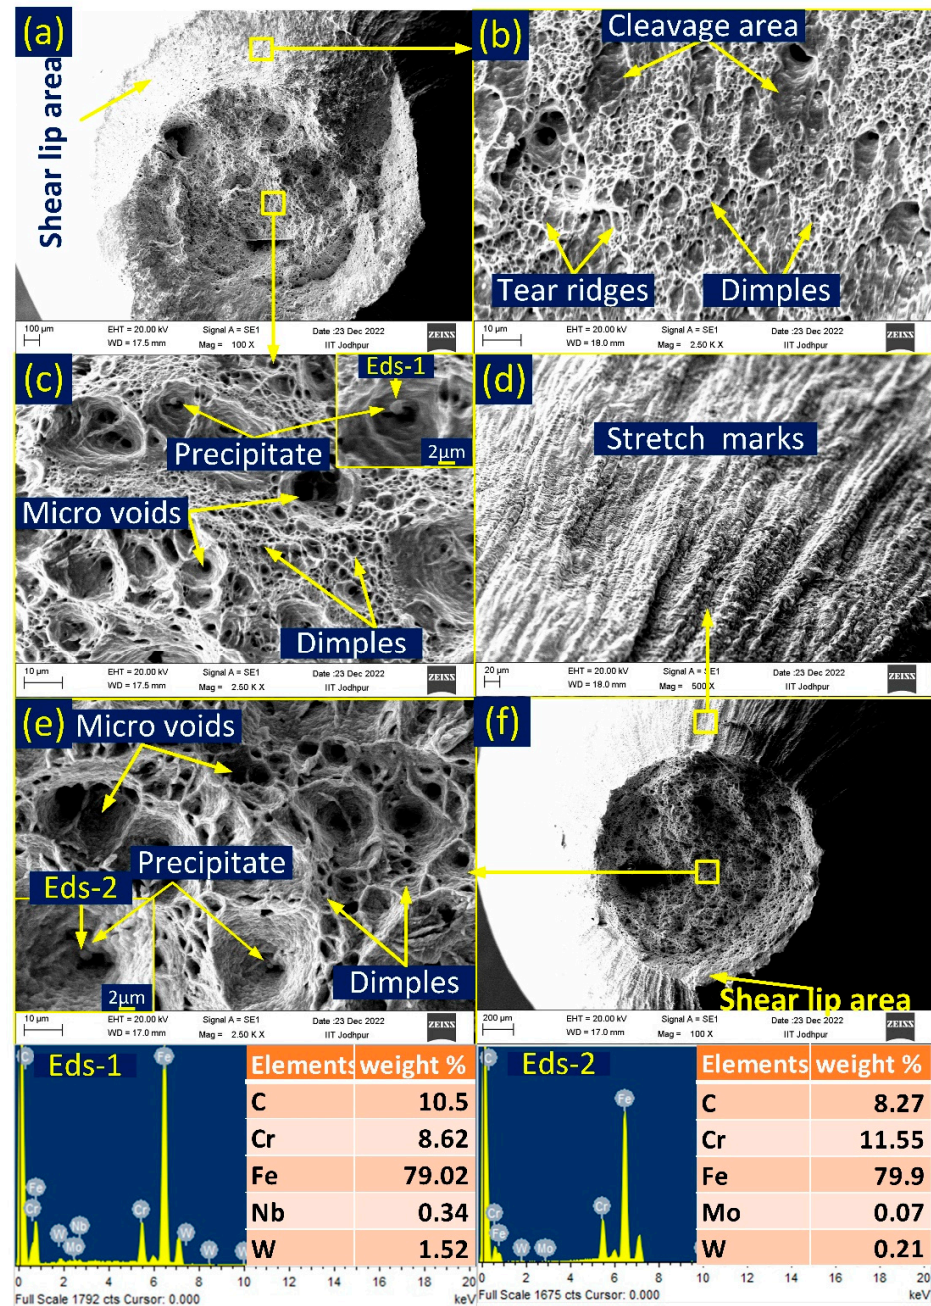
Figure 7. Fractographic SEM images of P92-weld sample (a–c) tested at 550 °C and (d–f) tested at 650 °C.

The fractography of P92-weld-550 °C and P92-weld-650 °C samples is shown in Figures 7a–c and 7d–f, respectively. At both temperatures, a cup–cone-shaped fracture was observed with shear lips, as shown in Figure 7a,b. The fracture mouth area of P92-weld-650 °C is less than the sample tested at 550 °C. The percentage area reduction is also shown in Table 1. The central region and shear lip of the fracture surface are shown in Figure 7b,c. The central area is mostly filled with dimples combined with microvoids; thus, the material is ductile in nature in the central region. The shear lip area indicates a shallow microvoid, cleavage area, tear ridges, and dimples, which indicates less ductility than the central region. Thus, for P92-weld-550 °C, this indicates a mixed mode of fracture characteristic. On the other hand, the P92-weld-650 °C sample indicates deeper microvoids rather than shallow dimples, and the size of the dimples and microvoids is also larger than the size observed at 550 °C (Figure 7e). From the morphology of the fracture surface, we can infer that a more ductile nature can be seen at 650 °C than the tested 550 °C. When a tensile sample undergoes stress, the stress concentration around the precipitates can cause localized deformation, leading to the formation of microvoids. These microvoids may grow and coalesce, eventually leading to the initiation and propagation of cracks. The point energy dispersive spectroscopy (EDS) was taken at the precipitate

observed inside the dimples. Points EDS-1 and EDS-2 confirm that the Cr-rich ( $M_{23}C_6$ ) carbide secondary phase [25] was observed in the vicinity of the microvoids. The outer surface near the fracture area is also seen via the SEM observation, and the surface was found rough due to axial force; stretch marks are shown in Figure 7d. Stretch marks on the outer surface of the lip can indicate that localized deformation has occurred in this area and that the material has undergone significant elongation or stretching.

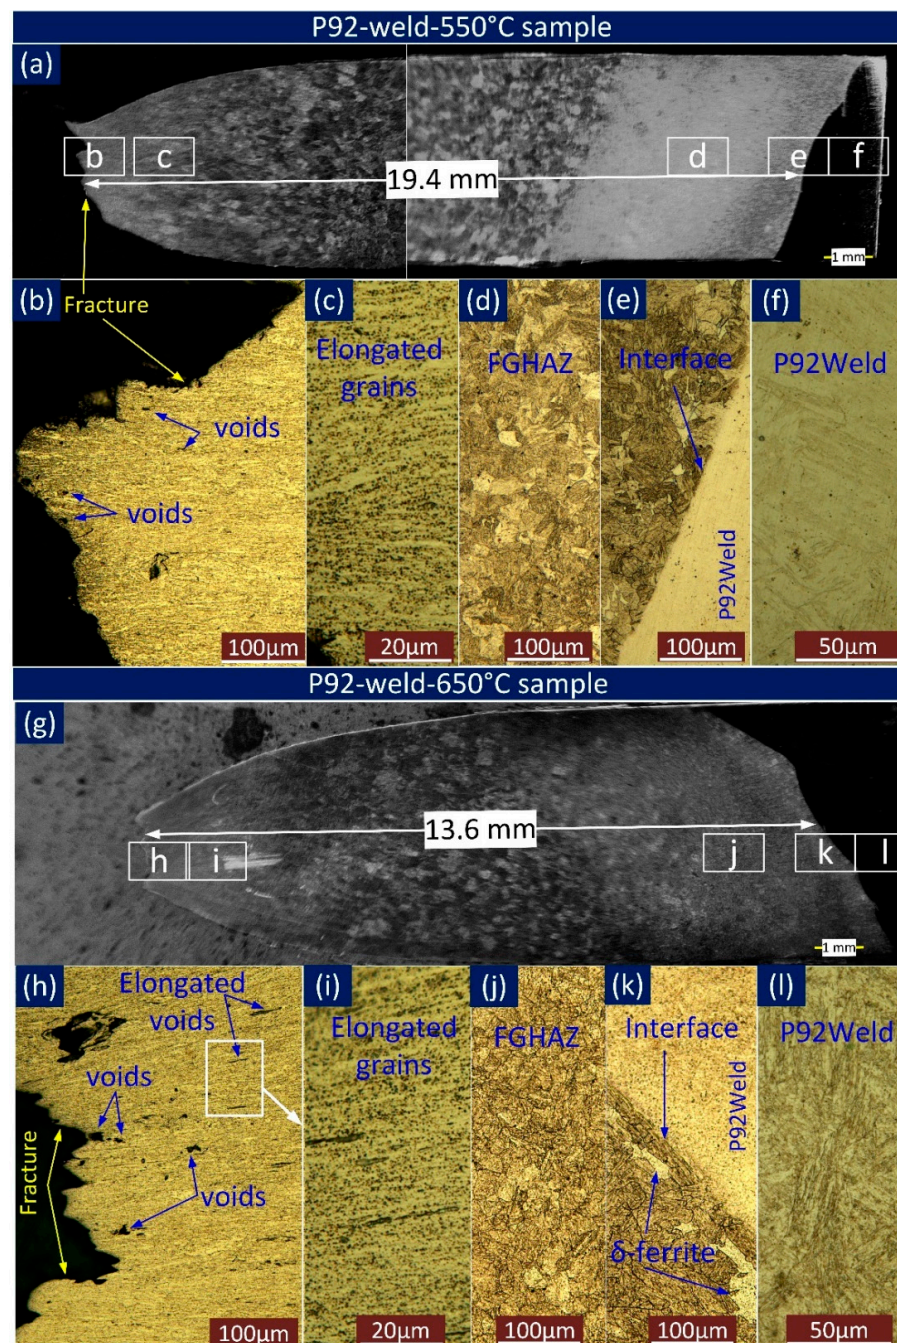
**Figure 8.** Macrograph and microstructure of longitudinal section of P92-weld sample. (a) SEM image of fractured specimen P92-weld-550 °C; optical image of various marked location of (a): (b) fracture tip (c) elongated grains (d) FGHAZ (e) Interface (f) P92 weld (g) SEM image of fractured specimen P92-weld-650 °C; optical image of various marked location of (g): (h) fracture tip (i) elongated grains (j) FGHAZ (k) interface (l) P92 weld.

The macrograph in Figure 8a,g indicates the fracture location is 19.4 mm from the weld interface for P92-weld-550 °C and 13.6 mm for P92-weld-650 °C. Larger-sized voids are seen near the fracture location in P92-weld-650 °C than in P92-weld-550 °C, as depicted in Figure 8c,i. The grains are elongated near the fracture location and are clearly seen in Figure 8b,h. Noticeably elongated voids are seen within the elongated grain in P92-weld-650 °C, whereas no elongated voids are seen in the optical image in P92-weld-550 °C.

No appreciable void or gap was noted at the P92-weld interface (Figure 8e,k) in both P92-weld-550 °C and P92-weld-650 °C samples. Furthermore, Figure 8d,j indicates no sign of appreciable voids at the FGHAZ and weld centre region in Figure 8f,l. The near-fracture areas of P92-weld-550 °C and P92-weld-650 °C samples are further characterized. The SEM image (Figure 9a) confirms the elongated fine voids appeared at the near-fracture area of the P92-weld-550 °C sample. The coarse-size elongated void appeared (Figure 9b) at the near-fracture area of the P92-weld-650 °C sample.

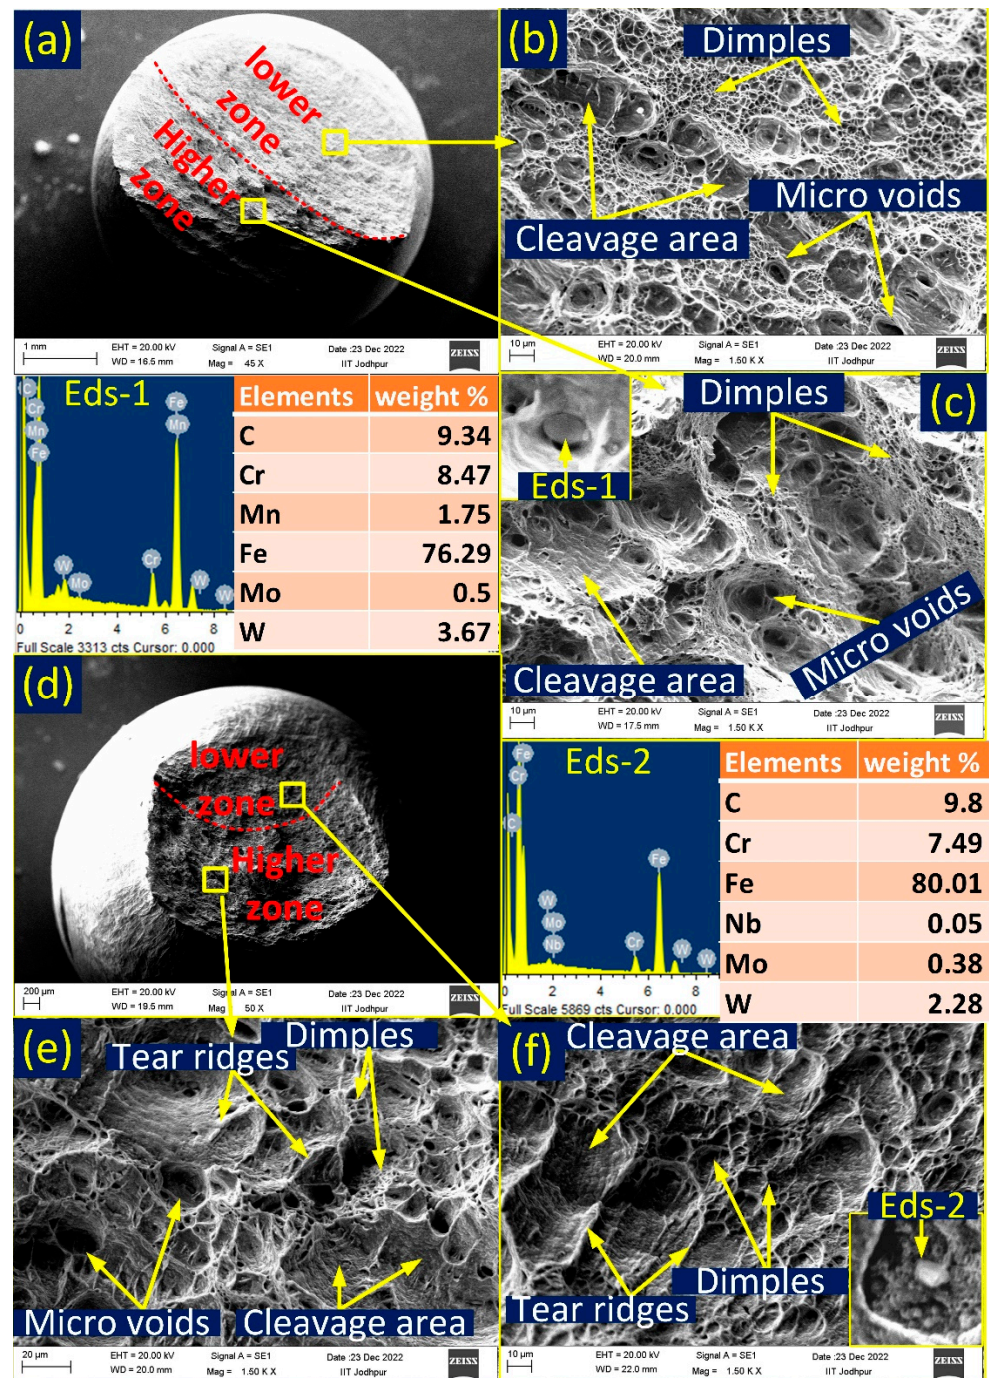
**Figure 10.** Fractographic SEM images of IN617-weld sample tested at 550 °C (a) top view, (b) lower zone detailed view, (c) higher zone detailed view and EDS of particles; sample tested at 650 °C, (d) top view, (e) higher zone detailed view, (f) lower zone detailed view and EDS of particles.

The fracture morphology of IN617-weld-550 °C and IN617-weld-650 °C samples is shown in Figures 10a–c and 10d–f, respectively. The fracture surface of both samples is divided into two zones: a lower zone and a higher zone. The lower fracture zone of IN617-weld-550 °C indicated a mixed mode (ductile + brittle) of fracture; microvoids, more dimples, and cleavage areas in Figure 10b show evidence of a mixed mode of failure. In the higher fracture zone, (Figure 10c) microvoids, less dimples, and cleavage area indicated a dominated mixed fracture mode. The IN617-weld-650 °C lower fracture zone (Figure 10e) specified shallow dimples and cleavage area, which indicates a brittle fracture mode, but the higher zone showed a mixed mode of fracture with microvoids, deep dimples, and cleavage areas, as evidenced in Figure 10f. From the morphology of the fracture, it can be concluded that the IN617-weld sample shows more ductile behaviour at 550 °C than at 650 °C during a test. It also provided good agreement with the observation made from the stress–strain curve (Figure 5c); the percentage of elongation of IN617-weld-550 °C was higher than the percentage of elongation of IN617-weld-650 °C, as shown in Table 1. The voids are nucleated from the secondary phase’s particles noticed in the fracture SEM images. Point EDS on the particles in the voids confirm the presence of Cr-rich carbide precipitate in the vicinity of voids. EDS-1 and EDS-2 confirm Cr-rich secondary phase presence in the vicinity of large voids seen in fracture images of IN617-weld-550 °C and IN617-weld-650 °C, respectively.

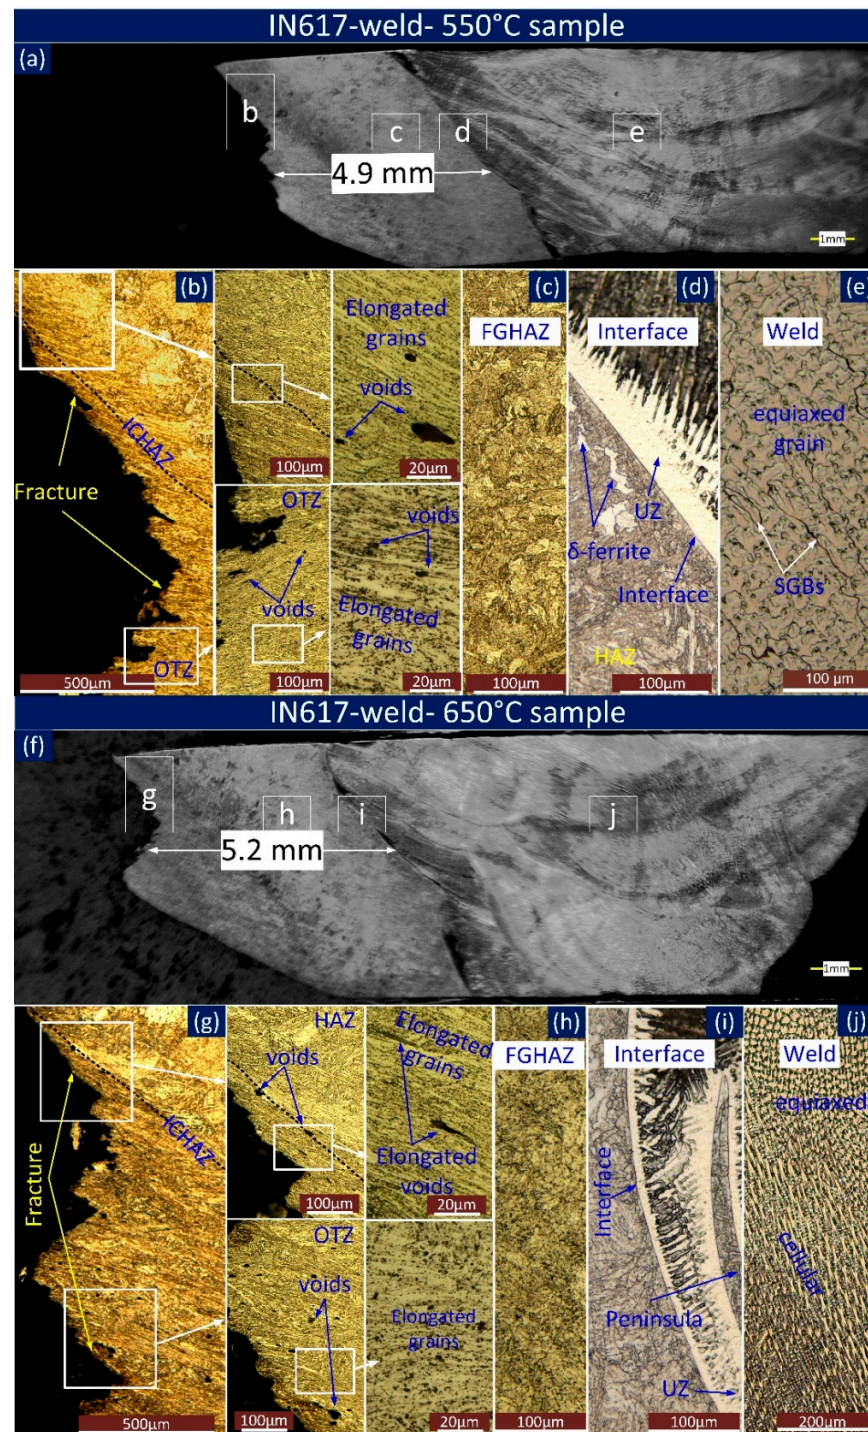
**Figure 11.** Macrograph and microstructure of longitudinal section of IN617-weld sample. (a) SEM image of fractured specimen IN617-weld-550 °C; optical image of various marked location of (a): (b) fracture tip (c) FGHAZ (d) Interface (e) weld; (f) SEM image of fractured specimen IN617-weld-650 °C; optical image of various marked location of (f): (g) fracture tip (h) FGHAZ (i) interface (j) weld.

An optical light image of the longitudinal section of macroscopic and microscopic characteristics of IN617-weld-550 °C and IN617-weld-650 °C was indicated in Figure 11. The macrograph (Figure 11a,f) indicates the fracture surface was 4.9 mm and 5.2 mm from the respective weld interface of IN617-weld-550 °C and IN617-weld-650 °C, respectively. The large-sized voids were observed just near the fracture location (Figure 11b,g). Near the fracture location, elongated grains and elongated voids were observed and no evidence of appreciable voids or elongation of grain was observed at the HAZ, interface, and weld of IN617-weld-550 °C (Figure 11c–e) and IN617-weld-650 °C (Figure 11h–j). Additionally, the voids and elongated grains seen in the optical image near the fracture are confirmed in the

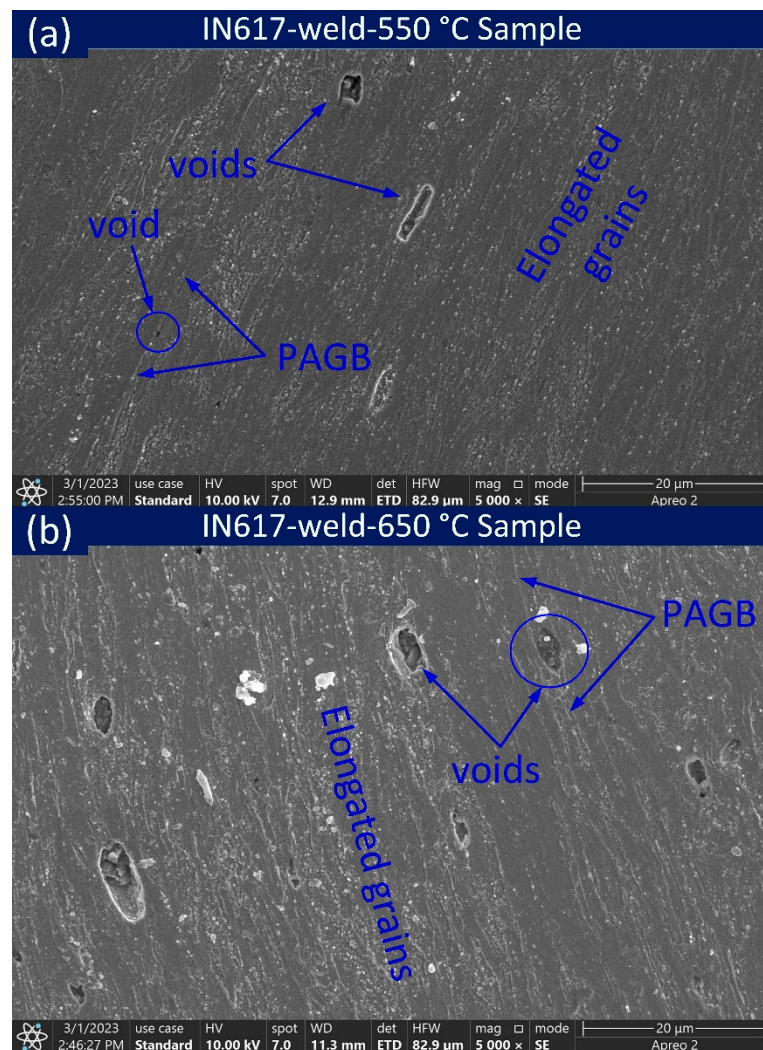
**Figure 12.** SEM images near fracture location of IN617-weld sample tested at (a) 550 °C and (b) 650 °C.

SEM image. Both coarse and fine voids were observed near the fracture locations. In ICHAZ, near the fracture location, fine voids were observed over the PAGBs, confirmed by the SEM images (Figure 12a) for IN617-weld-550 °C, and for IN617-weld-650 °C, comparatively coarse voids were noticed on the PAGBs (Figure 12b). The microstructure in Figure 12 also illustrated large particles distributed near the voids and along the grain boundaries.

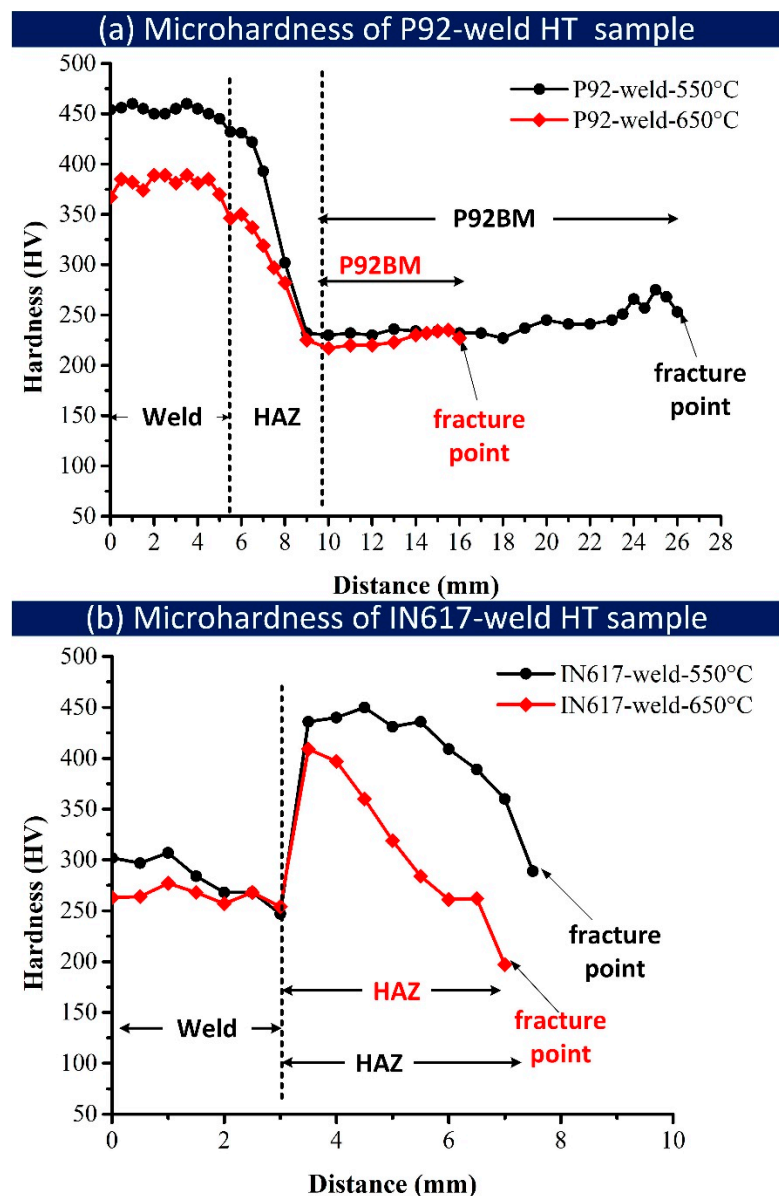
**Figure 13.** Hardness variation along the longitudinal section from weld centre to near-fracture location HT tensile sample of (a) P92-weld and (b) IN617-weld.

Based on the as-welded sample hardness profile for both welded plates (P92-weld and IN617-weld), the highest hardness was noticed in the position just near the fusion interface, i.e., CGHAZ, while the lower value of hardness was observed in ICHAZ. It can be seen that ICHAZ was the weakest region of the weldments (Figure 3a). However, the P92-weld sample failed from P92 BM instead of the ICHAZ, whereas in the IN617-weld sample, failure was observed at ICHAZ. The macrograph of the longitudinal section of the tested sample of the P92-weld indicates (Figure 8a,g) that the location of HAZ is very far from the fracture location, whereas the macrograph of the longitudinal section of the tested sample of the IN617-weld indicates (Figure 11a,f) that the fracture location is ICHAZ of P92. The hardness variation along the longitudinal section of the tested samples (P92-weld and IN617-weld) from the weld centre to the near-fracture location is depicted in Figure 13a,b. The sample of P92-weld tested at 550 °C indicates comparatively more hardness values of respective zones (weld, HAZ, 92BM) than the sample tested at 650 °C. The P92-weld displayed the highest hardness in the weld and the lowest at the outer edge of the HAZ and fracture location. The hardness of weld metal in P92-weld-550 °C and P92-weld-650 °C was  $454 \pm 4$  HV and  $382 \pm 7$  HV, respectively. The reduction in hardness of other regions of the weldments was also observed. The reduction in hardness might be due to the tempering reaction, which is a function of the operating temperature and time. For the IN-617 weld,

a lower hardness was measured for the weld metal tested at 650 °C as compared to the sample tested at 550 °C, but the difference was low as compared to the P92-weld. This may be due to the difference in microstructure of the weld metal, i.e., martensitic in the P92-weld and austenitic in the IN617-weld. The weld metal exhibited hardness values of  $287 \pm 17$  HV and  $266 \pm 7$  HV for IN617-weld-550 °C and IN617-weld-650 °C, respectively. For the region of P92 HAZs, a similar trend is observed in the IN617-weld as noticed in the P92-weld.
