# High-Temperature Tensile Behaviour of GTAW Joints of P92 Steel and Alloy 617 for Two Different Fillers

**Abstract:** This study explores the high-temperature (HT) tensile rupture characteristics of a dissimilar gas-tungsten-arc-welded (GTAW) joint between P92 steel and Alloy 617, fabricated using ER62S-B9 and ERNiCrCoMo-1 fillers. The high-temperature tensile tests were performed at elevated temperatures of 550 °C and 650 °C. An optical microscope (OM) and a field emission scanning electron microscope (FESEM) were utilized to characterize the joint. The high-temperature test results indicated that the specimen failed at the P92 base metal/intercritical heat-affected zone (ICHAZ) rather than the weld metal for the ERNiCrCoMo-1(IN617) filler. This finding confirmed the suitability of the joint for use in the Indian advanced ultra-supercritical (A-USC) program. The fracture surface morphology and presence of precipitates were analysed using an SEM equipped with energy dispersive spectroscopy (EDS). The appearance of the dimples and voids confirmed that both welded fillers underwent ductile–dominant fracture. EDS analysis revealed the presence of Cr-rich  $M_{23}C_6$  phases, which

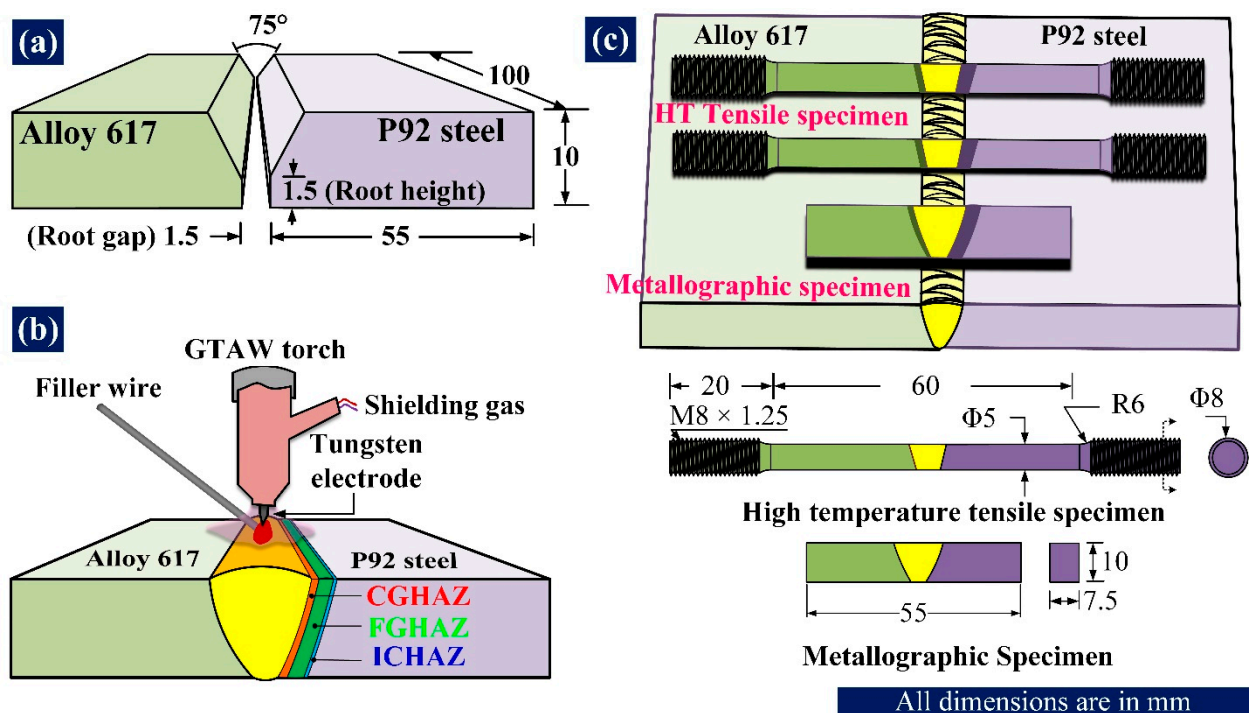
Figure 1. Schematic of (a) V-groove, (b) GTAW joint, (c) Welded plate and extracted samples with dimensions.

For this study, two 10 mm thick plates of P92 steel and Alloy 617 were welded together using the multi-pass gas tungsten arc welding (GTAW) process. The plates were cut and machined into dimensions of 100 mm  $\times$  55 mm  $\times$  10 mm. One side of the plates was machined as per the conventional V-groove of bevel angle 37.5° with a root face of 1.5 mm. All required dimensions related to the groove are illustrated in Figure 1a. Two joints were made: one joint with the P92 filler (ER62S-B9), and the other joint with the

ERNiCrCoMo-1 filler. The chemical compositions of plates and fillers are mentioned in previously published articles [22,23]. Each joint was completed in five passes, including the root pass. The root pass was completed with a welding current of 110 A and voltage of 12 V with a travel speed of 80 mm/min. For the remaining four passes, the welding current and voltage were 120–125 A and 12–14 V, respectively, with a travel speed of approximately 50–60 mm/min [22,23]. The argon gas was used for shielding purposes with a flow rate of 15 L/min. The P92 side HAZs include the region of the coarse grain heat-affected zone (CGHAZ), fine grain heat-affected zone (FGHAZ), and intercritical heat-affected zone (ICHAZ), all of which are shown in Figure 1b. To study the metallurgical and mechanical properties of the weldments, transverse samples were extracted from the plates (Figure 1c) using wire-cut electrical discharge machining (EDM). The metallurgical samples underwent grinding and polishing with sandpaper of grit sizes varying from 180 to 2000. To achieve a mirror surface finish, the sandpaper-grinded samples were further polished with alumina powder. Polished samples were then etched with Vilella's reagent for 60 s to reveal the microstructure of the P92 steel BM and P92 weld. The electrolytic etching was performed in a 10% oxalic acid solution to reveal the microstructure of Alloy 617 BM and the IN617-weld. The etched samples were analysed with an optical light microscope (model DMC4500 Leica) and scanning electron microscopes (model Apreo-2S ThermoScientific). The dimensions of the HT tensile test specimen and metallurgical specimen are displayed in Figure 1c. The HT tensile tests were performed at 550 °C and 650 °C, respectively, at a constant cross-head speed of 1 mm/min. The tensile tests were carried out on the universal testing machine 'Shimadzu AG-X-100KN'. The microhardness of the HT tensile samples was determined on a Vickers hardness tester (model AVHD-1000XY Banbros) along with the sample's longitudinal axis by applying a load of 500 g for a duration of 10 s. The indent was taken at every 0.5 mm gap. For the sake of convenience in this study, the P92-weld samples tested at 550 °C and 650 °C are represented as P92-weld-550 °C and P92-weld-650 °C, respectively. The IN617-weld samples tested at 550 °C and 650 °C are represented as IN617-weld-550 °C and IN617-weld-650 °C, respectively.
