# Case Studies in Construction Materials

## Characterization of corrosion in reinforced concrete beams using destructive and non-destructive tests

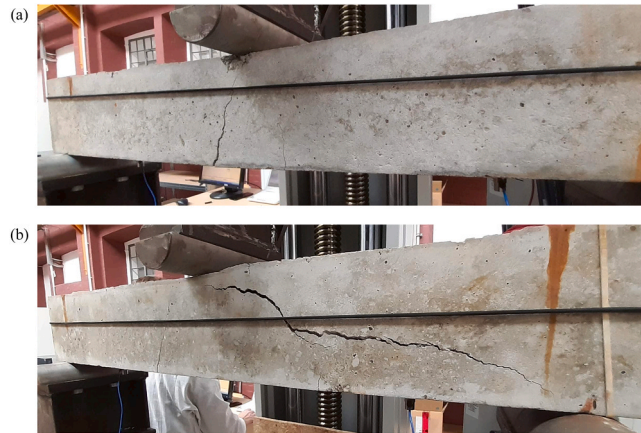
Fig. 13. Two types of failure modes: (a) type A – flexural failure, (b) type B – shear failure.

During experiments, the first cracks started to appear in the middle of the length of the specimen, in the bottom areas of the cross-section. Two types of failure modes can be distinguished for different specimens. The first one, designated as "type A", is typical for concrete structures reinforced with a single bar known as a flexural failure. In this mode, the cracks propagated together with the increase of their width. From a certain point, only a single steel bar carried the internal bending moment caused by the applied force until the stress level reached its yield point. The second failure mode, designated as "type B" also known as a shear failure, was characterized by cracks appearing at an angle of about 45° or less. This means that it was not the bending moment but the shear force that determined the achievement of the load capacity. While the level of the applied load increased, the width of cracks increased, until the specimens failed, which occurred when the steel rod lost adhesion to the concrete and detached. The specimens subjected to corrosion for more days showed type B of failure mode (shear failure), i.e., specimens C6-C9 (Table 4). This proves that the presence of corrosion weakens the bond between the concrete and steel reinforcement. The examples of both types of failure modes are presented in Fig. 13. Moreover, Fig. 14 shows the specimen after destruction according to type B, where the rebar detached from the concrete.

- Two failure modes were observed in a three-point bending test, i.e., “type A” (flexural failure) and “type B” (shear failure). For specimens that were kept in the solution for a shorter time, type A was dominant, in which damage to the specimens was caused by the stress level that was equal to the yield point of the rebar. However, for the specimens that were kept in the solution longer, a different scheme was observed (type B), in which the diagonal and longitudinal cracks occurred as a result of the loss of adhesion of the bar to the concrete and, then, detachment. The lowest capacity was obtained for specimen C9, which was immersed in the NaCl solution for the longest time.
