## Sustainable development requires risky decisions - problematic 300 ton overweight transport passing a bridge

Mikołaj Miśkiewicz, Andrzej Kozakiewicz, Lukasz Pyrzowski, Bartosz Sobczyk

Gdańsk University of Technology, Gdańsk, Poland

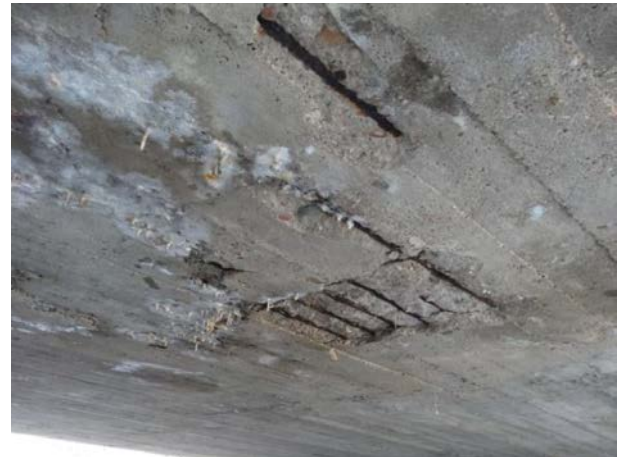
A detailed inspection of the bridge did not reveal severe cracking. Scratches or delamination would indicate a significant reduction of the load carrying capacity, namely suggest that the structure had been overloaded. However, numerous concrete losses, efflorescence and corrosion of the reinforcement were noticed on the underside of the concrete slab (Figure 3).

Figure 3. Bottom of the slab

This damage was evidently caused by leaking insulation. With regard to the supports, the cracking of the abutment wing and its waterlogging by rainwater were identified as the most significant damages.

Non-destructive field testing was done to determine the amount of reinforcement in the slab. Visible reinforcement at the bottom of the slab

was (Figure 3) counted. Scanning of the slab from above was done using GPR technology to inventory the upper slab reinforcement.

Visual inspection revealed that the slab at the mid-span is reinforced with  $\varnothing 20$  smooth rods with spacing between the bars to be approximately 10 cm. It was assumed that the reinforcing steel has the properties of the A-0 class material ( $f_d=190$  MPa).

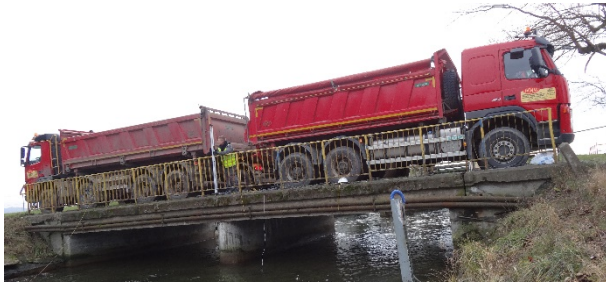
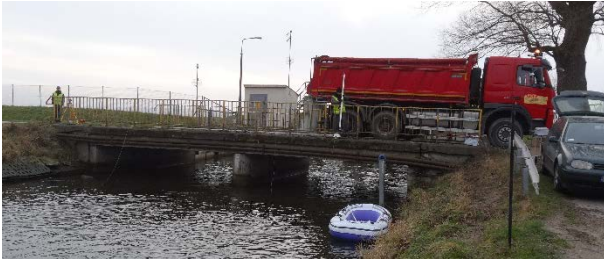
The loading test was carried out using 2 3-axle trucks with a total mass of 33 tonnes each and 2 4-axle trucks each having a mass of 40 tonnes. The trucks were positioned on the bridge according to five different arrangement configurations. These were aimed to induce extreme values of reaction forces over the supports and bending moments at the mid-span and over the support as well. Examples of vehicle alignments are shown in Figure 4.

Figure 4. Test load settings: top - inducing a minimum bending moment over the intermediate support, bottom - inducing a maximum span bending moment

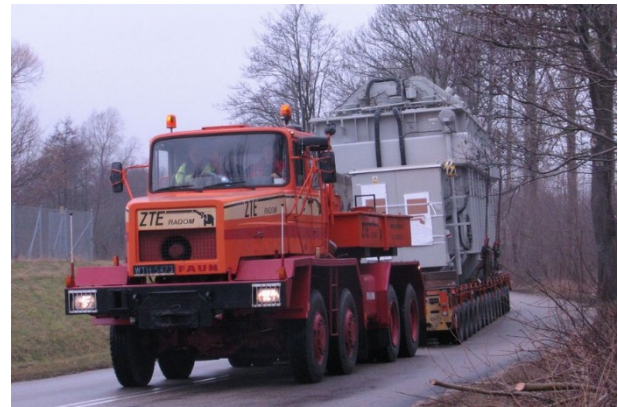
Figure 10. The oversized vehicle before driving onto the bridge
