## Geotechnical analysis and stability assessment of a landslide event in Gera Woreda, Ethiopia

This study investigates the geotechnical factors influencing a recent landslide event in Gera Woreda, Ethiopia. The primary objective was to identify the soil properties contributing to landslide occurrence and understand the triggering mechanisms. Field investigations, soil sampling from both affected and unaffected areas, and subsequent laboratory characterization were conducted. The analysis revealed a dominance of fine-grained soils, such as clay and silt, which are susceptible to weakening upon saturation, thereby increasing landslide susceptibility. Rainfall is identified as the primary trigger for the landslide. Numerical stability assessments using the Limit Equilibrium Method (software, Slide™) and the Finite Element Method (software, PLAXIS®) were performed to assess the stability of the slopes. The stability analysis revealed a notable decrease in the factor of safety (FS) under rising groundwater levels. For example, the FS for Slope 1 decreased from 1.42 under dry conditions to 0.73 at a 2 m groundwater depth. Similarly, Slope 2's FS decreased from 2.06 to 1.18 under simila

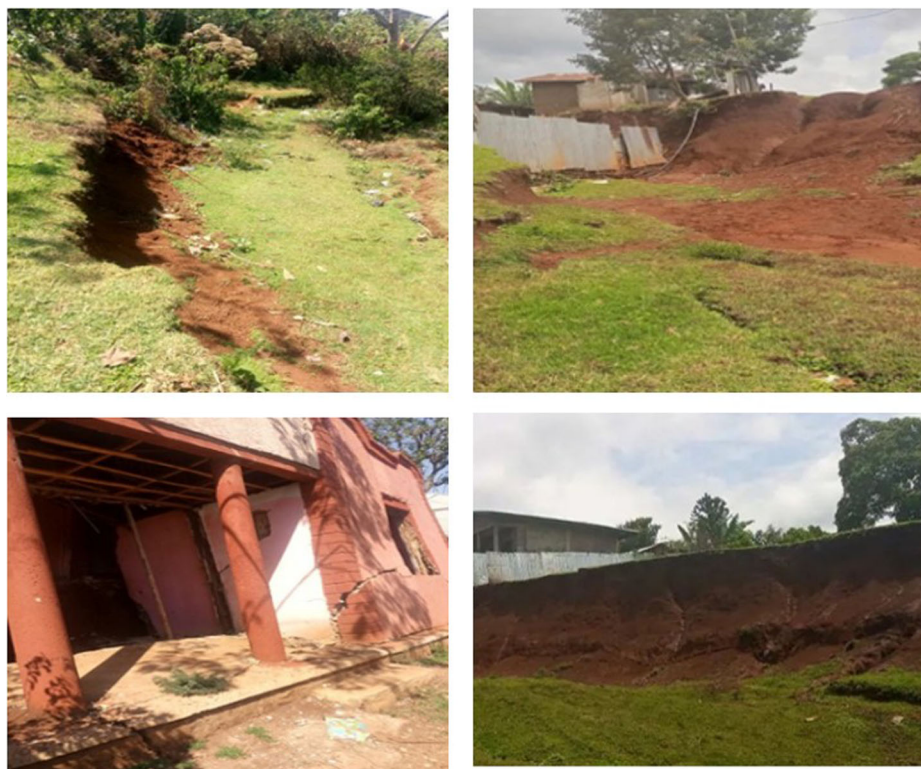
**Figure 3.** Land subsidence and effects on residential houses and roads.

The initial site visits provided critical insights into the environmental conditions contributing to the Gera Woreda landslide. The primary observations included visual indicators of ground instability, such as cracks on exposed subsurface profiles and evidence of ground subsidence. The destructive impact on infrastructure, including houses, roads, and utilities, was apparent, forcing residents to relocate (Figure 3). Despite the evident risks, some residents continued to live in precarious housing near the slope's toe, highlighting socio-economic challenges.

The observations indicate ongoing slope movement, particularly exacerbated by seasonal rainfall, which may increase pore pressure and trigger further instability. The continued habitation in high-risk areas underscores the need for targeted relocation and risk mitigation strategies. The presence of a river and springs at the slope's foot suggests a
