## CAUSES OF DEFECTS AND DAMAGE TO BRICK MASONRY ELEMENTS IN HISTORIC BUILDINGS

### Abstract

The paper is an engineering review of the causes of damage to masonry structures and indicates the need for cooperation between representatives of various specialties of science and technology, in particular architectural historians, specialists in the field of conservation of monuments, structural engineers and specialists in the field of geotechnics, geology, hydrogeologists and meliorators in order to ensure the protection of masonry structures in historic buildings.

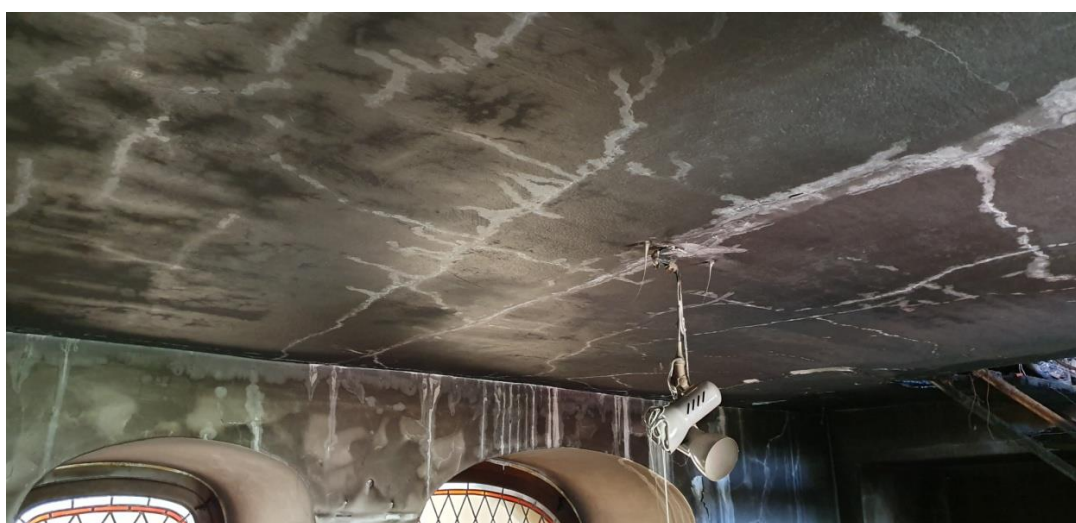
Fig. 5. Fire damage to solid ceramic brick wall and ceiling on wooden beams, visible cracks in plaster on wall and ceiling (photo: Maciej Niedostatkiewicz)

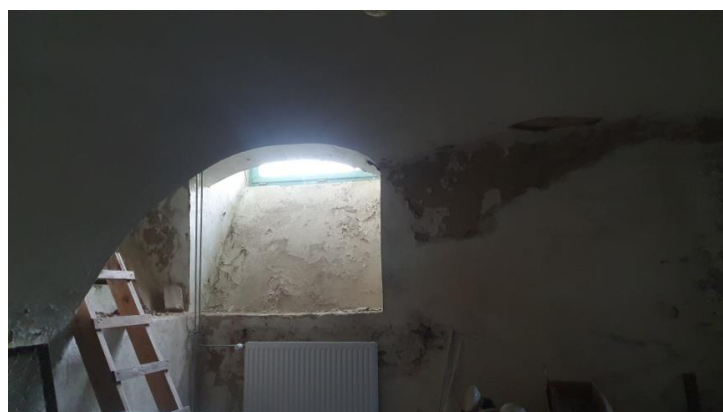
Fig. 7. Dampness of the external wall made of solid ceramic brick caused by the lack of vertical damp proofing in the part sunk in the ground (photo: Maciej Niedostatkiwicz)

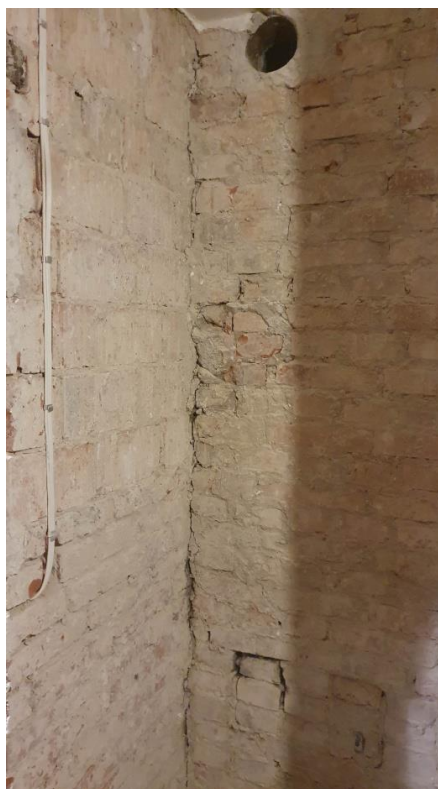
Fig. 13. No masonry bond between transverse and longitudinal interior walls made of ceramic solid brick  
(photo: Maciej Niedostatkiwicz)

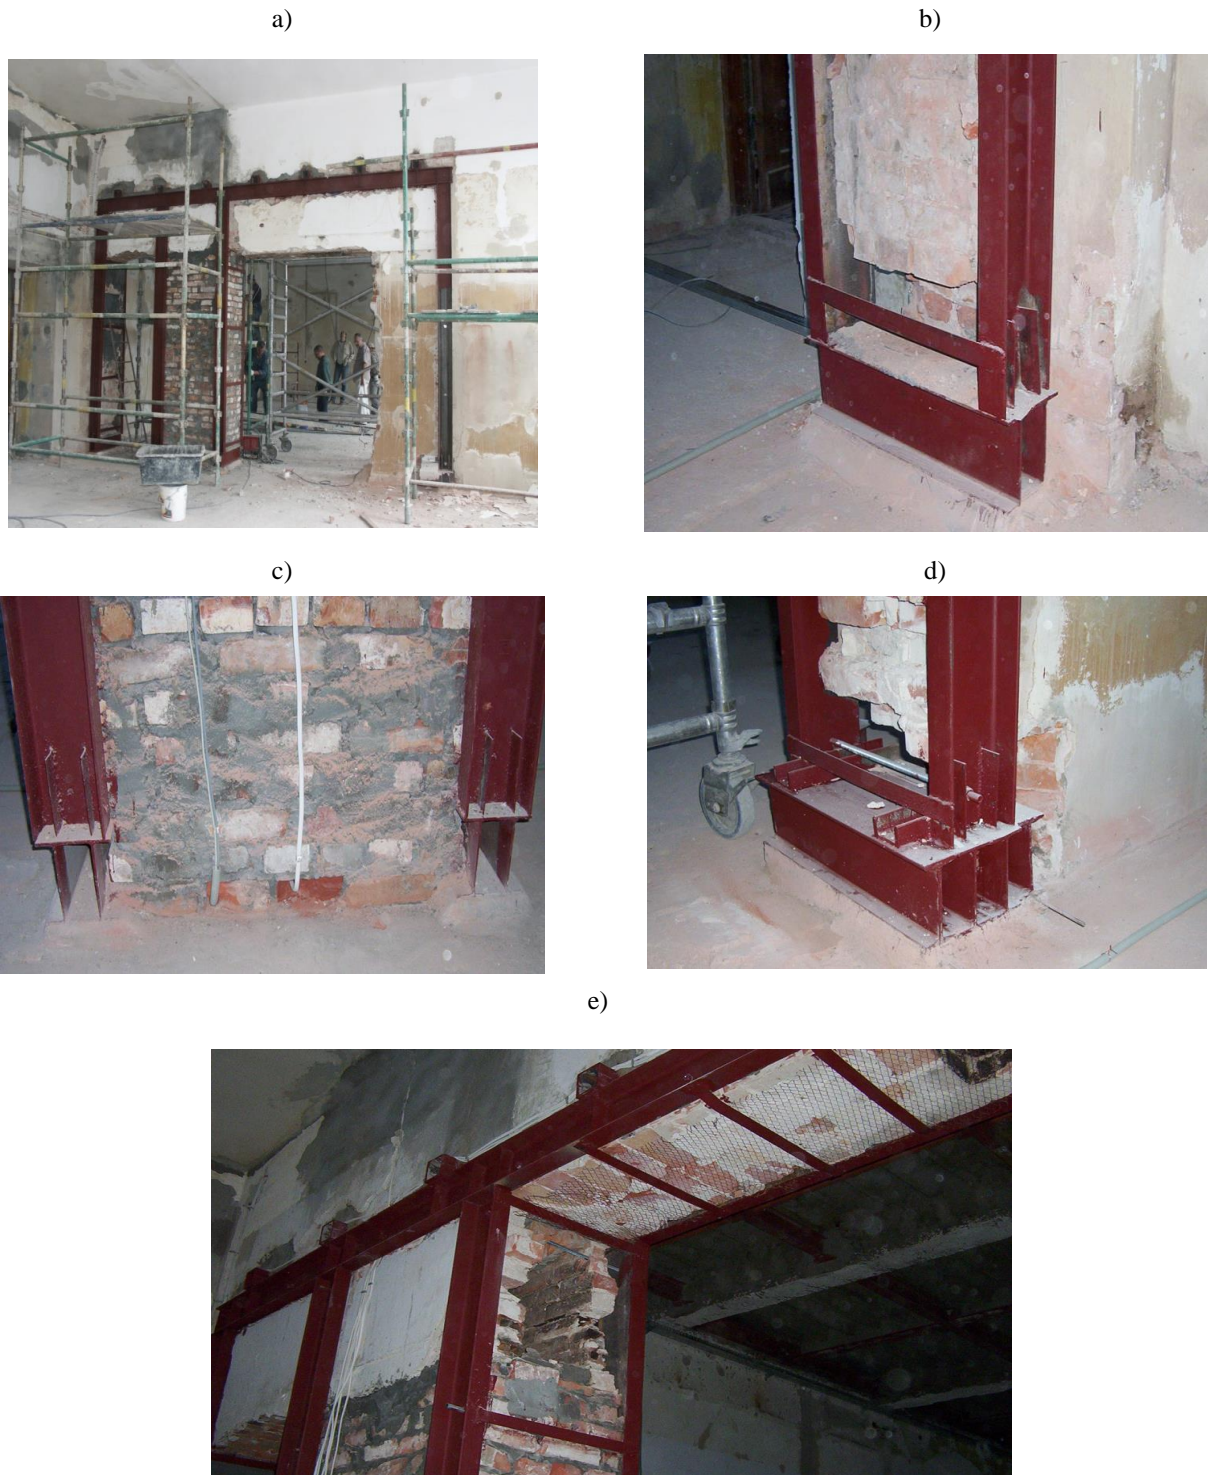
Fig. 17. Making door openings in the inner wall of solid ceramic brick: a) view of the steel frame, b), c), d), e) construction details (photo: Tomasz Majewski)

The renovation documentation developed in accordance with the recommendations of *Conservation Works Program*, makes it possible to safely carry out works related to the reconstruction and expansion of immovable monuments (Fig. 16), including carrying out works aimed at the ultimate change of use of the historic building (Fig. 17 and Fig. 18).

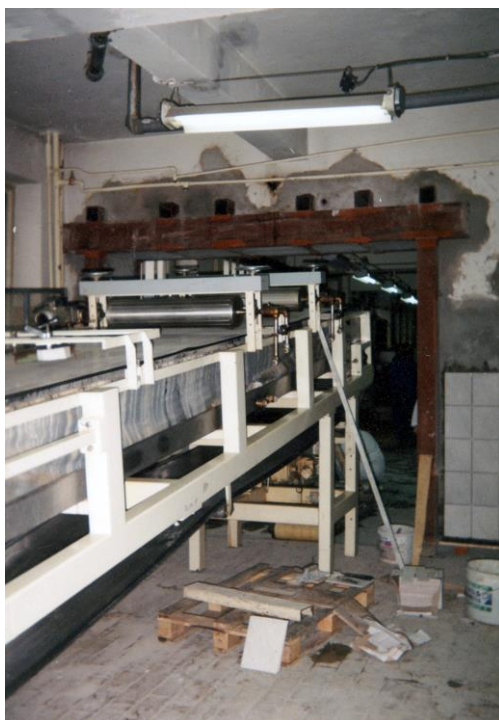
Fig. 18. Widening of the door opening in the inner wall of solid ceramic brick  
– view of the steel frame construction  
(photo: Maciej Niedostatkiwicz)

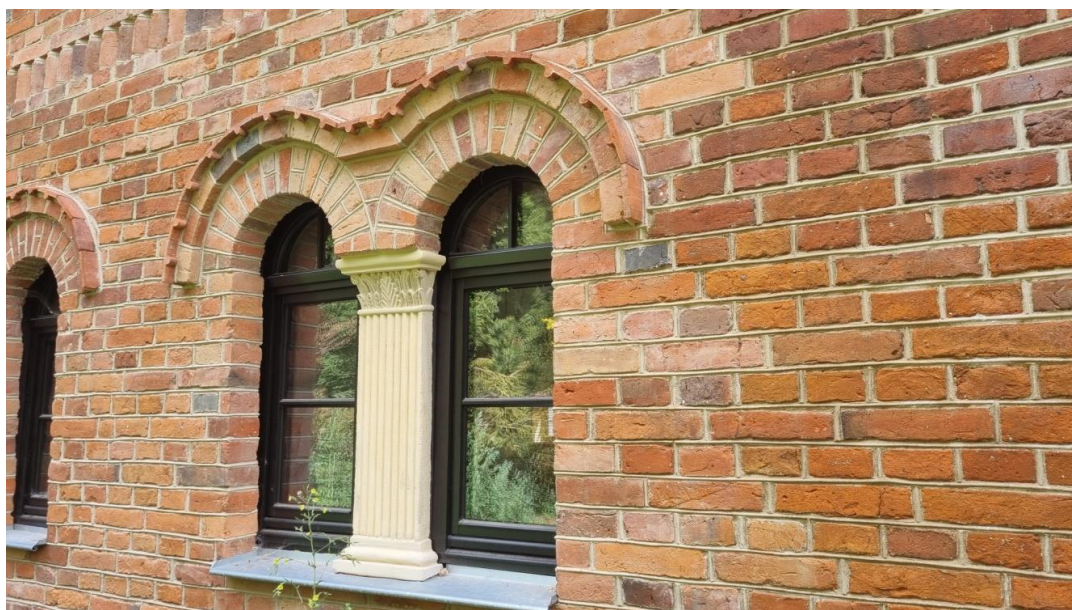
Fig. 19. Revitalization of historic solid ceramic brick wall using contemporary brick  
and ceramic tile and limestone details  
(photo: Maciej Niedostatkiwicz)
