Mechanism of hydrogen enhanced-cracking of high-strength steel welded joints

J. Ćwiek*, A. Zieliński

Faculty of Mechanical Engineering, Gdańsk University of Technology,
ul. Narutowicza 11/12, 80-952 Gdańsk, Poland

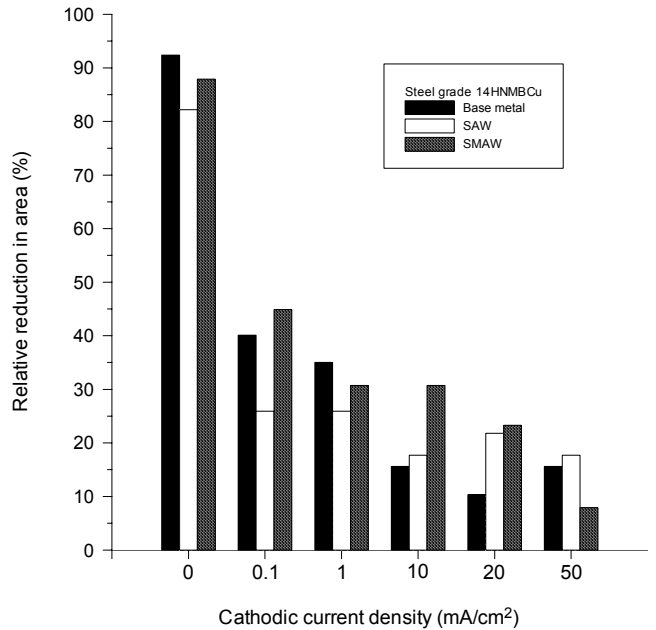
Fig. 2. Relative reduction in area versus cathodic current density for 14HNMBCu steel and its welded joints

Elongation and reduction in area were chosen as measures of hydrogen embrittlement. Then, relative parameters determined as

the ratio of the appropriate value measured in air to that measured in artificial sea-water were calculated and presented as bar charts (Fig. 1-2).

Observed decrease of relative values of elongation, and reduction in area with the increase of current density exhibits a certain minimum. Further increase of current density does not cause higher degradation. The loss of elongation was as high as 10% for base metal, and 35% for welded joints. Reduction in area decreased of 40% for base metal, and 55-75% in the case of SMAW and SAW welded joints respectively.

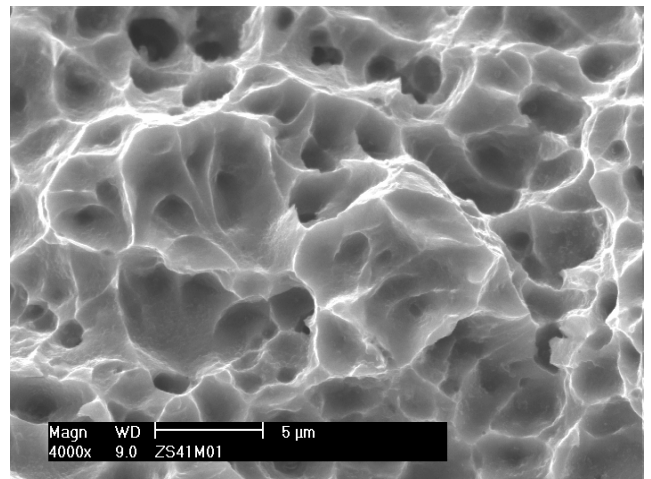
Fig. 3. SEM image of the fracture surfaces of welded joint (SMAW) of 14HNMBCu steel. SSRT test in seawater $i = 0.1 \text{ mA/cm}^2$

Fracture surfaces of failed samples were investigated with the use of the scanning electron microscope (SEM) to determine mode of fracture. Examples of fractographic observations are shown in Fig. 3-4.

Failure of samples with welded joints occurred always in weld metal, where strength was lower comparing to base metal. The reduction of ductility by hydrogen was accompanied by a change in fracture mode. For samples tested in air crack growth occurred in a ductile mode with microvoid coalescence and quasi-cleavage fracture. For samples tested in sea-water transgranular brittle mode with quasi-cleavage and cleavage fracture was observed. At higher cathodic current densities the presence of hydrogen induced microcracks and flakes appeared (Fig. 4).
