## Hydrogen degradation of high strength weldable steels

**Purpose:** Purpose of this paper is presentation of hydrogen degradation issue of high strength steels and especially their welded joints. Establishing of applicable mechanisms of hydrogen-enhanced cracking was the aim of performed research.

**Design/methodology/approach:** High strength quenched and tempered steels grade S690Q were used. Welded joints were prepared with typical technology used in shipyards. Susceptibility to hydrogen degradation in sea water under cathodic polarization was evaluated with the use of mechanical tests. Various kinds of loads were applied, i.e. monotonically increasing static, constant, and cyclic. Appropriate measures of hydrogen degradation were chosen and analyzed. Mechanisms of hydrogen degradation were detected and established on the basis of scanning electron microscopy (SEM) observation of fracture samples surface.

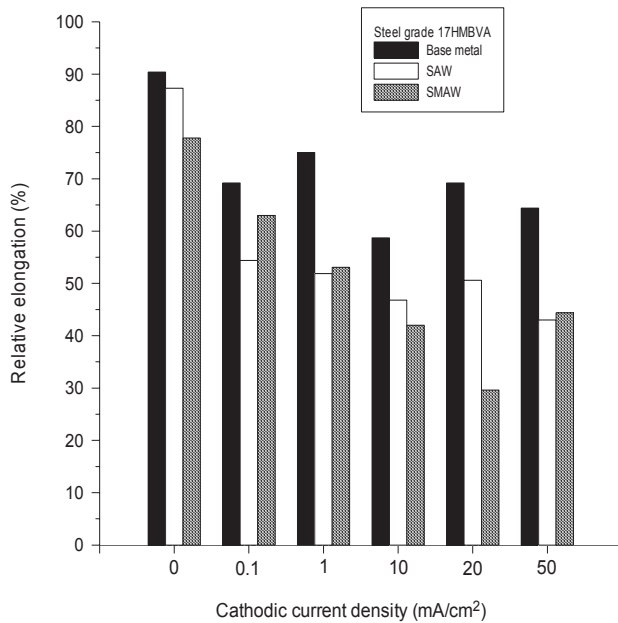
Examples of obtained results for loss of elongation after SSRT tests presents Fig. 1. Observed decrease of relative values of elongation with the increase of current density exhibits a certain minimum. Further increase of current density does not cause higher degradation due to deposits evolution on samples surface and hindering of hydrogen absorption. The loss of elongation was as high as 40-45% for base metals, 40-55% for SAW, and 55-70 for SMAW joints.

Fig. 1. Relative elongation vs. cathodic current density for 17HMBVA steel and its welded joints

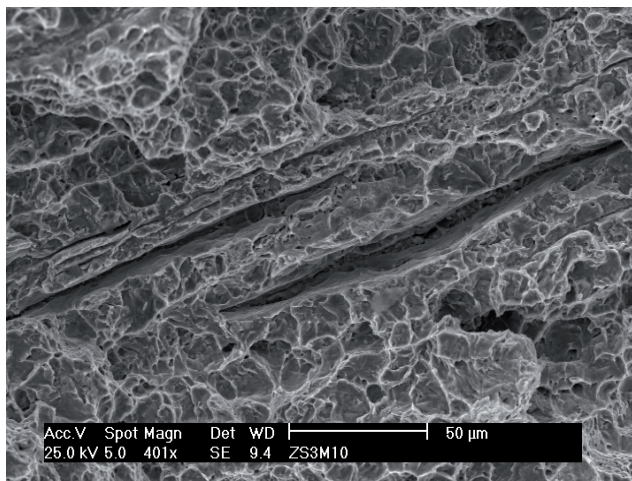
Samples with welded joints tested in air revealed ductile – MVC fracture mode. When cathodic polarization was applied mixed – MVC and quasi-cleavage fracture was observed. At higher cathodic current densities the presence of hydrogen induced microcracks and flakes in weld metal (Fig. 2). Obtained results of SSRT test and fractographic observations suggest that hydrogen-enhanced localized plasticity (HELP) model is the more applicable mechanism of hydrogen degradation. Hydrogen assisted-cracking occurs at load level as high as flow stress (yield strength) of tested steel and its welded joints.

Fig. 2. SEM image of fracture surface of 17HMBVA steel sample with SAW welded joint after SSRT test in seawater,  $i = 10 \text{ mA/cm}^2$ . Fracture localized in weld metal

Ductile and quasi-cleavage fracture modes support suggestion that hydrogen interacts with dislocations and increase their mobility, and at the same time hydrogen is transported by mobile dislocations. Hydrogen ions transported with mobile dislocations locally increasing hydrogen concentration which facilitates cracking.

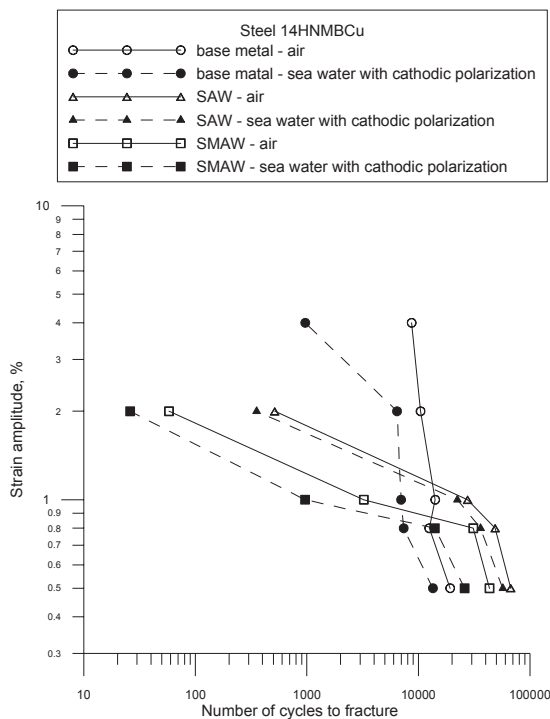
Results of fatigue tests of 14HNMBCu steel and its welded joints are presented in Fig. 3. Significant reduction of fatigue life time (30-90%) due to hydrogen absorption was observed for 14HNMBCu steel. Reduction increased with increase of strain amplitude. Welded joints of 14HNMBCu steel had higher resistance to low-cycle fatigue assisted by hydrogen. It should be noted that low-cycle fatigue test is very severe since plastic deformation is reached.

Fig. 3. Number of cycles to fracture versus strain amplitude for 14HNMBCu steel and its welded joints
