B. Świczko-Żurek¹, M. Krzemiński²

THE DEGRADATION OF METAL IMPLANTS

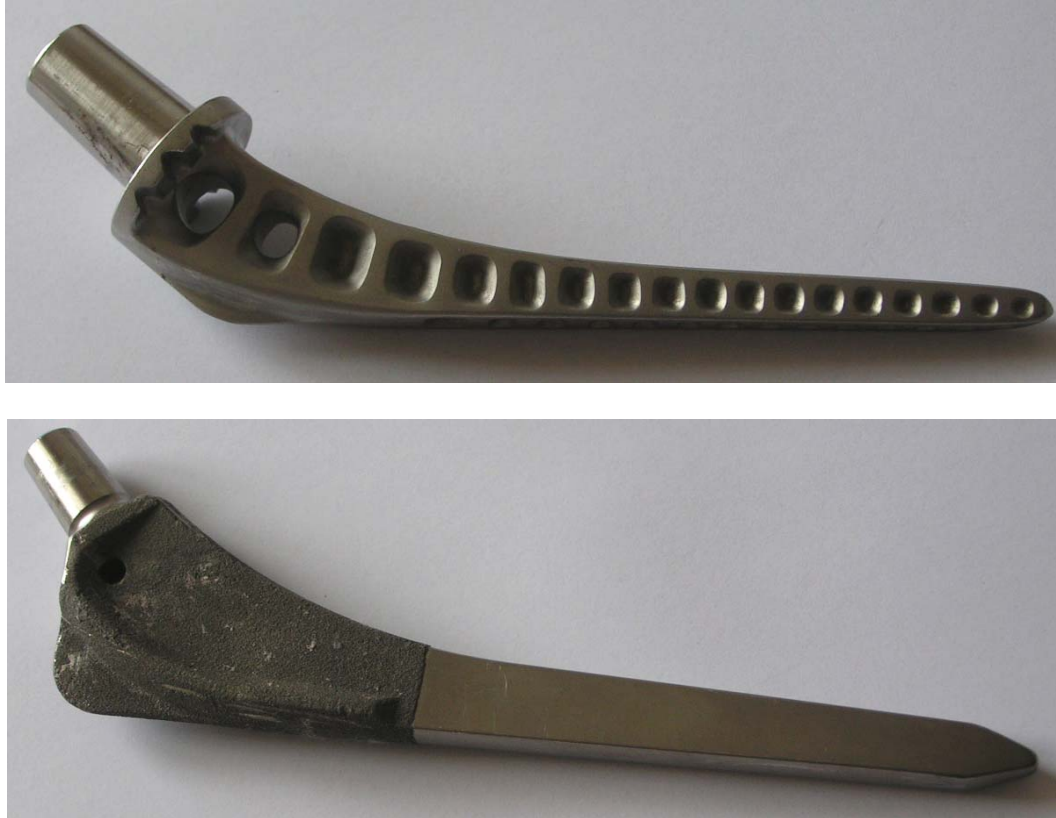
Two endoprothesis made of alloy steel - Ti6Al4V (pic.1). The chemical composition was as follows: Ti, 4,08%V, 6,39%Al, 0,17%Fe, 0,015%C, 0,185%O, 0,005%N, 0,0035%H

Pic.1. The endoprothesis made of titanium alloy (Ti-6Al-4V)

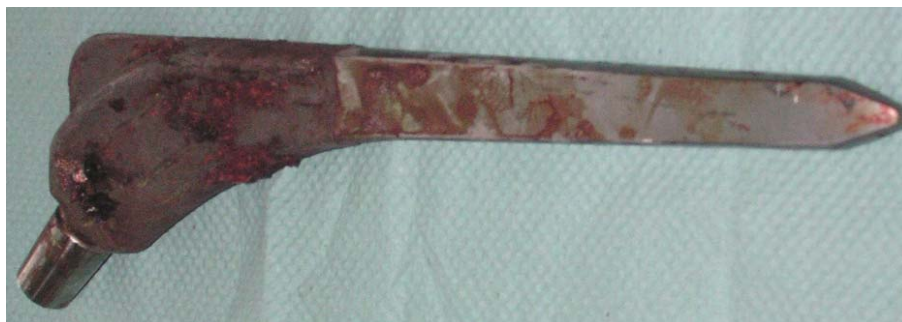
Those were endoprothesis of two men. First one aged 59 (had his endoprothesis planted in 1991 and removed in 2003). The other patient aged 65 (had his endoprothesis planted in 1997 and removed in 2005). In both cases aseptic loosening was the reason for removal.

Picture 4 and 5 show degraded implants, after removed of human body.

Pic.5. The degraded implants from the second patient
