**B. Świczko-Żurek, W. Serbiński, A. Szumlański<sup>1</sup>**

Gdańsk University of Technology, Faculty of Mechanical Engineering,

## **ANALYSIS OF THE FAILURE OF FIXATOR USED IN BONE SURGERY**

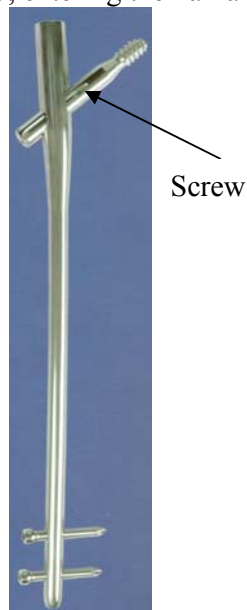
**Fig. 1.** The Gamma nail [2]

The Gamma nails (Fig.1) make it possible to cure complicated comminuted fractures, fractures of neck of femur as well as intertrochanteric fractures and pathological ones. They must transform loadings caused by forces on head of femur, which bend position crew, entering the nail and introduced through the neck into the head of femur [2].
