**B. Majkowska<sup>1</sup>, W. Serbiński<sup>1</sup>, I. Skalski<sup>2</sup>**

<sup>1</sup>Gdansk University of Technology, Faculty of Mechanical Engineering, Department of Materials Science and Engineering, Gdansk, Poland

## **ASSESSMENT OF CAVITATION EROSION DAMAGE OF LASER REMELTED THE SUPERSTON ALLOY**

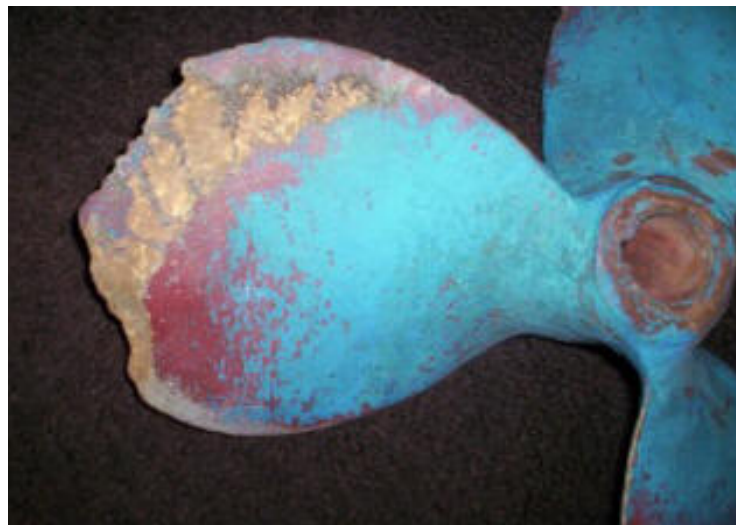
Degradation by the cavitation is very popular in ship propellers, usually made of copper alloys e.g. SUPERSTON alloy [1-3]. The cavitation phenomenon causes excessive vibrations, noise and finally degradation of the propeller blades (Fig. 1).

**Fig. 1.** Cavitation erosion damage of the ship propeller [4]

This phenomenon is the result of formation of vapour bubbles in the fluid in regions where the flow conditions produce fall of pressure and subsequent violent collapse of these bubbles on surface of these blades in neighbouring areas where the local pressure is higher.
